Final Report Review of Blast Documentation Data White Rock Quarry North (WRQN) Miami-Dade County Lake Belt

Florida Department of Financial Services

Lampl Herbert Consultants PO Box 10129 Tallahassee, FL 32302

June 12, 2017

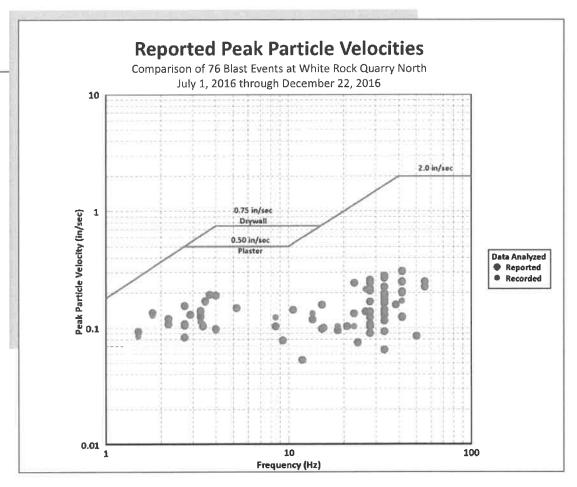
Figure 10: Comparison of Reported Versus Recorded PPV Data

☐ These discrepancies are attributed to human error that occurred when the electronic data were reentered on to the paper DSFM form.

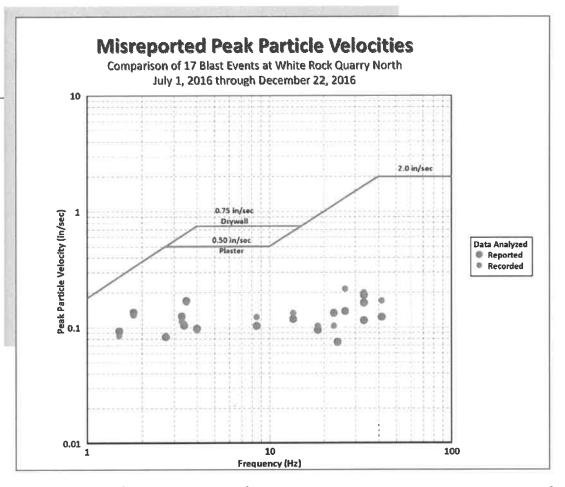
Figure 12: Comparison of Misreported PPV Data

There were 17 misreported Peak Particle Velocity (PPV) values from July 1, 2016 through December 22, 2016. Eight values were over-reported, nine values were under-reported, and zero values were non-reported. None of the reported or recorded values exceeded the 0.50 IPS limit (Figure 12). The misreported PPV values likely occurred during transcription from Velocity Waveform Analysis sheets (recorded data) to the Blasting Activities Reports (reported data) by WRNQ.

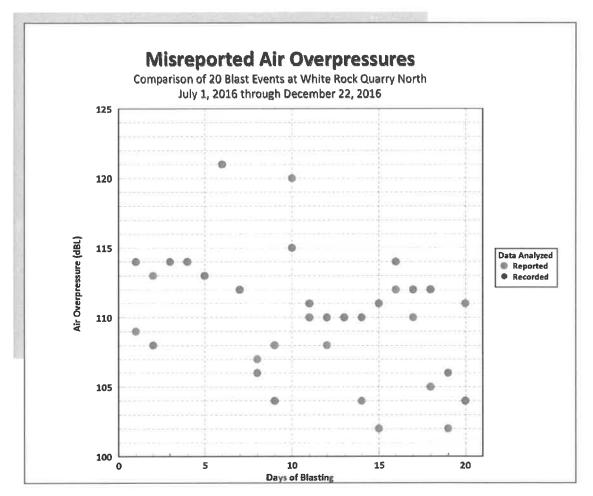
Figure 13: Comparison of Misreported AO Data

There were 20 misreported Air Overpressure values from July 1, 2016 through December 22, 2016. Nine values were overreported, five values were under-reported, and six values were non-reported. None of the reported or recorded values exceeded the 121 dBL (Figure 13). The over-reported and under-reported Air Overpressure values likely occurred during transcription from Velocity Waveform Analysis sheets (recorded data) to the Blasting Activities Reports (reported data) by WRNQ. LHC did not receive the Velocity Waveform Analysis Sheets for six blast events, therefore, we cannot verify the reported values.

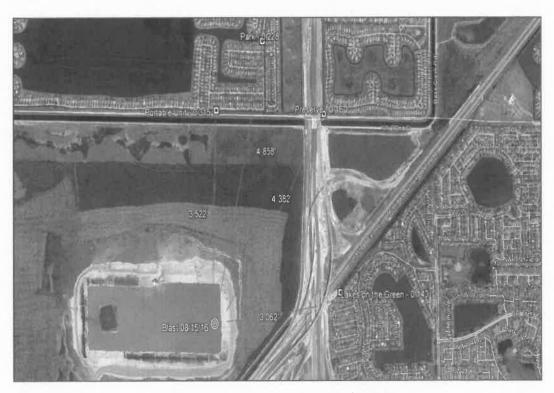
Figure 16: Seismograph Location and Readings for August 15, 2016

While the blast event was within the acceptable range below 0.5 IPS, this example illustrates the quality of reporting, which opens the process to scrutiny. A discrepancy was noted in that the closest seismograph was not the portable unit deployed for DSFM compliance but the PPV reading for the portable unit was the highest value reported as shown in Table 1 and Figure 16. Additionally, one of the WRQN seismographs (unit 7787) had not been calibrated according to manufacturer's recommendation of annual calibration.

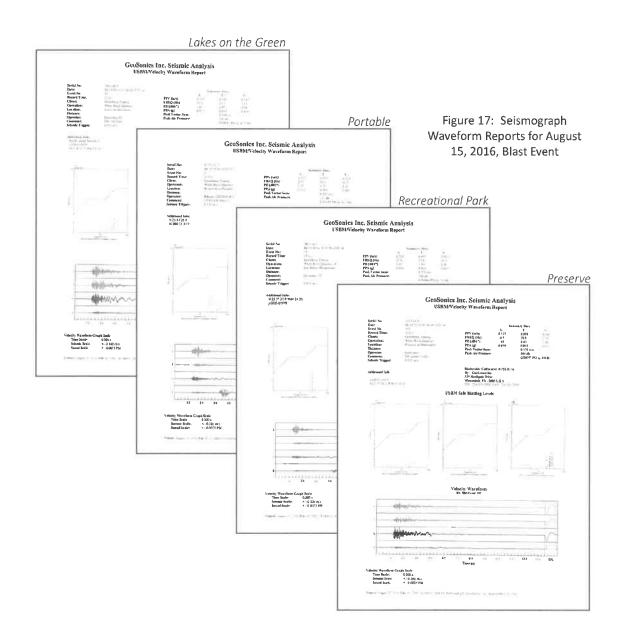
The seismograph waveform records for the August 15 blast event are from the four locations shown in Figure 17. The SW 54th Street location had the highest PPV levels; as noted above, at a higher level than the Lakes on the Green location that was not the closest structure but, in fact, was 300 feet farther east than the closest structure. No information was presented in the DSFM compliance report as to why the closer structure was not used.

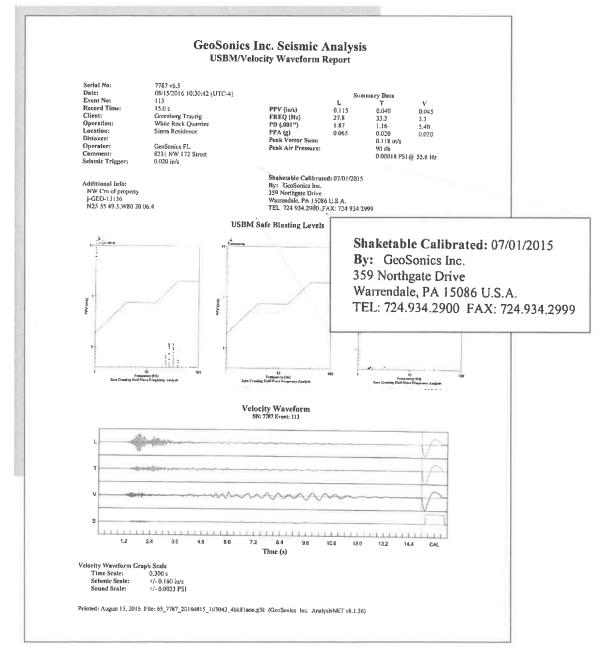
Figure 18: Waveform Report Showing Out of Date Calibration for August 15, 2016, Blast Event

Seismographs are calibrated on an annual basis. Seismograph 7787 was last calibrated on July 1, 2015; consequently, the instrument was past its calibration date for the blast on August 15, 2016 (Figure 18).

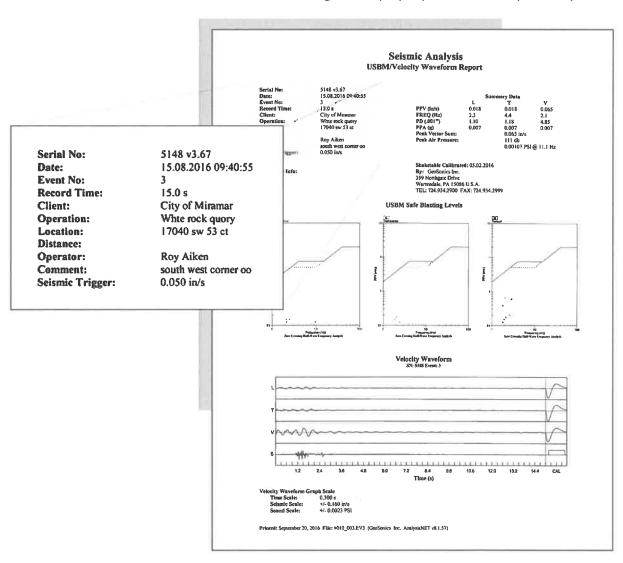
Figure 19: Miramar Portable Seismograph Waveform Report for August 15, 2016, Blast Event

- ☐ Trigger level is set at 0.05 IPS when the industry standard is a setting of 0.03 IPS or lower (Figure 19).
- ☐ The time on the waveform does not match the time of the blast; this is the clock timing error noted previously
- ☐ The air overpressure arrival time does not match the monitor distance; this is a microphone not being utilized properly which is noted previously.
