# Town of Miami Lakes

## Storm Water Management Master Plan and Drainage Capital Improvements Program Prepared for:

# Town of Miami Lakes Storm Water Management Master Plan and Drainage Capital Improvements Program

## *Table of Contents*

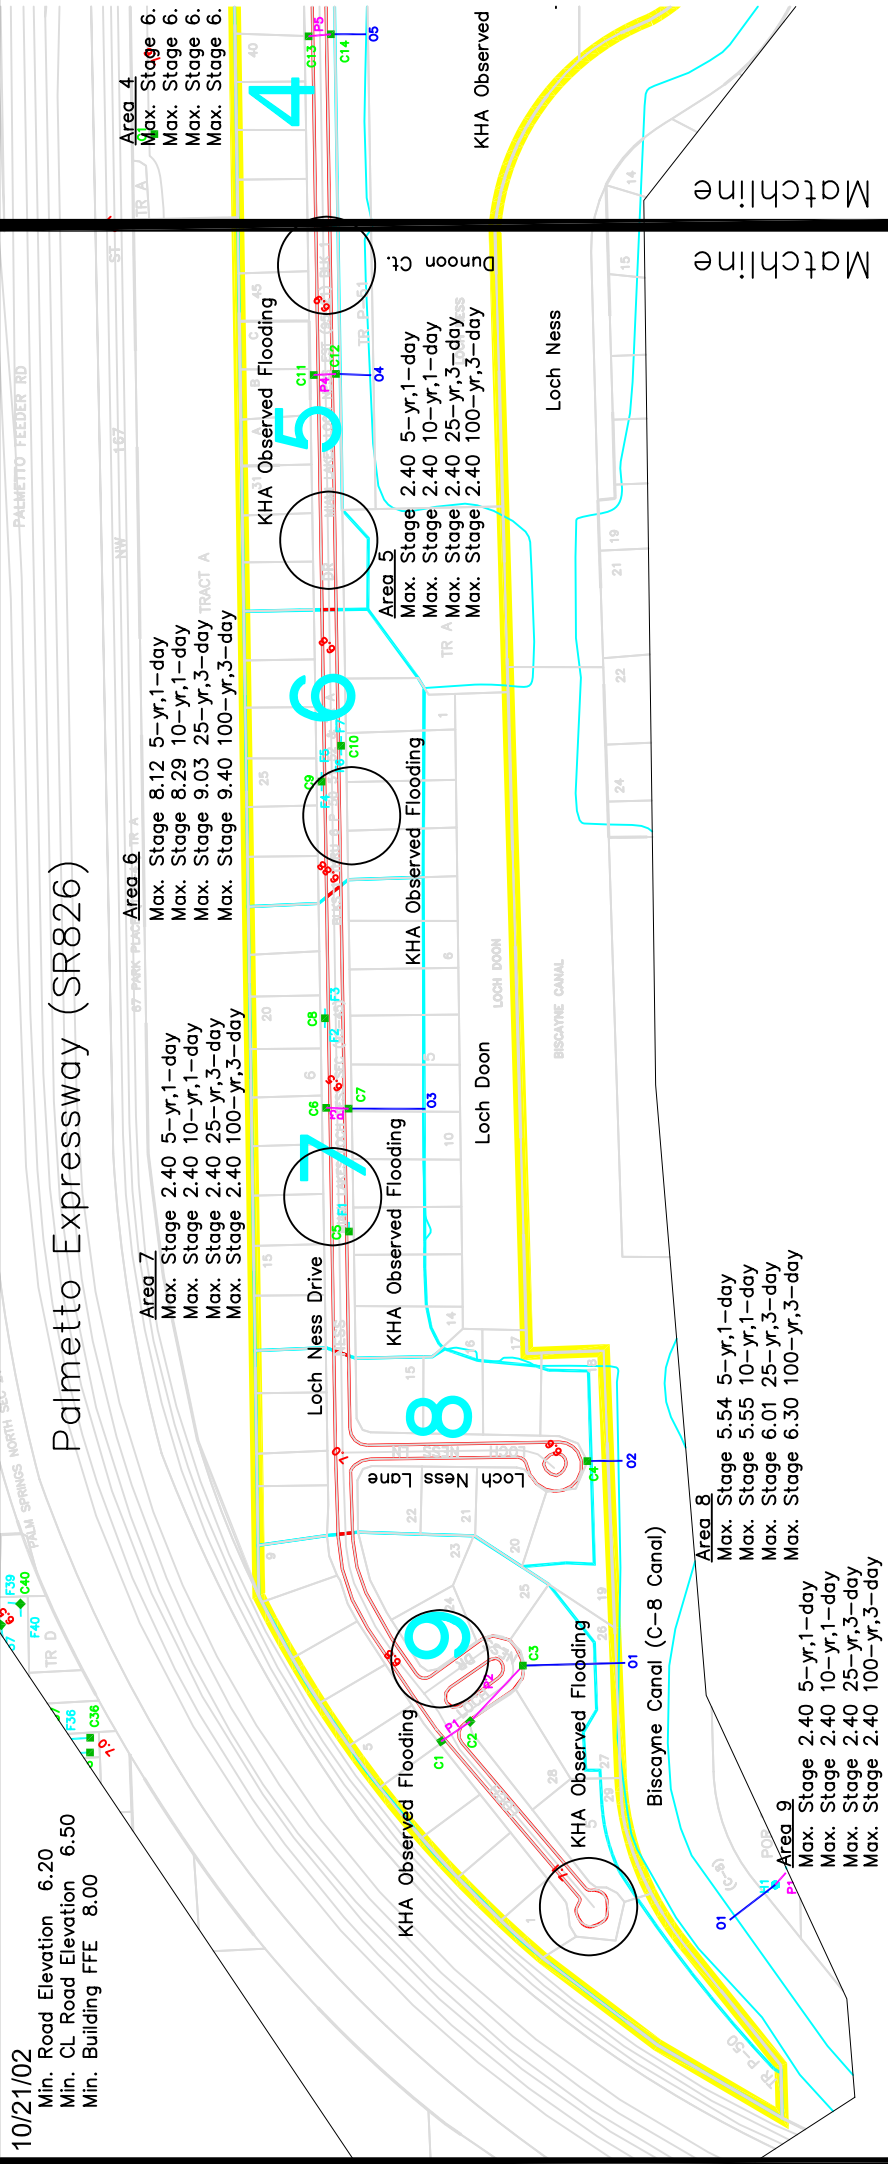
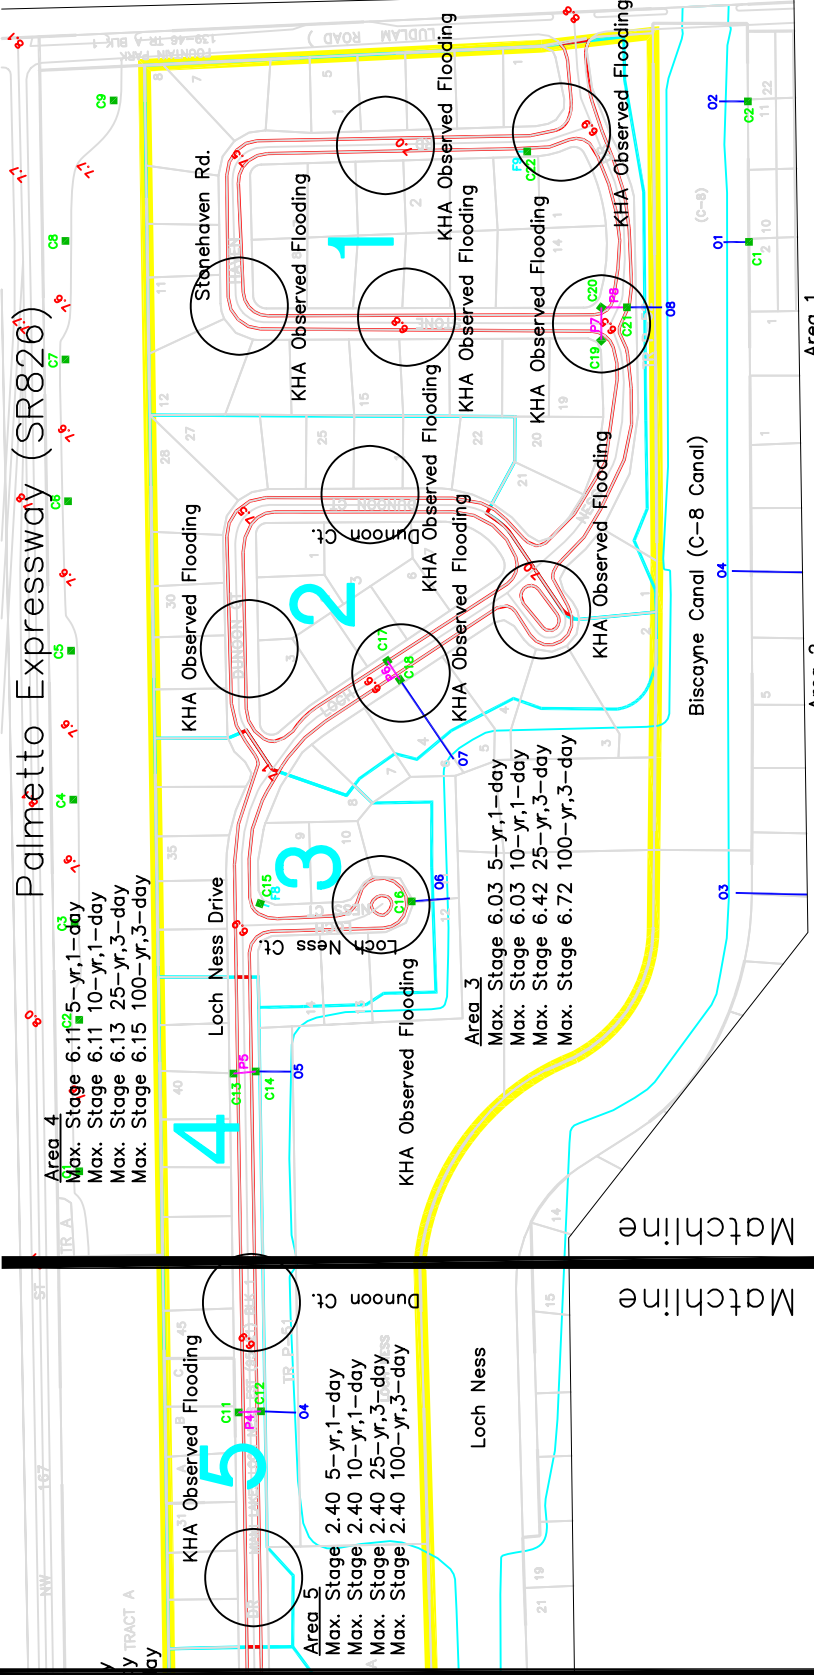
**Figure 8. Loch Ness Sub-Basin (30-2014-010)-Existing**

Figure 8 shows existing conditions for the Loch Ness sub-basin. The sub-basin consists of approximately 43.2 acres of existing detached single family development with approximately 8,400 linear feet of roadway, including: Dunoon Court, Loch Ness Court, Loch Ness Drive, Loch Ness Lane and Stone Haven Road. The existing roads range in elevation from a low of approximately 5.7 to a high of approximately 7.5 feet. The sub-basin was subdivided into nine areas. Some of these areas have catchbasins, short sections of exfiltration trench, interconnecting culverts and outfalls. The Sub-basin was subdivided into 9 areas. There are three areas (1, 8 & 9) with direct outfalls into the C-8 Biscayne Canal, five areas (2, 3, 4, 5 & 7) with existing outfalls into the Loch Doon and Loch Ness Lakes (widened sections of the C-8 Biscayne Canal). Area 6 does not have an existing outfall. There are a few sections of road that only have catchbasins with short (30 ± feet) sections of exfiltration trench without any outfall. Stone Haven Road and Dunoon Court are poorly drained roads with flat slopes and no drainage infrastructure.

**Maintenance:** There are a few catchbasins that were observed to be filled with debris and sediment such that water flow was blocked or highly restricted. This condition was observed at the catchbasins leading to the outfalls in drainage areas 1, 2, 3 and 9.

**Lack of Infrastructure:** There are several flat (minimum slopes) stretches of roadway, that do not have any existing storm drainage infrastructure. These areas have several low points in the roadway, that were observed to pond during storm events because runoff cannot flow to the existing catchbasins. This condition is found in Stone Haven Road (area 1) and Dunoon Court (area 2) and a few sections (areas 5, 7 and 9) of Loch Ness Drive.

**Inadequate Drainage Infrastructure:** There are some low points in the roads which have existing catchbasin(s) and short sections of exfiltration trench, but no positive outfall. The capacity and performance of the existing exfiltration (estimated to be 20 to 30 years old) trenches may be reduced due to sedimentation build up in the trenches and perforated pipes. Based on the hydraulic analysis the existing catchbasins and short exfiltration trenches in Area 6 are inadequate. Area 6 is the only area that does not have an existing positive outfall.

Areas 1 and 7 also have some isolated catchbasins with short length of exfiltration trench that are not connected to a positive outfall. Although it is beyond the scope (lack of detail survey data) of the Master Plan to hydraulically evaluate these small isolated areas, the results would be expected to be very similar to basin 6 results and frequent flooding would be expected, as has been observed in these areas.

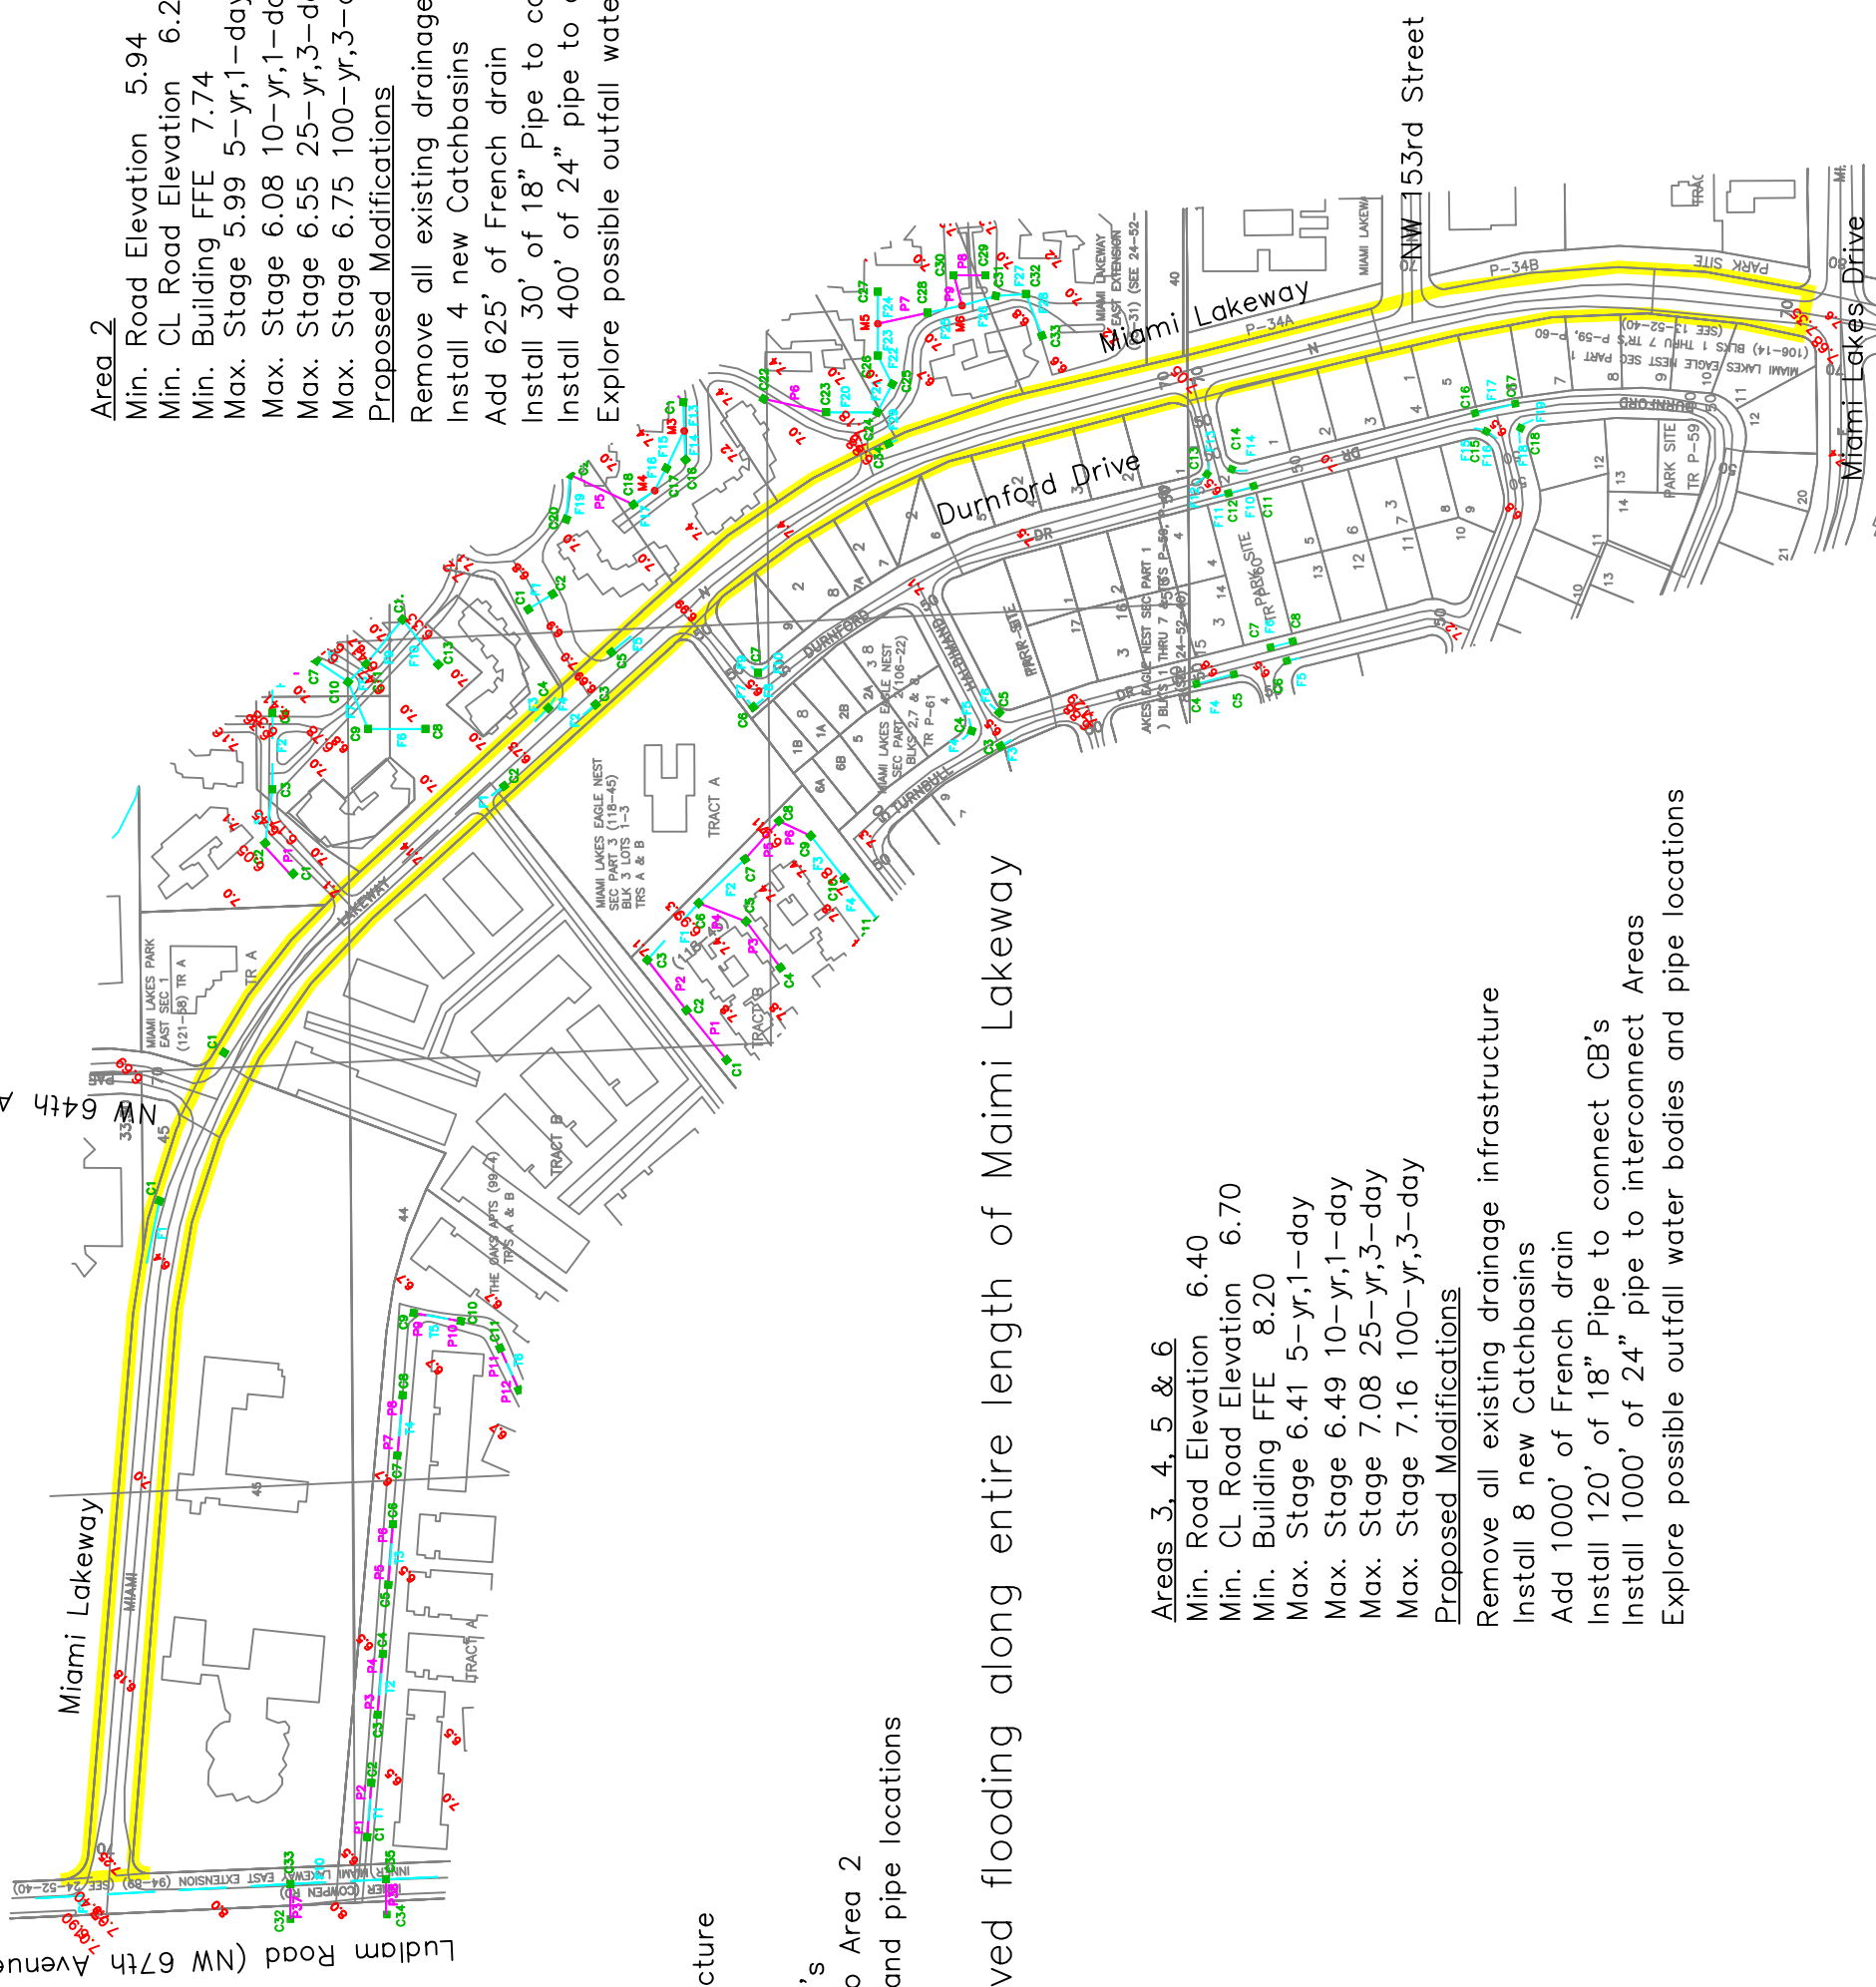
**Lack of Outfalls or Drainage Wells:** Based on the observed ponding the existing drainage system appears to be undersized and does not have sufficient capacity to meet the performance goals. Drainage wells or outfalls may be required.

**Area 2**  
 Min. Road Elevation 5.94  
 Min. CL Road Elevation 6.24  
 Min. Building FFE 7.74  
 Max. Stage 5-yr, 1-day 6.08  
 Max. Stage 10-yr, 1-day 6.55  
 Max. Stage 25-yr, 3-day 6.75  
 Max. Stage 100-yr, 3-day

**Proposed Modifications**  
 Remove all existing drainage infrastructure  
 Install 4 new Catchbasins  
 Add 625' of French drain  
 Install 30' of 18" Pipe to connect CB's  
 Install 400' of 24" pipe to connect to Area 3  
 Explore possible outfall water bodies and pipe locations
