MASTER PLAN

Update #1

Storm Water Master Plan Update #1

The Town of Miami Lakes,
Miami-Dade County, Florida

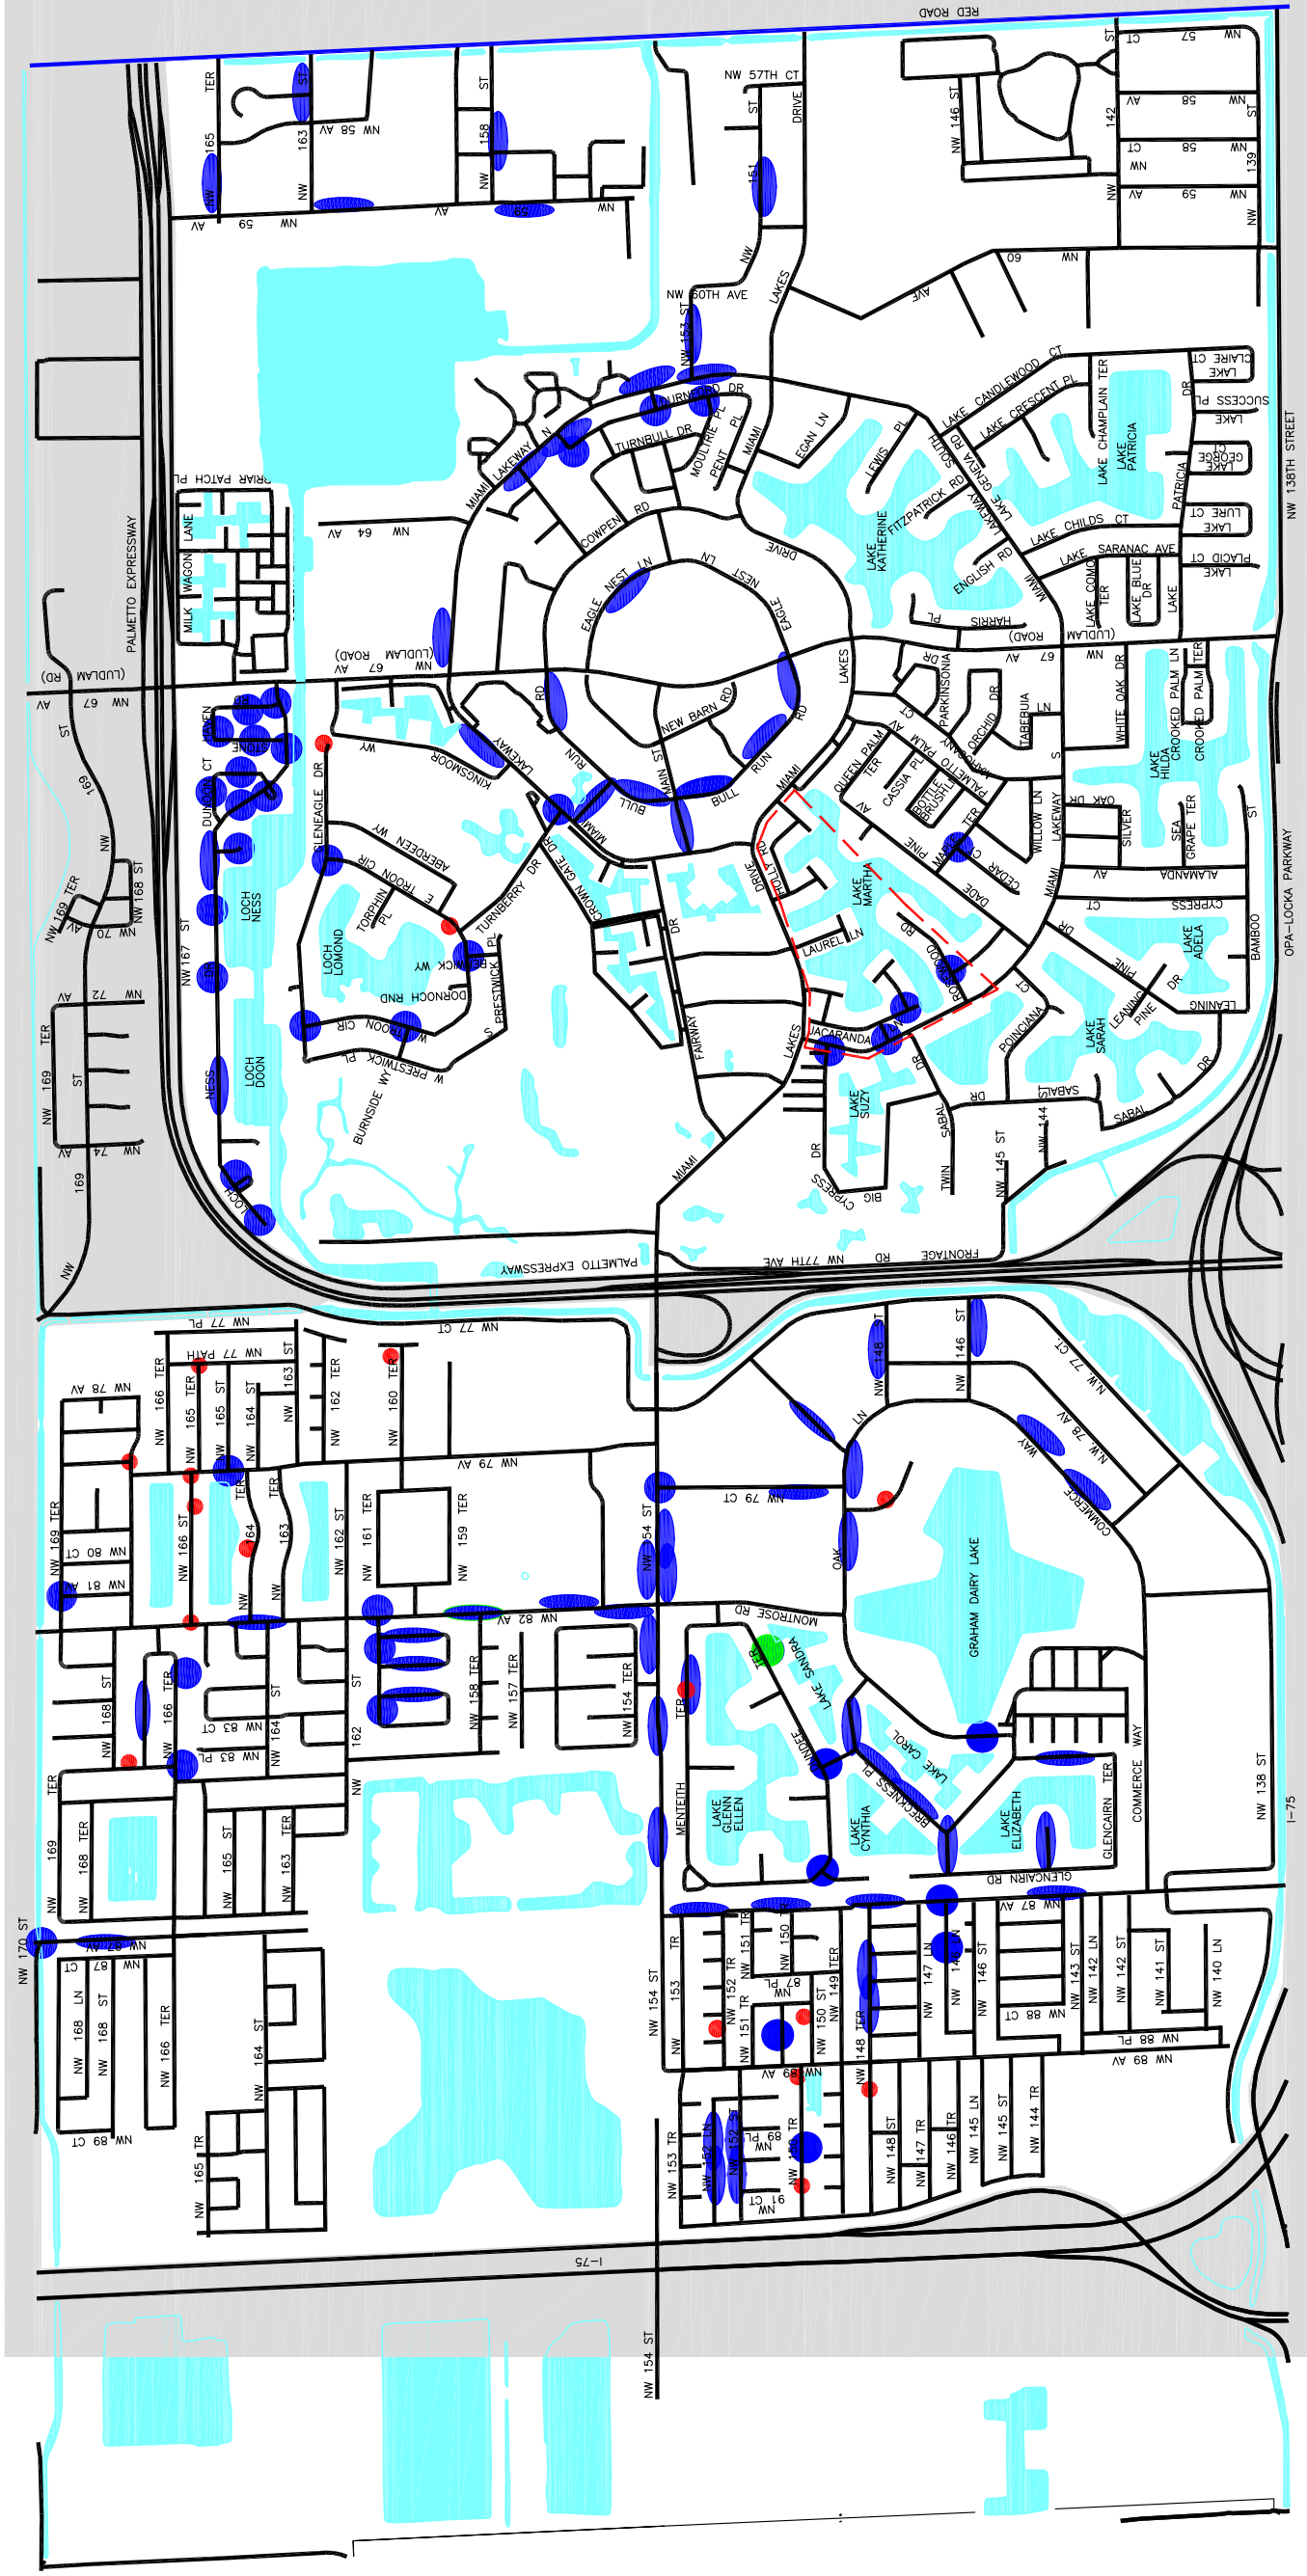
FIGURE 1. DRAINAGE DEFICIENCIES IDENTIFIED IN 2003 STORM WATER MASTER PLAN

KHA obtained copies of unresolved storm water related complaints from Town staff. The areas represented by these complaints are shown in Figure 1. Most of these areas correspond to drainage deficiencies observed during the field review of storm water problem areas.

The results of the field review can be seen in Figure 1. Based on this field review, it appears that some of the drainage deficiencies identified in the Town's original Storm Water Master Plan have been corrected by either improved maintenance by the Town or capital improvements projects completed by the Town under the Storm Water Utility or by Miami-Dade County under the FEMA/DORM program. However, there are still several areas within the Town where drainage deficiencies were observed.

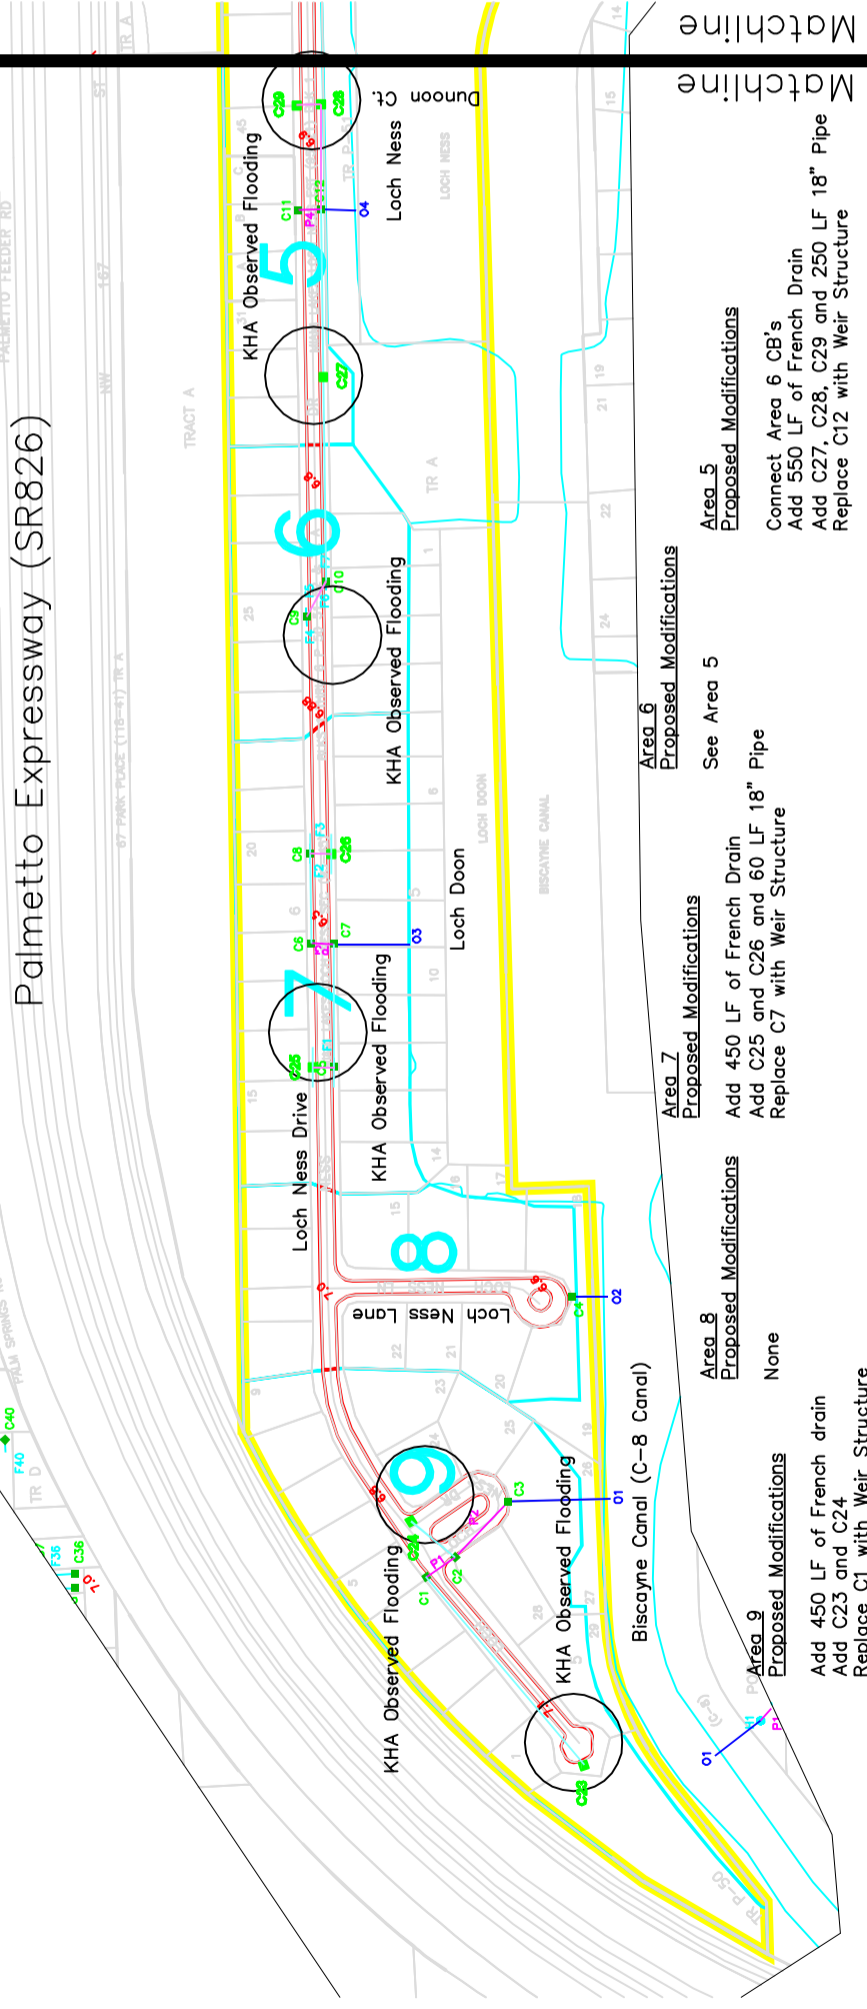
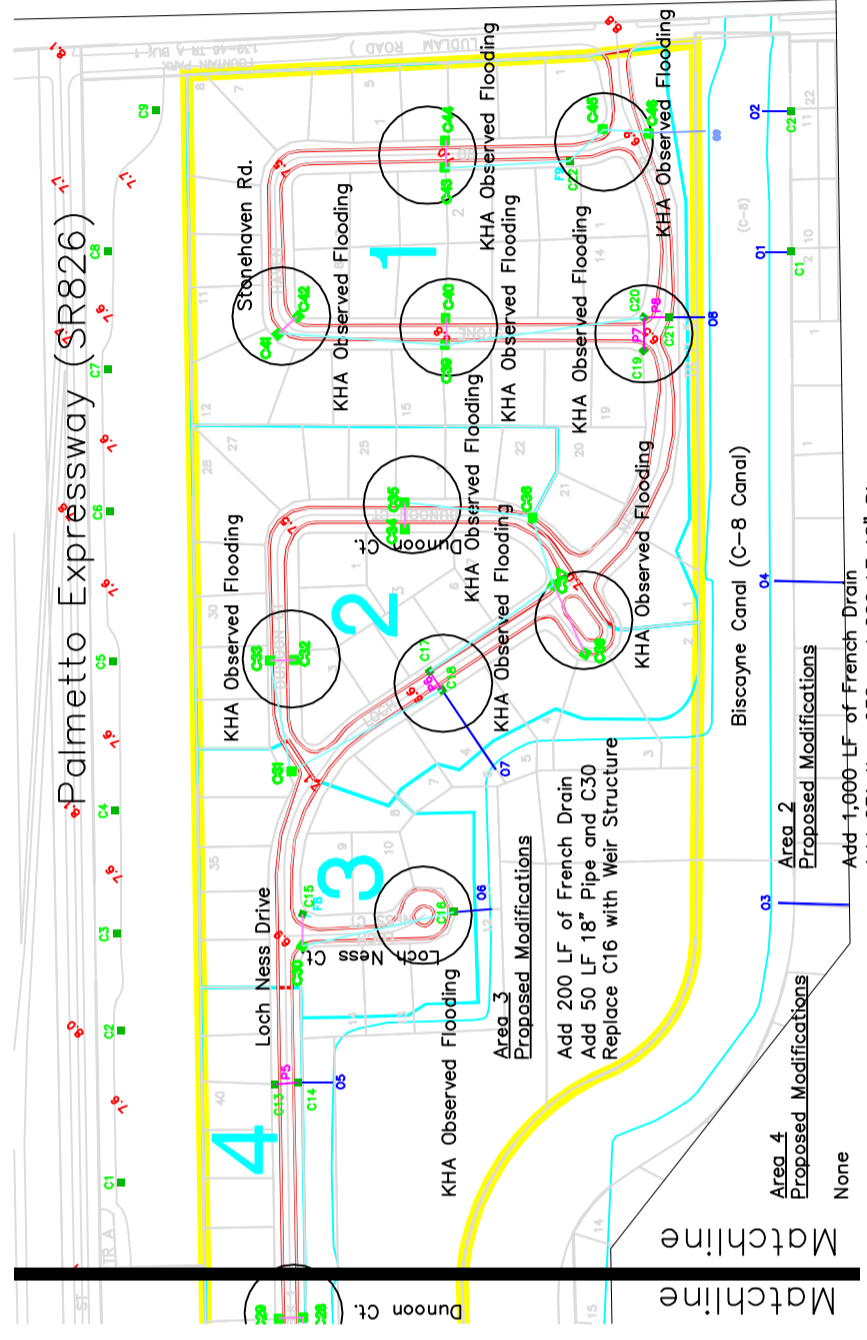
Maintenance: There are a few catchbasins that were observed to be filled with debris and sediment such that water flow was blocked or highly restricted. This condition was observed at the catchbasins leading to the outfalls in drainage areas 1, 2, 3 and 9.

Lack of Infrastructure: There are several flat (minimum slopes) stretches of roadway that do not have any existing storm drainage infrastructure. These areas have several low points in the roadway that were observed to pond during storm events because runoff cannot flow to the existing catchbasins. This condition is found in Stone Haven Road (area 1) and Dunoon Court (area 2) and a few sections (areas 5, 7 and 9) of Loch Ness Drive.

Inadequate Drainage Infrastructure: There are some low points in the roads which have existing catchbasin(s) and short sections of exfiltration trench, but no positive outfall. The capacity and performance of the existing exfiltration (estimated to be 20 to 30 years old) trenches may be reduced due to sedimentation build up in the trenches and perforated pipes. Based on the hydraulic analysis the existing catchbasins and short exfiltration trenches in Area 6 are inadequate. Area 6 is the only area that does not have an existing positive outfall.

Areas 1 and 7 also have some isolated catchbasins with short length of exfiltration trench that are not connected to a positive outfall. Although it is beyond the scope (lack of detail survey data) of the Master Plan to hydraulically evaluate these small isolated areas, the results would be expected to be very similar to basin 6 results and frequent flooding would be expected, as has been observed in these areas.

Undersized Outfalls: Based on the hydraulic analysis the existing outfalls appear to be of sufficient size and capacity. This assumes that they are free of sediment, debris and structural defects. However, some outfalls were observed to be blocked by debris, sediment or concrete that highly restricts water flow. This condition was observed in drainage areas 1, 3, 7 and 9. The 21-inch diameter culvert outfall in area 3 appears to be restricted with only an 8-inch concrete slot opening. Also, the 21-inch diameter culvert outfall in area 7 appears to be restricted by a concrete block. These restrictions should be removed. Flooding was also observed at the outfall catchbasin in area 2. The outfall culverts should be inspected (tele-video), thoroughly cleaned, flushed and repaired (any structural defects) as necessary.

- Add 23 Catchbasins
- Add 1 Weir Structure and Headwall
- Add 3,550 LF French Drain
- Add 780 LF 18" Pipe
- Replace 6 Catchbasins with Weir Structures
- Coredrill 18 Existing Catchbasins

Low Areas With Inadequate Drainage: Construct catchbasins at low points with exfiltration trench and connect them to an existing or proposed outfall. The isolated catchbasins in area 6 should be interconnected with exfiltration trench or culvert to the storm drainage outfall in area 5.

An additional outfall is recommended in Basin 1. An additional outfall is a potential alternative for the western end of Loch Ness Drive in area 9. This alternative should be evaluated when detail survey is available during the preliminary design phase.

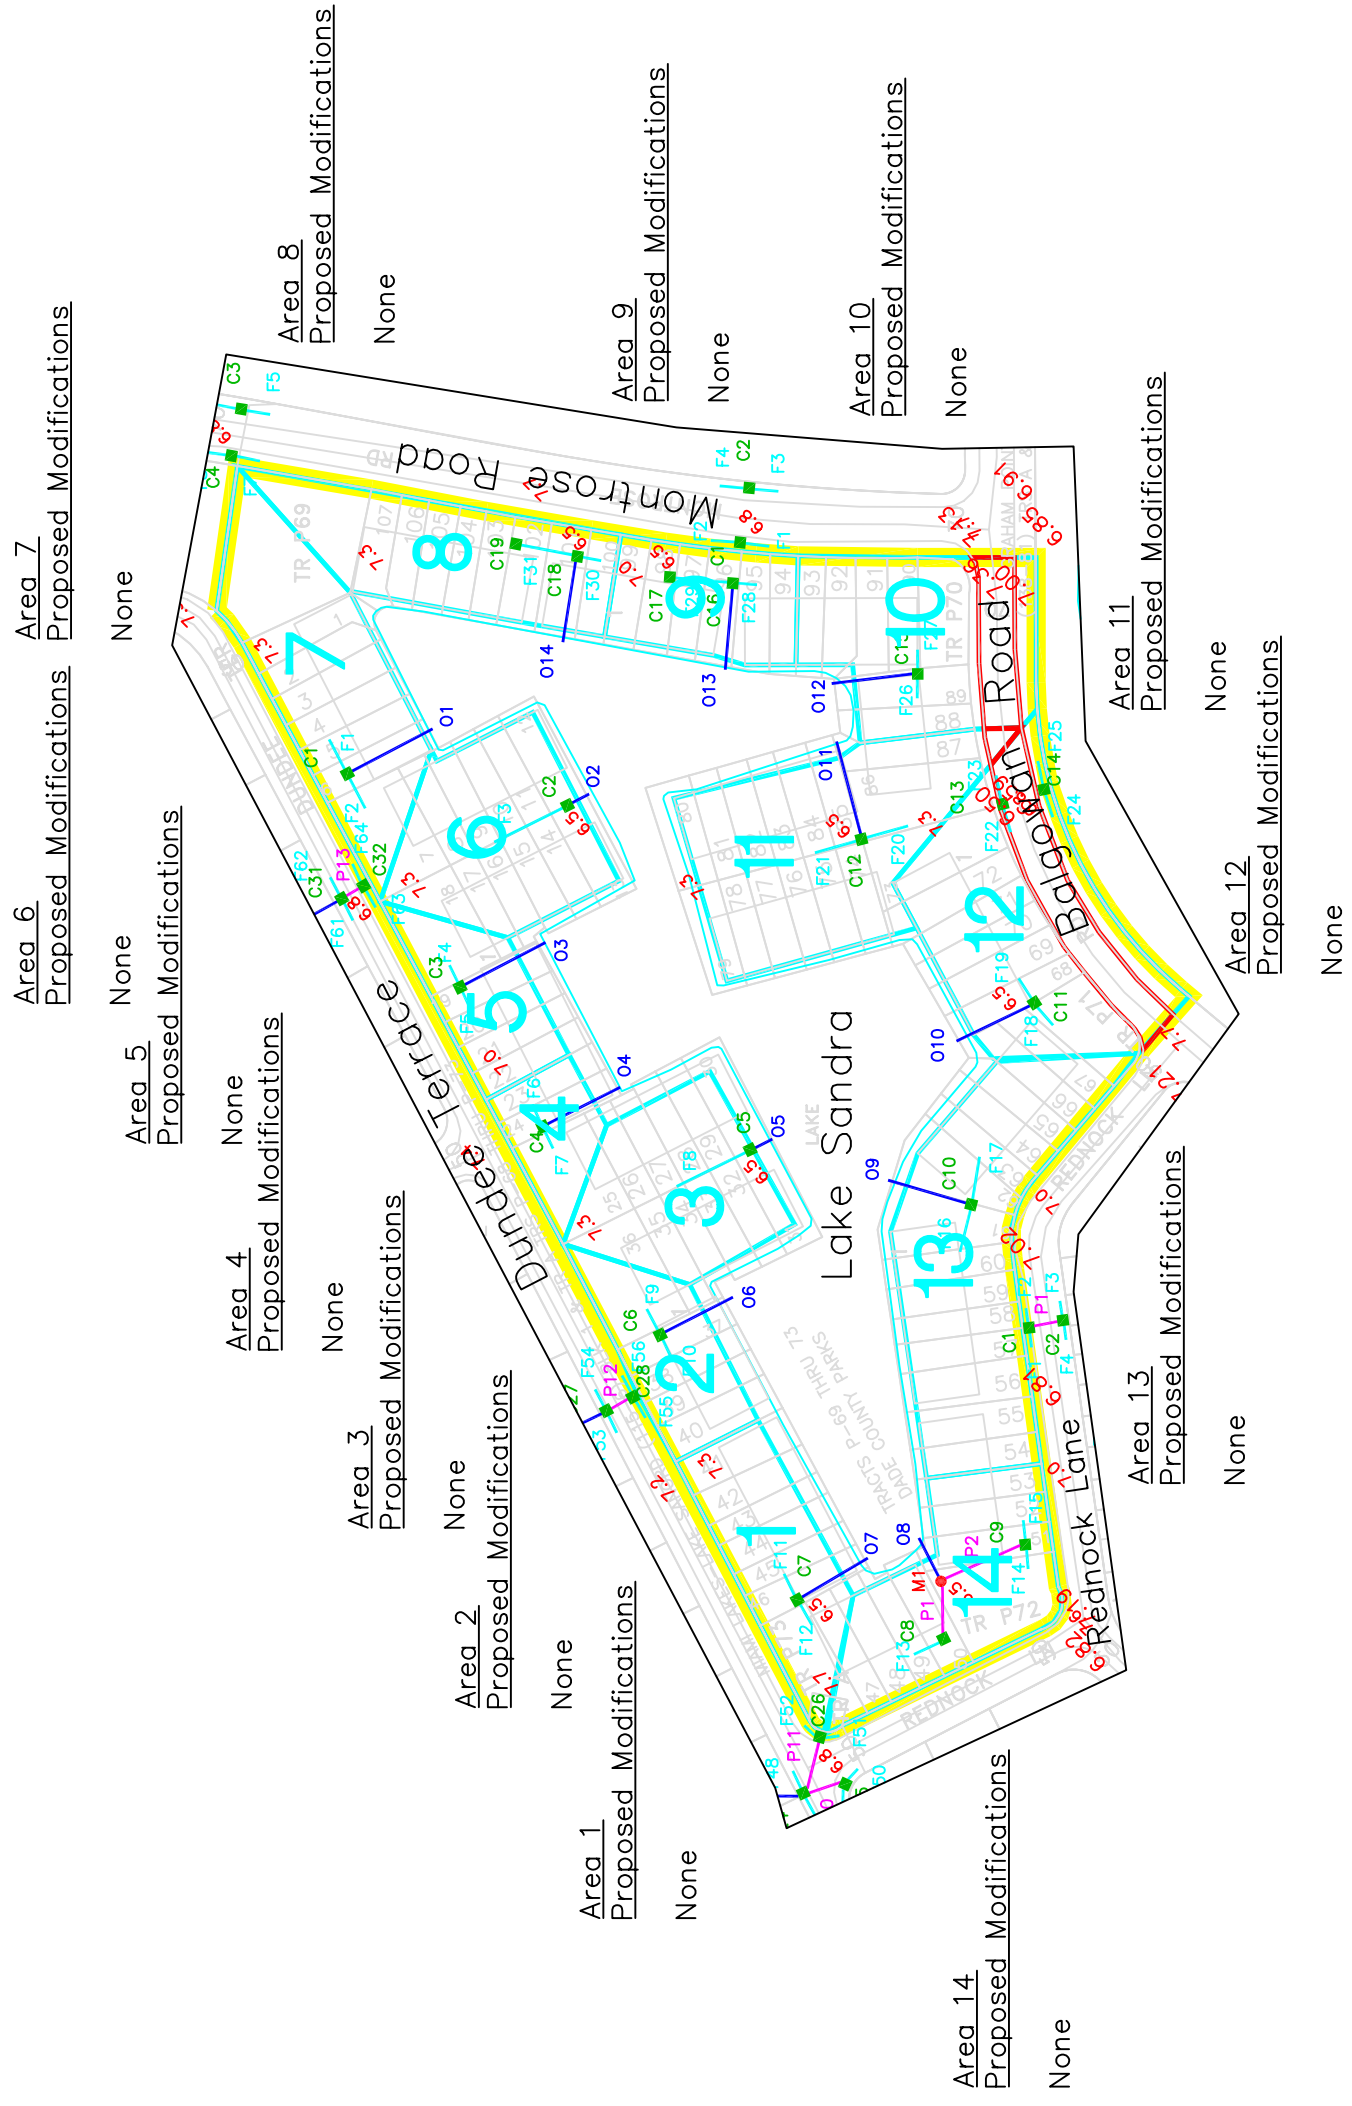
The existing exfiltration trench drainage system, if properly maintained, meets the water quality requirements in all area except area 10. The existing outfalls fail to meet the water quantity performance

goals for the 5-year storm in all areas except 6 and 14. The existing outfalls meet goals for the 25-year storm in all areas. The existing outfalls fail to meet goals for the 100-year storm in areas 11 and 13.

Maintenance: Due to the small existing 8-inch outfalls the culverts and catchbasins may frequently clog with debris and sediment such that water flow is blocked or highly restricted. Frequent maintenance is recommended for the existing system.

Water Quality Deficiencies: Area 10 does not have sufficient length of exfiltration trench to meet the water quality goals.

No improvements are proposed for this sub-basin. After the Town's Stormwater Master Plan was completed and regular maintenance activities were introduced drainage conditions in this sub-basin improved. Any remaining drainage deficiencies will be addressed in projects serving the adjacent sub-basins.

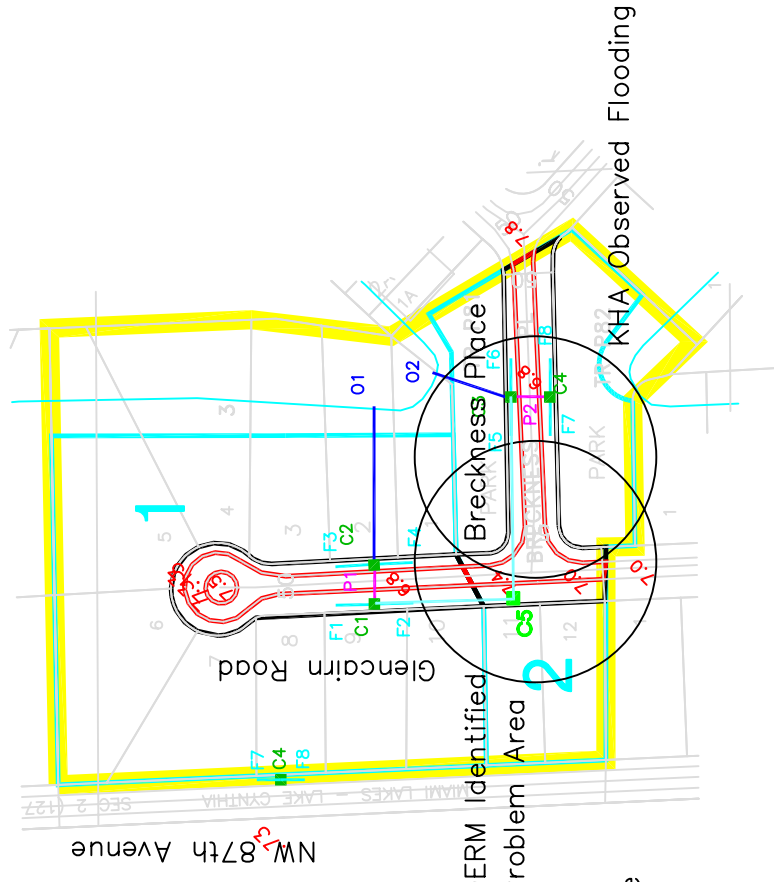
Figure 5.
 Lake Cynthia Section 2 Sub-basin
 (30-2022-011)

The existing exfiltration trench drainage system, if properly maintained, meets the water quality requirements. The existing outfall in area 1 fails to meet the water quantity performance goals for the 5, 25 and 100-year storm events. The existing outfall in area 2 fails to meet the water quantity performance goals for the 5-year storm event.

Maintenance: Due to the small existing 8-inch outfalls the culverts and catchbasins may frequently clog with debris and sediment such that water flow is blocked or highly restricted.

Area 1
Proposed Modifications
 Add 150 LF of French Drain
 and Connect to Area 2

Area 2
Proposed Modifications
 Add 200 LF of French Drain and C5
 Upgrade O2 from 8" pipe to 1-30" Pipe
 Replace C3 with Weir Structure

Undersized Outfall: Based on the hydraulic analysis the existing outfalls appear to be undersized and do not have sufficient capacity to meet the performance goals. The outfall in Area 2 should be replaced with a larger outfall. The final catchbasin prior to the outfall into the lake should be replaced with a control structure catchbasin. The control structure catchbasin should include a weir, pollution retardant baffle and a sedimentation sump.

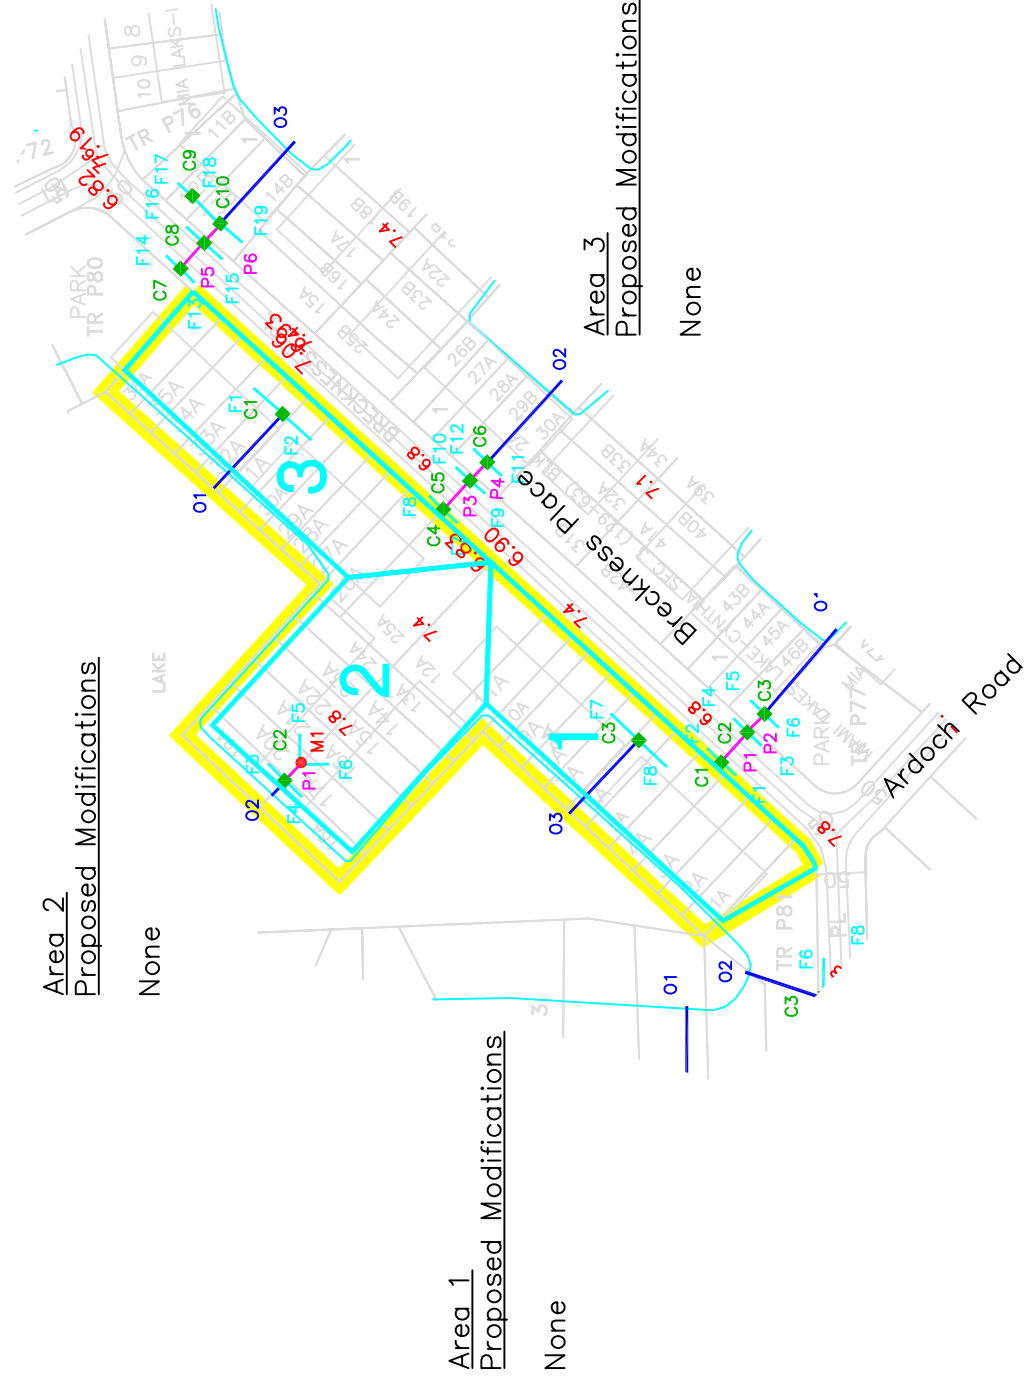
The existing exfiltration trench drainage system, if properly maintained, meets the water quality requirements. The existing outfall in area 1 fails to meet the water quantity performance goals for the 5, and 10-year storm events. The existing outfall in area 3 fails to meet the water quantity performance goals for the 5-year storm event.

No improvements are proposed for this sub-basin. After the Town's Stormwater Master Plan was completed and regular maintenance activities were introduced drainage conditions in this sub-basin improved. Drainage deficiencies on Breckness Place will be addressed in projects serving the adjacent sub-basins.

Since improved maintenance resulted in a decrease in observed drainage deficiencies in the Lake Cynthia Section 3 Sub-Basin, no capital improvements are proposed for this sub-basin. Any remaining drainage deficiencies along Breckness Place will be addressed in projects serving the adjacent sub-basins. Figure 6 shows the location of the Lake Cynthia Section 3 sub-basin.

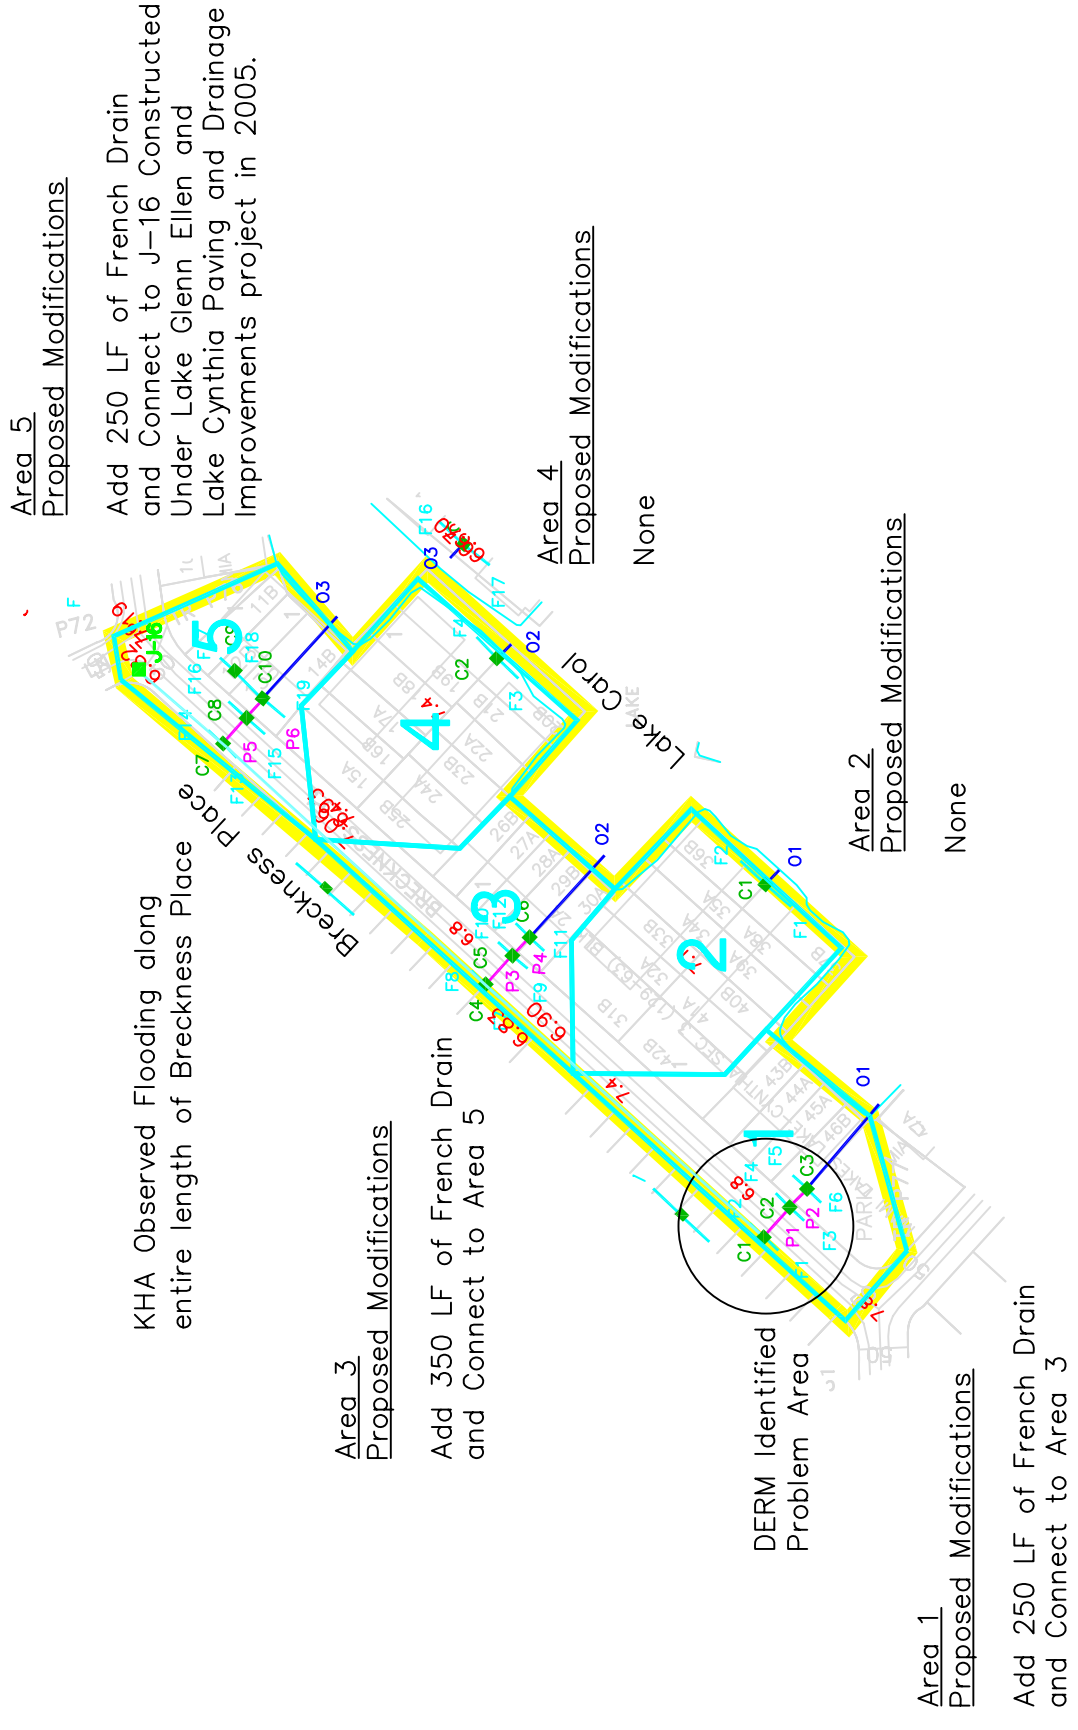
Undersized Outfalls: Based on the hydraulic analysis the existing outfalls appear to be under sized and do not have sufficient capacity to meet the performance goals. The drainage system should be connected to an outfall constructed under the Lake Glenn Ellen and Lake Cynthia Paving and Drainage Improvements project in 2005.

Add 850 LF French Drain
Coredrill 3 Existing Catchbasins

Existing Infrastructure Modifications: Additional exfiltration trench is recommended in Areas 1, 3, and 5 to provide additional storage capacity for the system.
