**LAKE WATER QUALITY
LAKE CONDITIONS AND
TOWN MANAGEMENT RECOMMENDATIONS**

**Prepared For:
The Town of Miami Lakes
Public Works Department
6601 Main Street
Miami Lakes, FL 33014**

**Prepared by:
Calvin, Giordano and Associates, Inc.
1800 Eller Drive
Ft. Lauderdale, FL 33316**

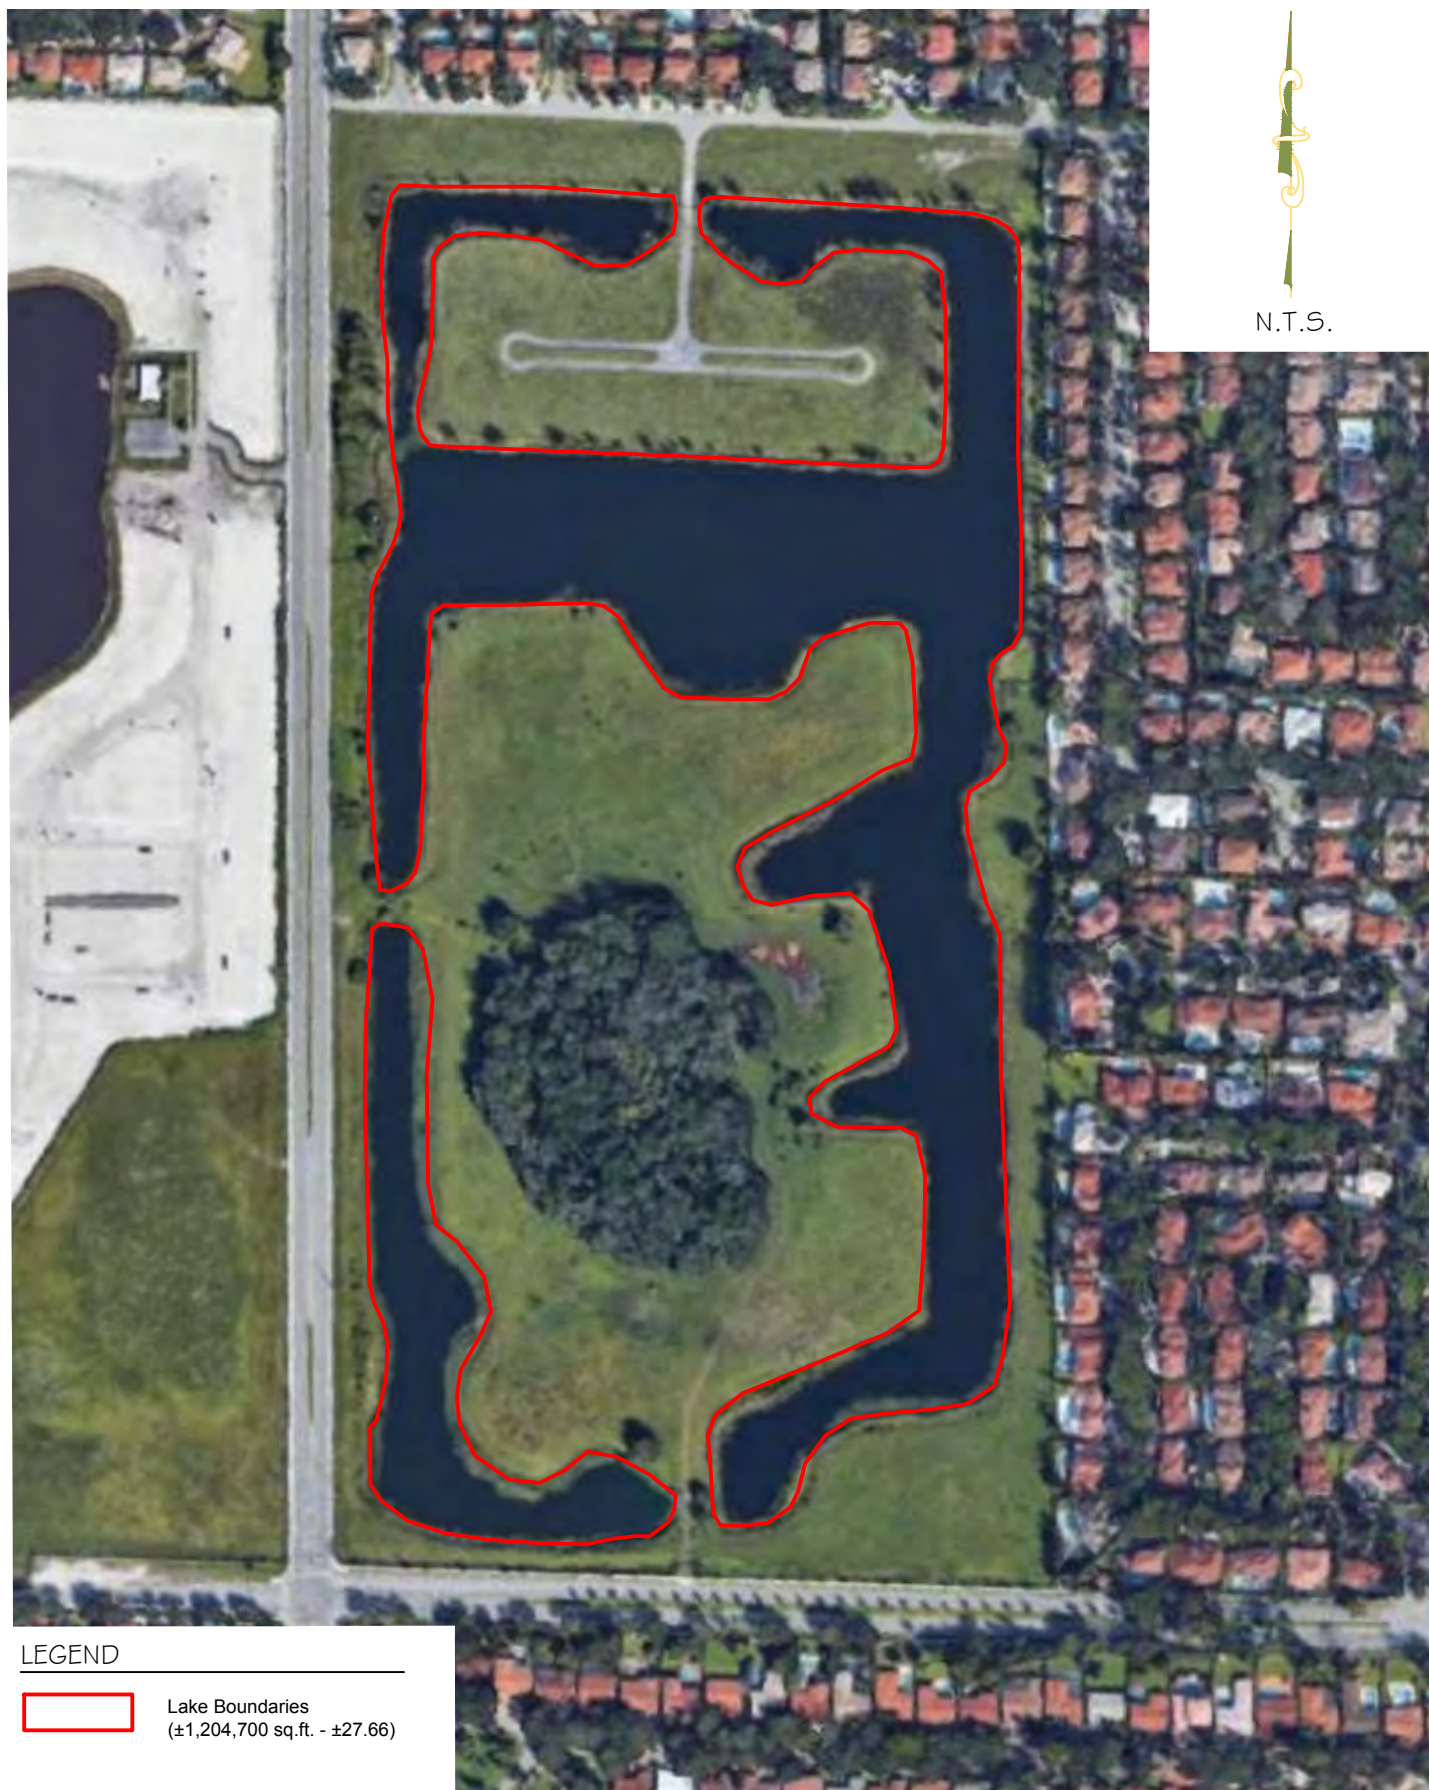
The inspection to evaluate the lake’s current condition was conducted on 7/19/18. The inspection showed the shoreline was unconsolidated adjacent to vacant land. The lake depth was measured to be 25 feet. No fountains or aerators were observed at the time of the inspection. Observed native shoreline vegetation included Spikerush (*Eleocharis* sp.), Giant bulrush (*Schoenoplectus californicus*), Green Buttonwood (*Conocarpus erectus*), Coastal plain willow (*Salix caroliniana*), Giant leather fern (*Acrostichum danaeifolium*), and Spatterdock (*Nuphar lutea*). The invasive species observed included Torpedo grass (*Panicum repens*), Cattail (*Typha* sp.), Australian pine (*Casuarina equisetifolia*), and Brazilian pepper (*Schinus terebinthifolia*). Observed wildlife at the time of the inspection was limited to the invasive Green iguana (*Iguana iguana*). This lake did not appear to contain blue dye.

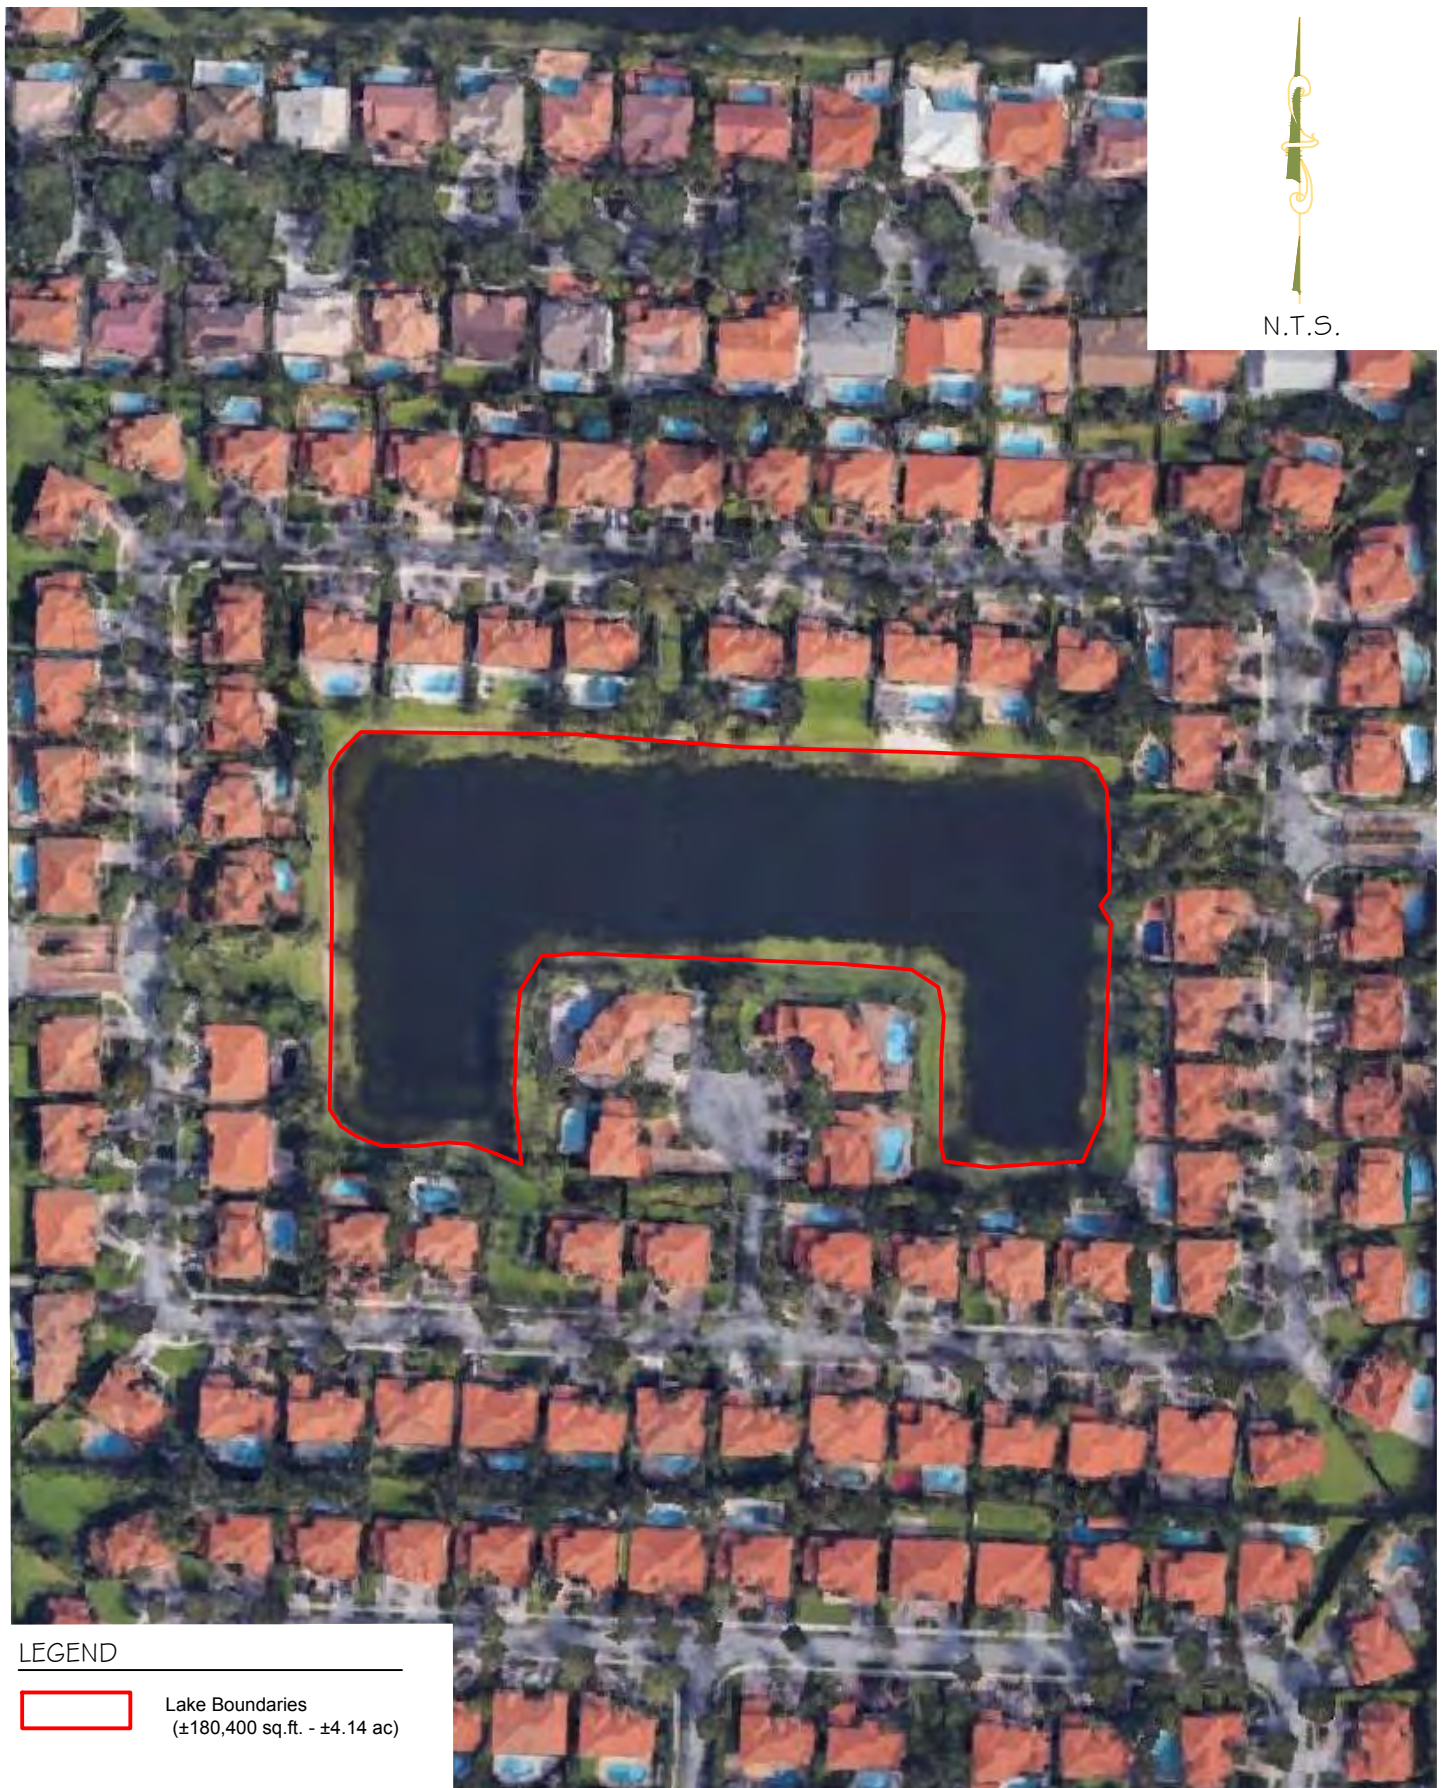
The inspection to evaluate the lake’s current condition was conducted on 7/19/18. The inspection showed the shoreline was unconsolidated (lawns abutting shoreline) adjacent to single family residences. The lake depth was measured to be 35 feet. No fountains or aerators were observed at the time of the inspection. In addition to the invasive, submerged species Hydrilla (*Hydrilla verticillata*), the invasive species Torpedo grass (*Panicum repens*) was observed along the shoreline. Observed wildlife at the time of the inspection was limited to native Ross's goose (*Chen rossii*).

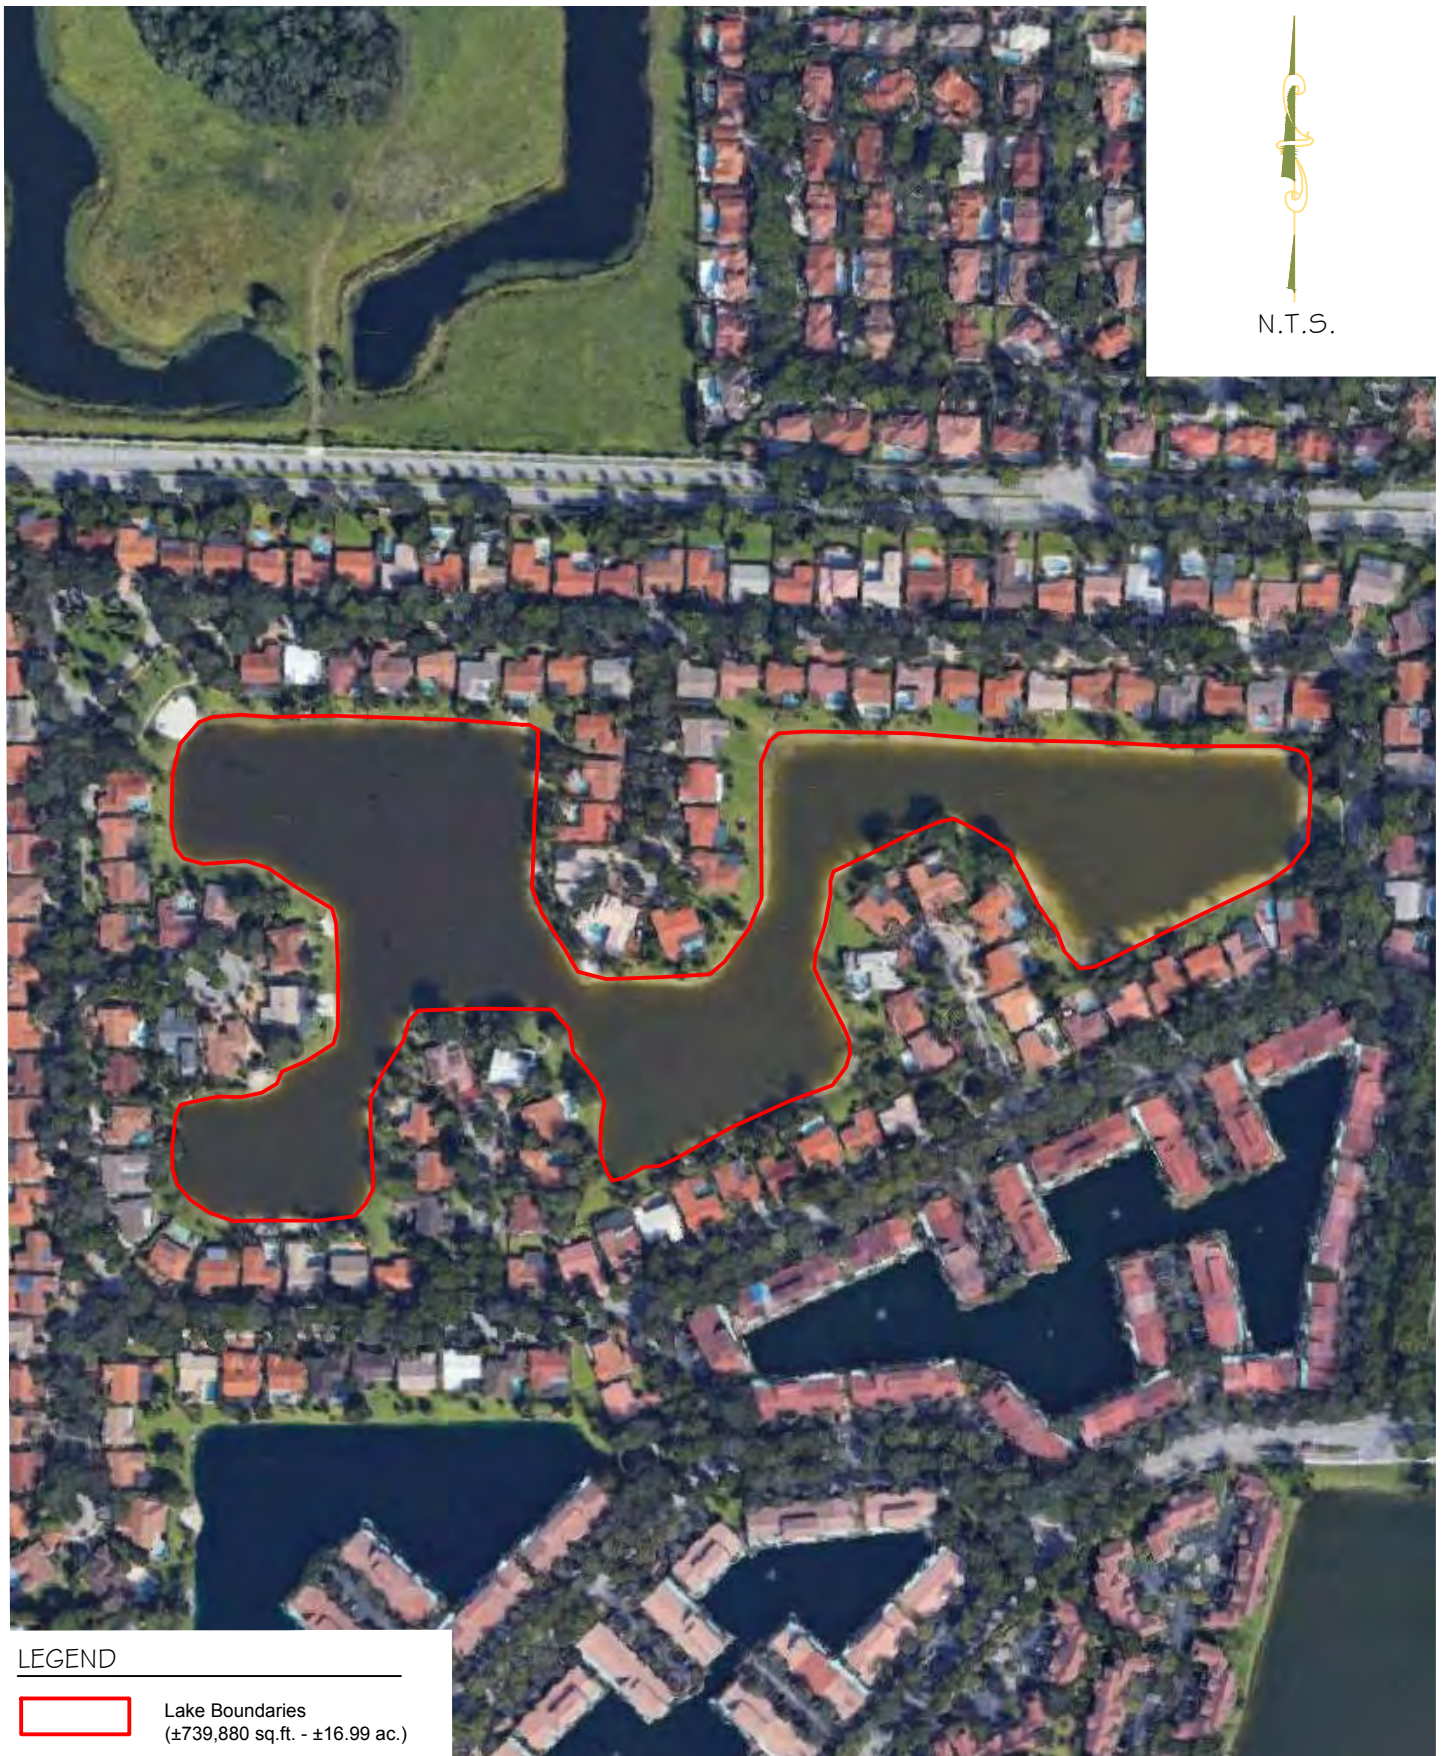
The inspection to evaluate the lake’s current condition was conducted on 5/3/18. The inspection showed that the shoreline was mostly unconsolidated, but there are a few concrete sandbags, or concrete panel seawalls. As indicated in the 2008 report, the shoreline still contained a shallow littoral shelf around most of the lake. The unconsolidated areas appear to provide opportunity to install shoreline plantings. The depth of the lake was measured to be 25 feet. A public beach, with signage regarding pet waste, exists at the northwestern corner of the lake. No fountains or aerators were observed. The native submerged species Coontail (*Ceratophyllum demersum*) was observed along the shoreline. Observed wildlife was limited to the native Ross's goose (*Chen rossii*) at the time of the inspection.

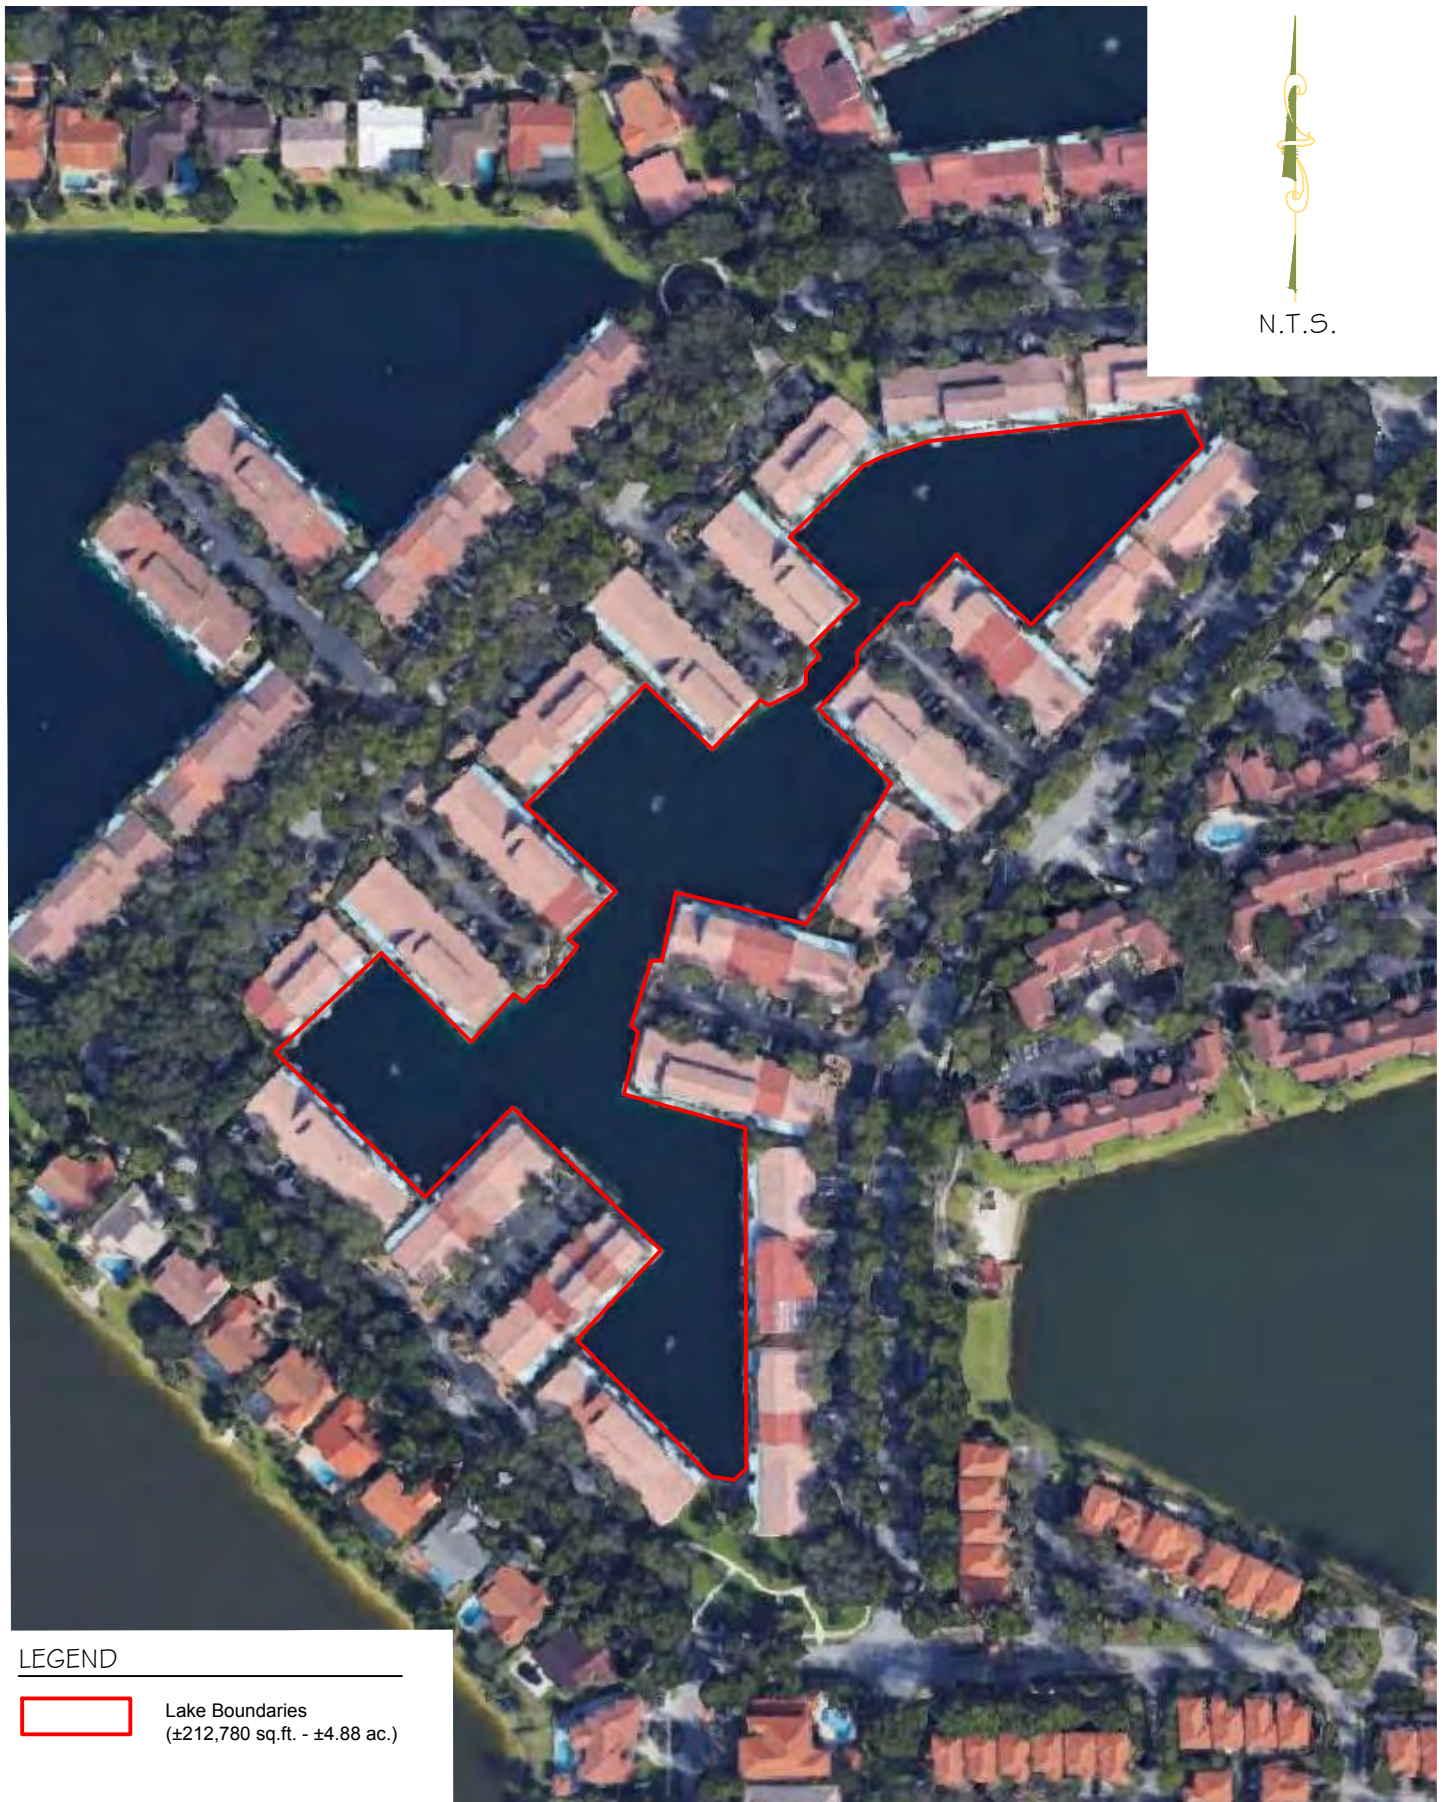
The inspection to evaluate the lake’s current condition was conducted on 5/3/18. It was observed that the entire shoreline consisted of a concrete sandbag seawall with a potential footer or rock ledge at the base, with no lawns abutting the seawall. The lake depth was not measured due to the inaccessibility created by the seawall. The 2008 study stated the average depth was 12.5 feet. In addition, it was observed that the lake has four (4) fountains but not all were in operation at the time of the inspection. No vegetation was observed, however observed wildlife was limited to Red-eared slider (*Trachemys scripta elegans*) – a semiaquatic turtle. Lastly, at the time of the inspection, the lake appeared to have been dyed blue.

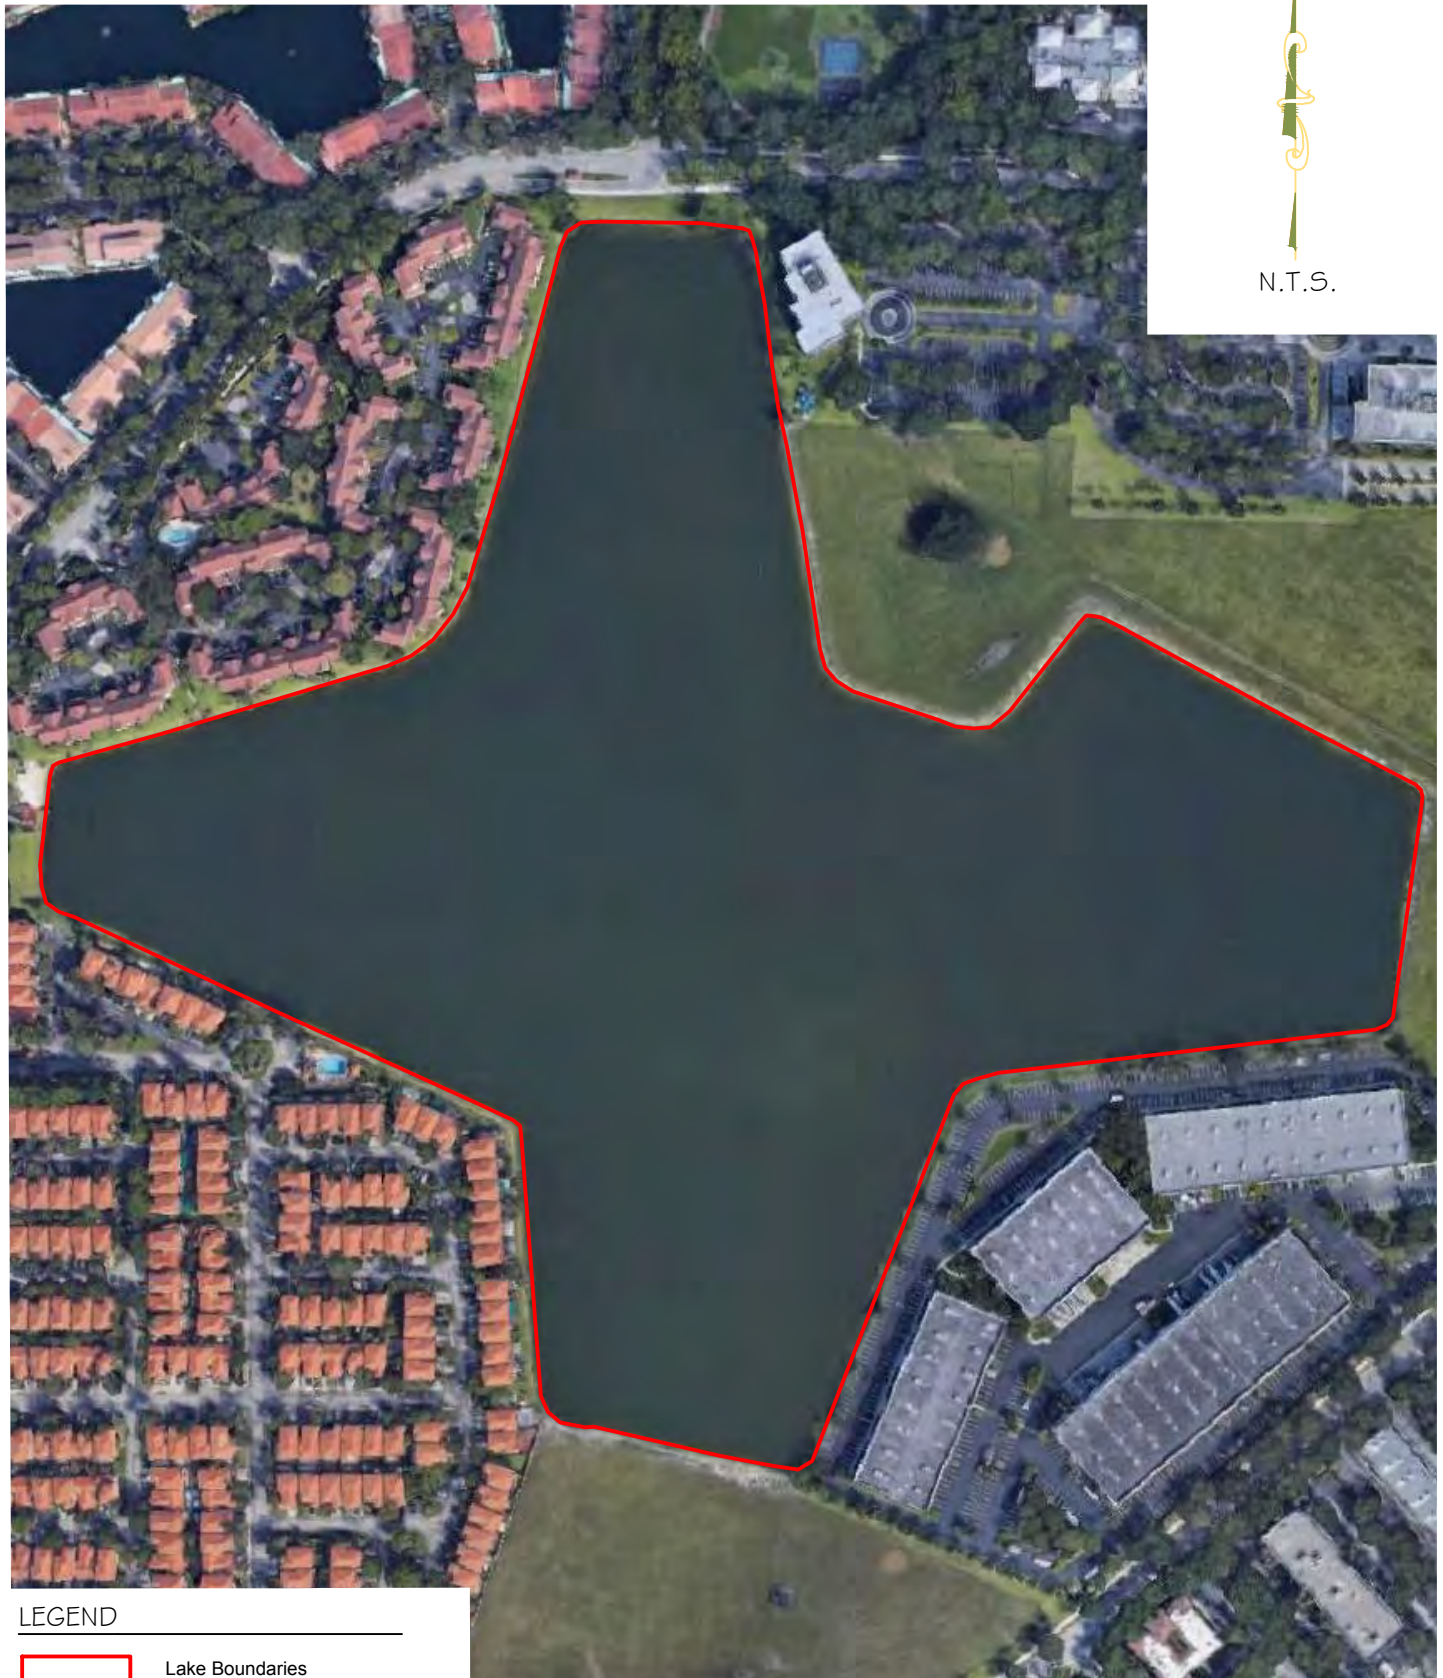
The inspection to evaluate the lake’s current condition was conducted on 5/1/18. The lake depth was measured to be 25 feet. The entire shoreline is unconsolidated with no seawalls. There is turf/lawn upland of the shoreline around the entirety of the lake except for a small sandy “beach” area on the east side serving the gated residential developments. Approximately 1/3rd of the shoreline (eastern portions) was an active construction site and did not have turbidity barriers along the shoreline. Active construction sites and earthwork can lead to increased turbidity due to the release of sediment into the water. Signage discouraging the feeding of wildlife was observed at the northern portion of the lake. One (1) fountain was observed at the time of the inspection. The invasive exotic, submerged aquatic species Hydrilla (*Hydrilla verticillata*) was observed along the shoreline. Wildlife observed at the time of the inspection included: Red-eared slider turtle (*Trachemys scripta elegans*), Double-crested cormorant (*Phalacrocorax auritus*), and the non-native Egyptian goose (*Alopochen aegyptiaca*).

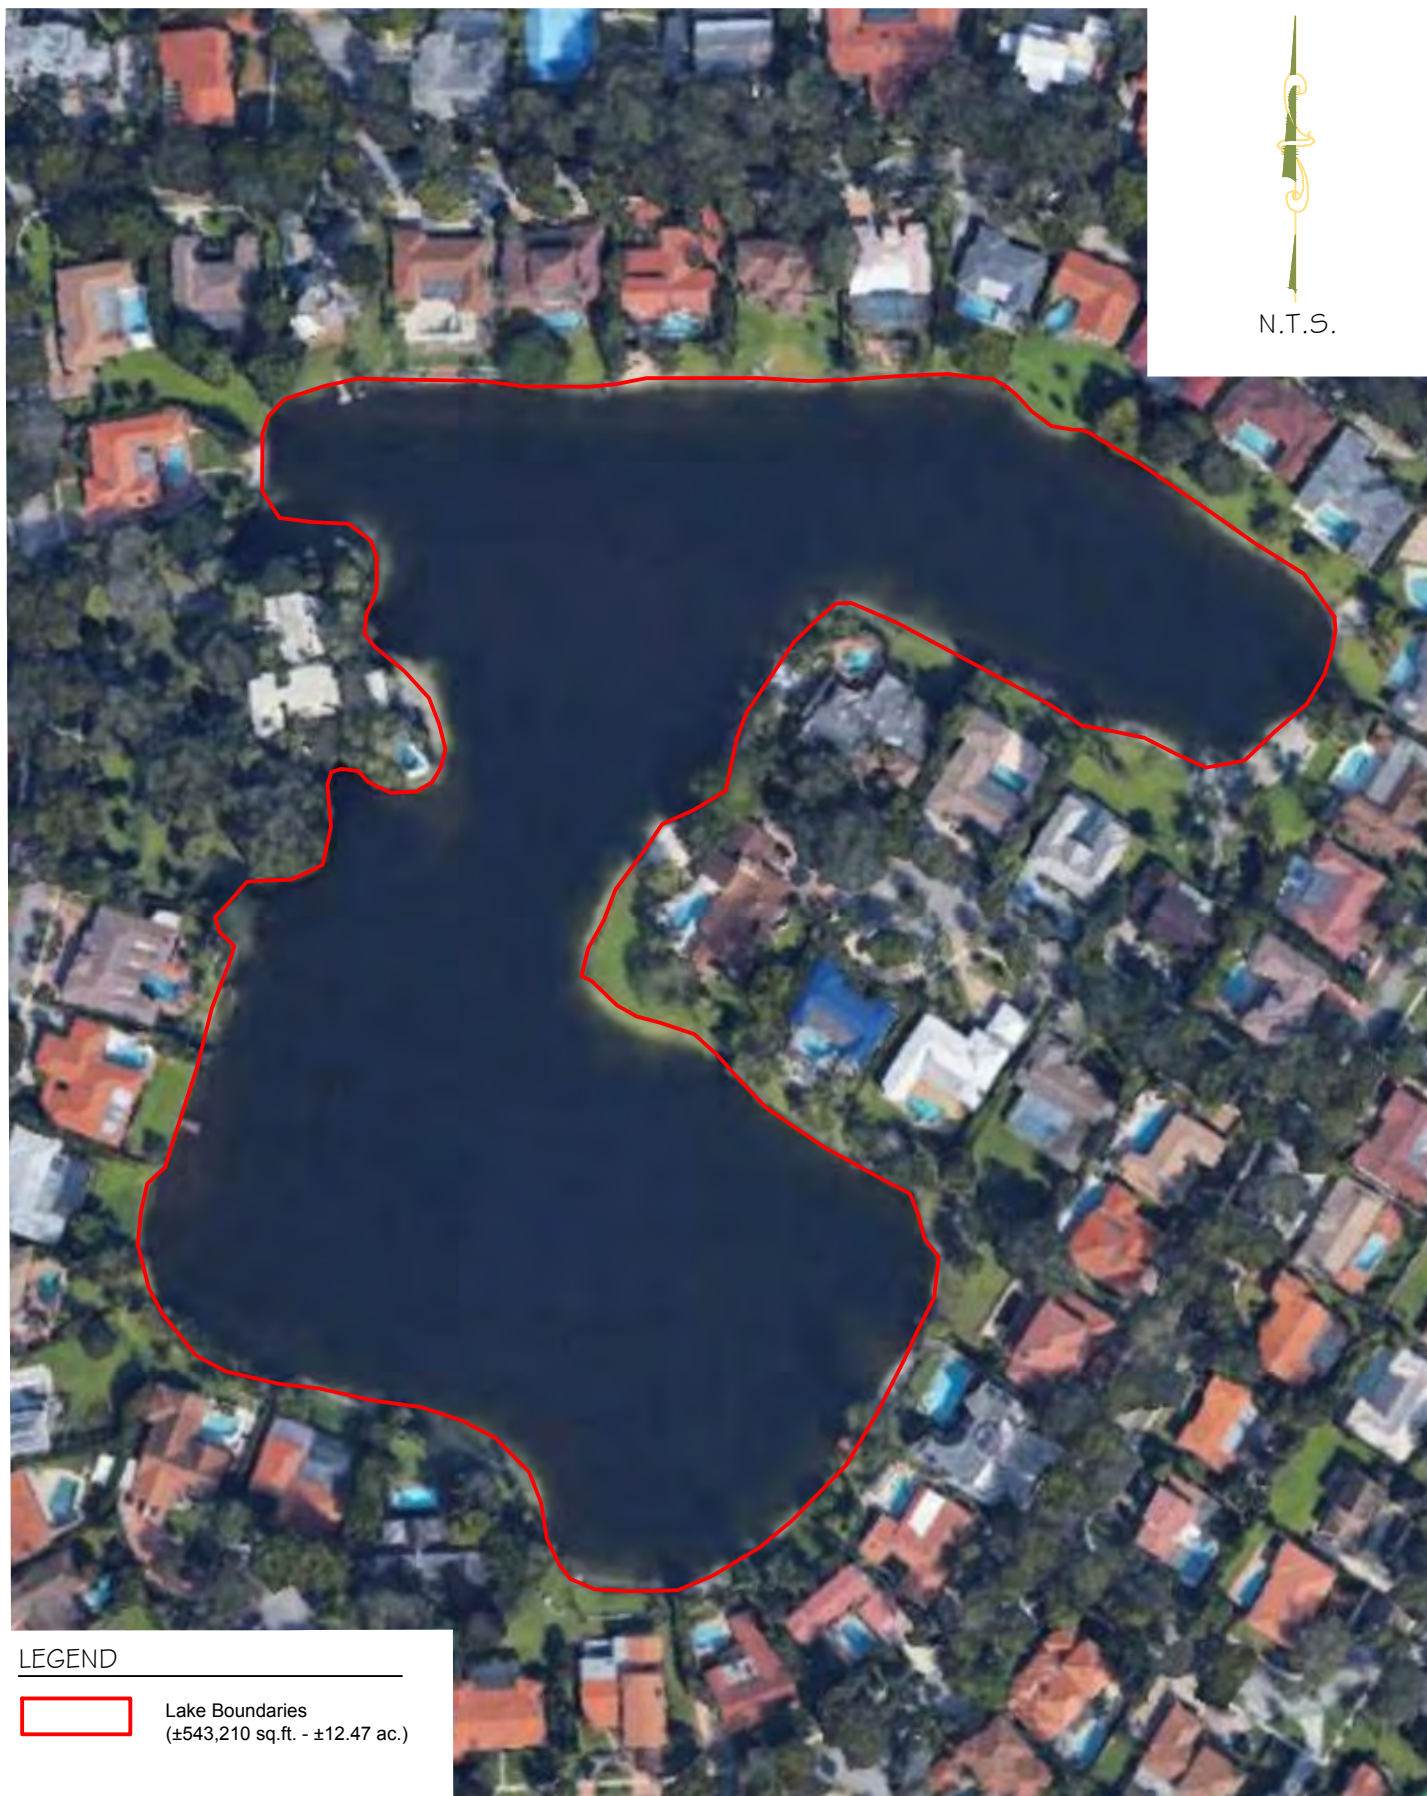
The inspection to evaluate the lake’s current condition was conducted on 7/20/18. It was observed that the shorelines were a combination of unconsolidated and concrete sandbag. The lake depth was measure to be 30 feet. No fountains or aerators were observed at the time of the inspection. Invasive species of vegetation observed along the shoreline was limited to Torpedo grass (*Panicum repens*). Observed wildlife was limited to the non-native Muscovy duck (*Cairina moschata*) at the time of the inspection.

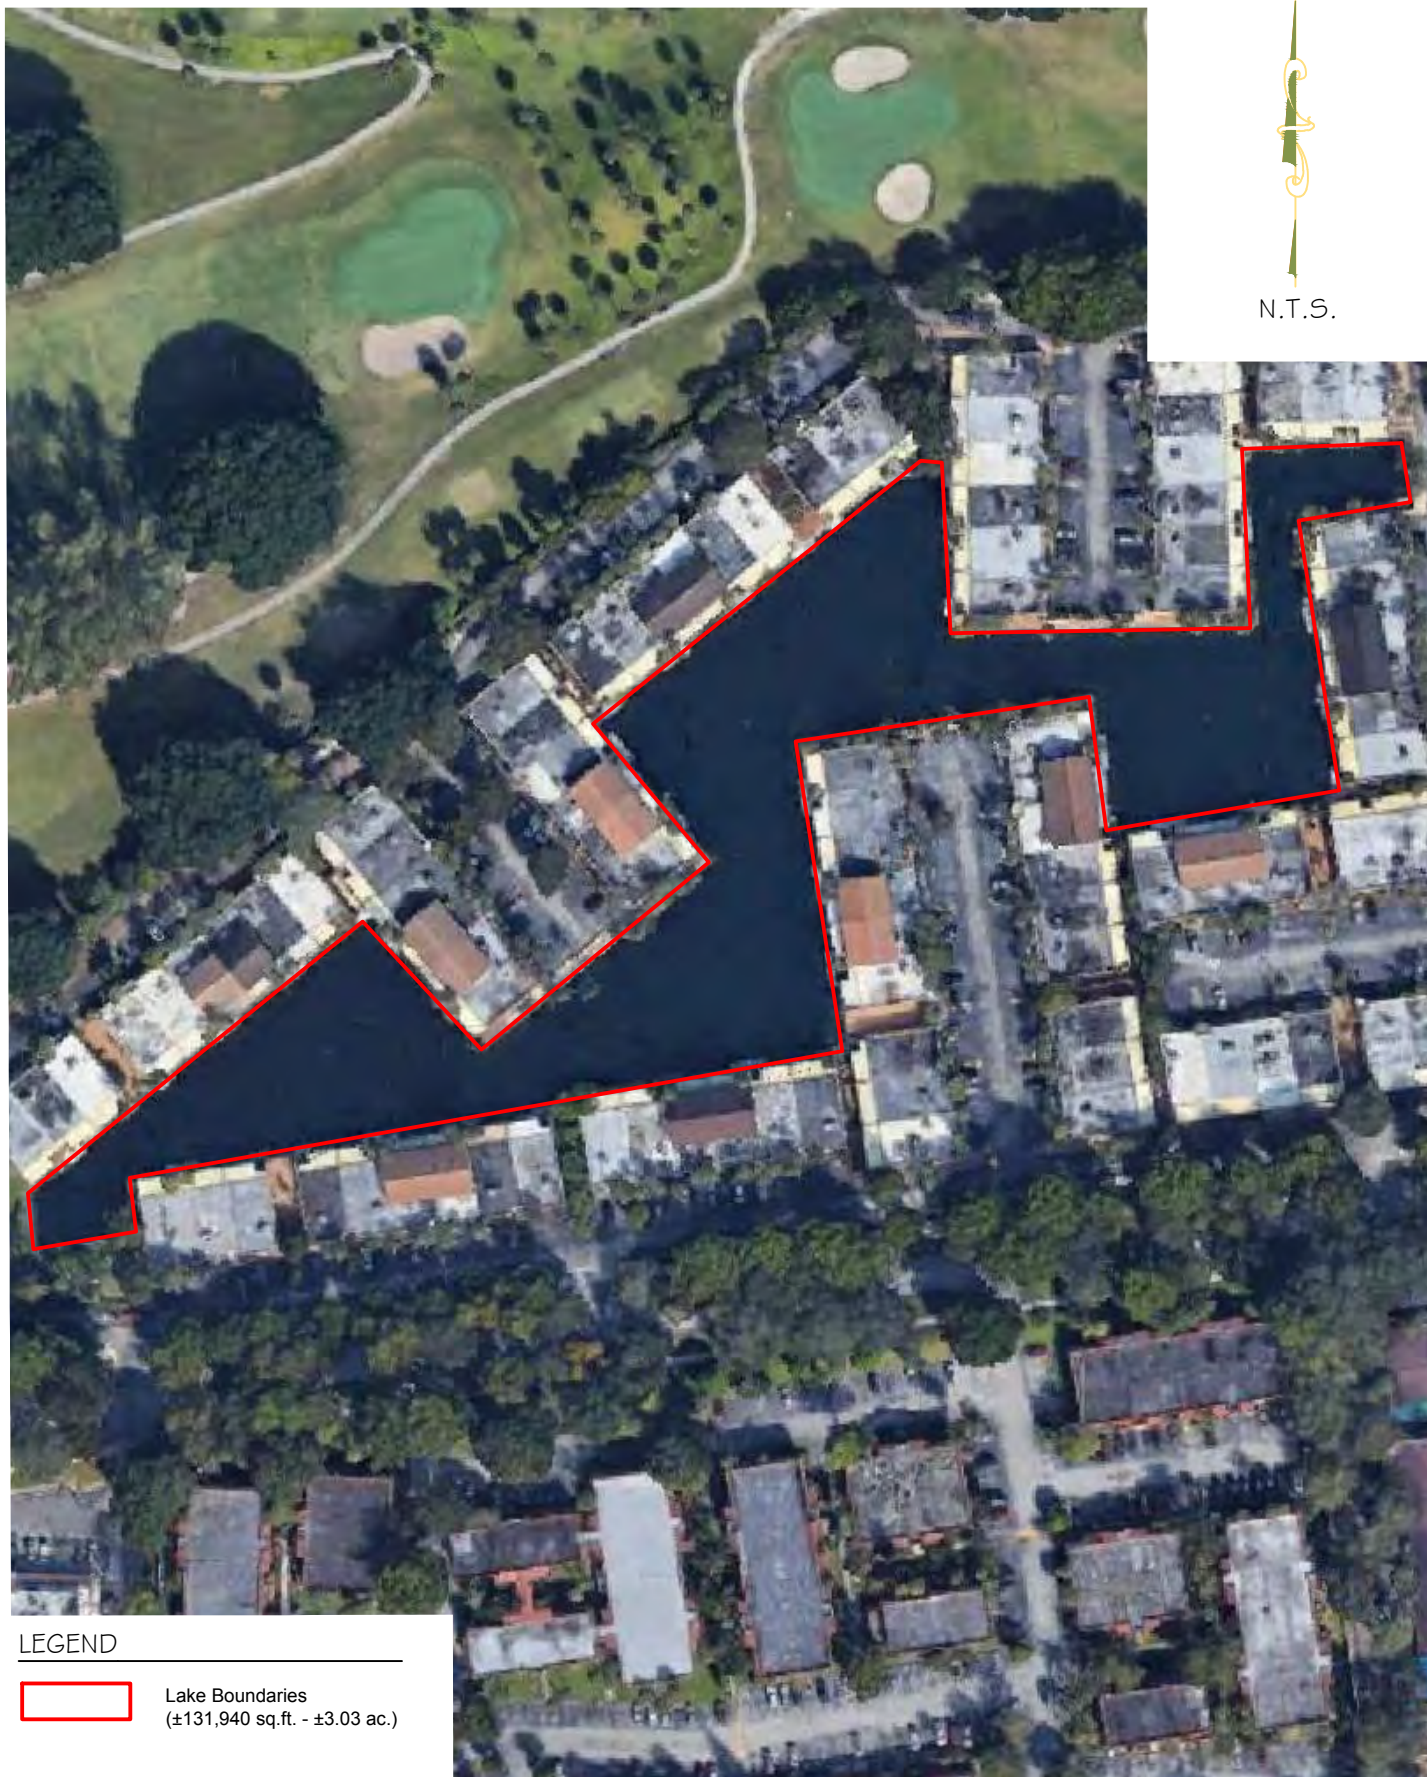
The inspection to evaluate the lake’s current condition was conducted on 5/3/18. It was observed that the entire shoreline consisted of a concrete sandbag seawall with a potential footer or rock ledge at the base. Nearly all the uplands surrounding the lake were comprised of concrete decking. Some trees were observed but little to no area of ground cover vegetation to filter runoff was observed. The lake depth was not measured due to the inaccessibility created by the seawall. The 2008 study stated the average depth was 13 feet. It was observed that the lake has both fountains and aerators. At the time of the inspection, some or all of the fountains/aerators were not in operation. No vegetation was observed. Observed wildlife was limited to Green iguana (*Iguana iguana*). The lake appeared to have been dyed blue.

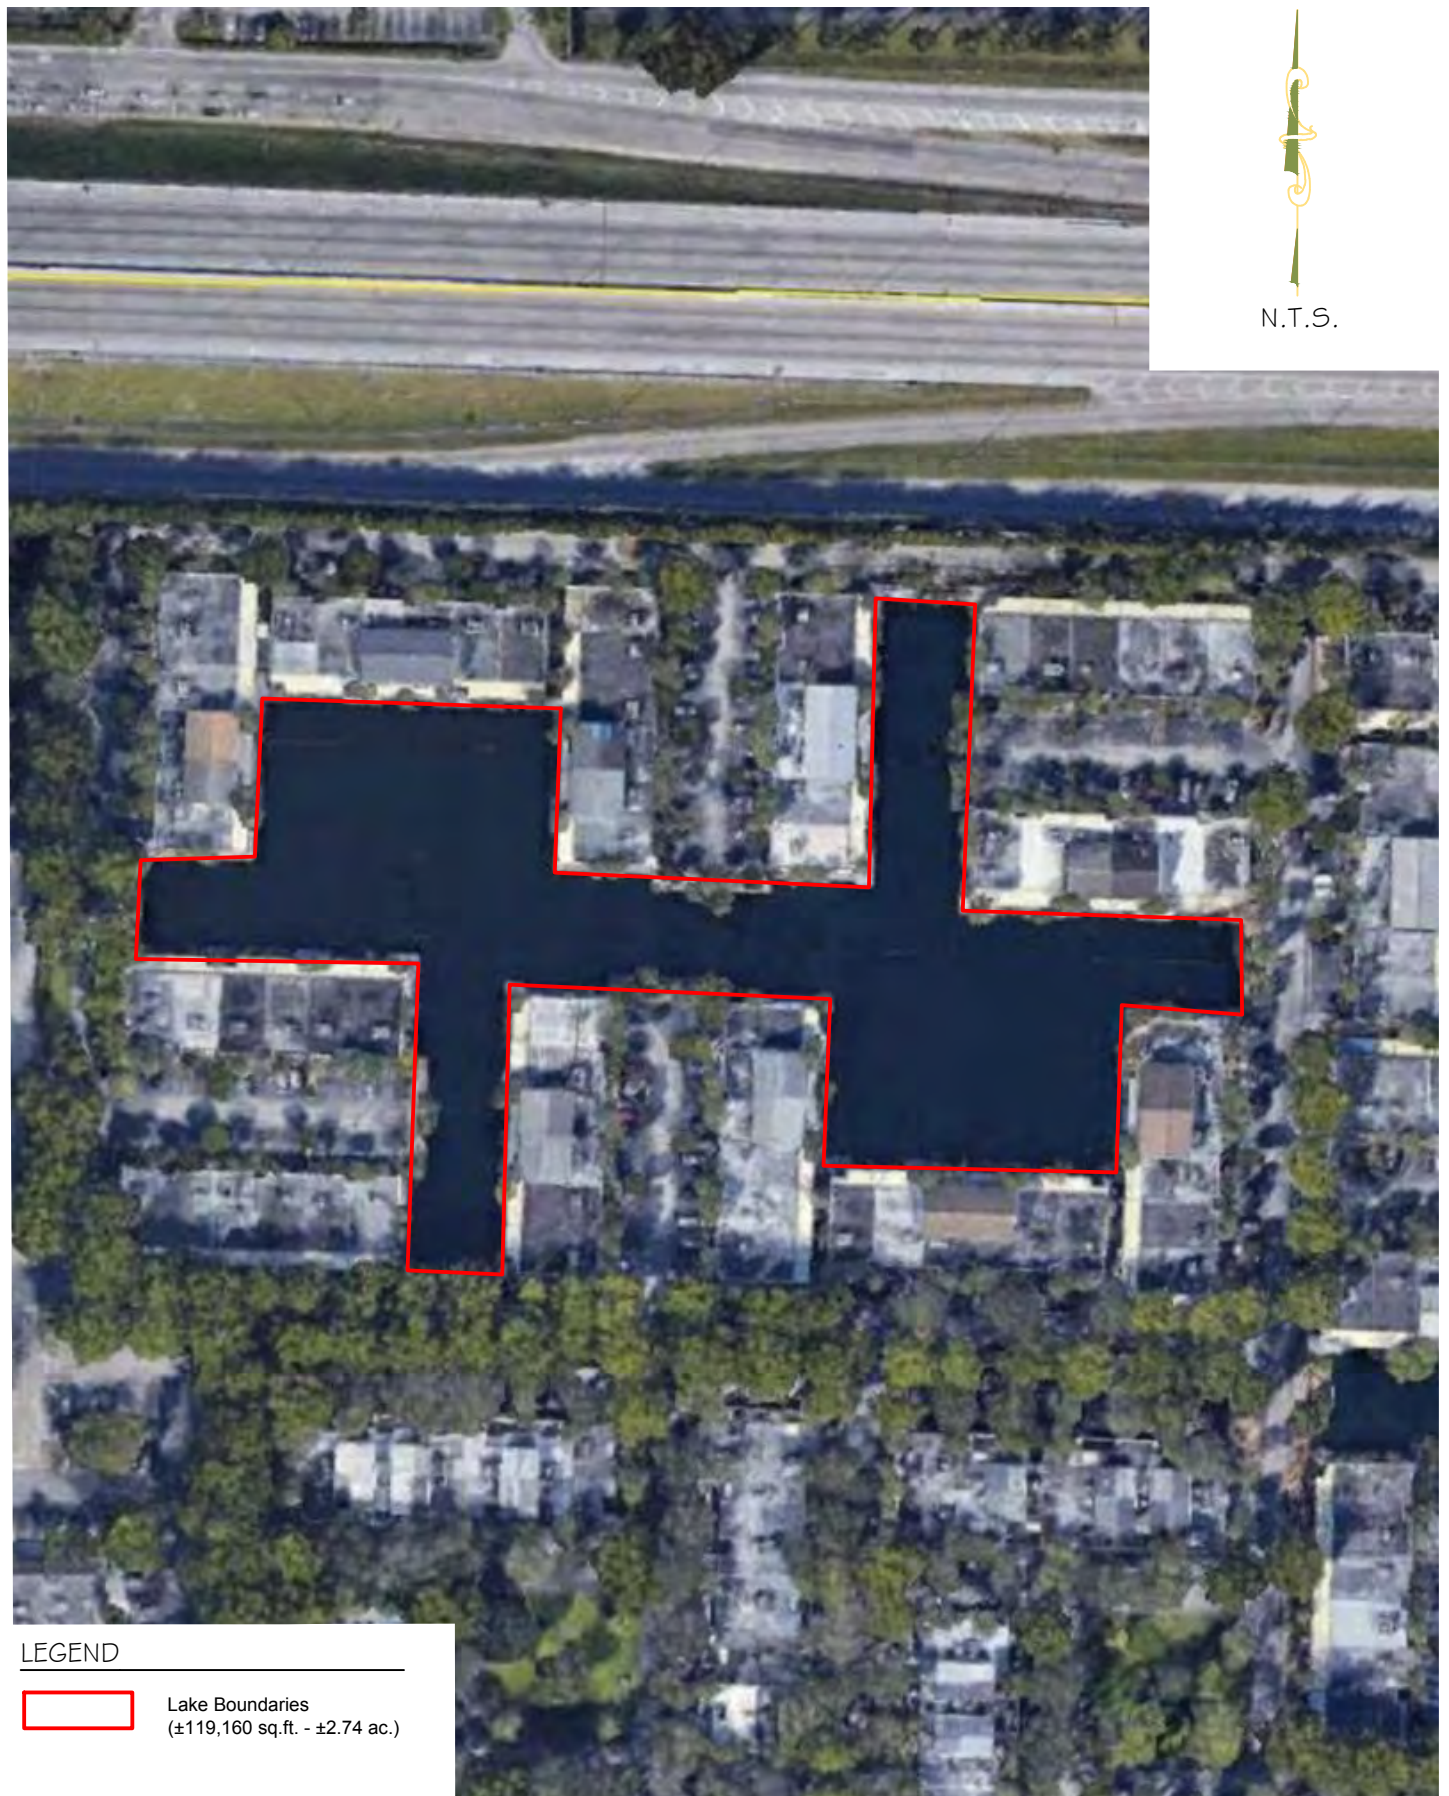
The inspection to evaluate the lake's current condition was conducted on 5/3/18. It was observed there is a seawall surrounding the lake. Multi-family residences surround the lake and nearly all the uplands surrounding the lake were comprised of concrete decking. Some trees were observed but little to no area of ground cover vegetation to filter runoff was observed. The lake depth was not measured due to the inaccessibility created by the seawall. The 2008 study stated the average depth was 13 feet. Two aerators were observed at the time of inspection. A Tri-colored heron (*Egretta tricolor*) and non-native Iguana (*Iguana iguana*) were observed. No submergent or emergent vegetation was observed at this lake. This lake appeared to contain pond dye.
