**LAKE WATER QUALITY
LAKE CONDITIONS AND
TOWN MANAGEMENT RECOMMENDATIONS**

**Prepared For:
The Town of Miami Lakes
Public Works Department
6601 Main Street
Miami Lakes, FL 33014**

**Prepared by:
Calvin, Giordano and Associates, Inc.
1800 Eller Drive
Ft. Lauderdale, FL 33316**

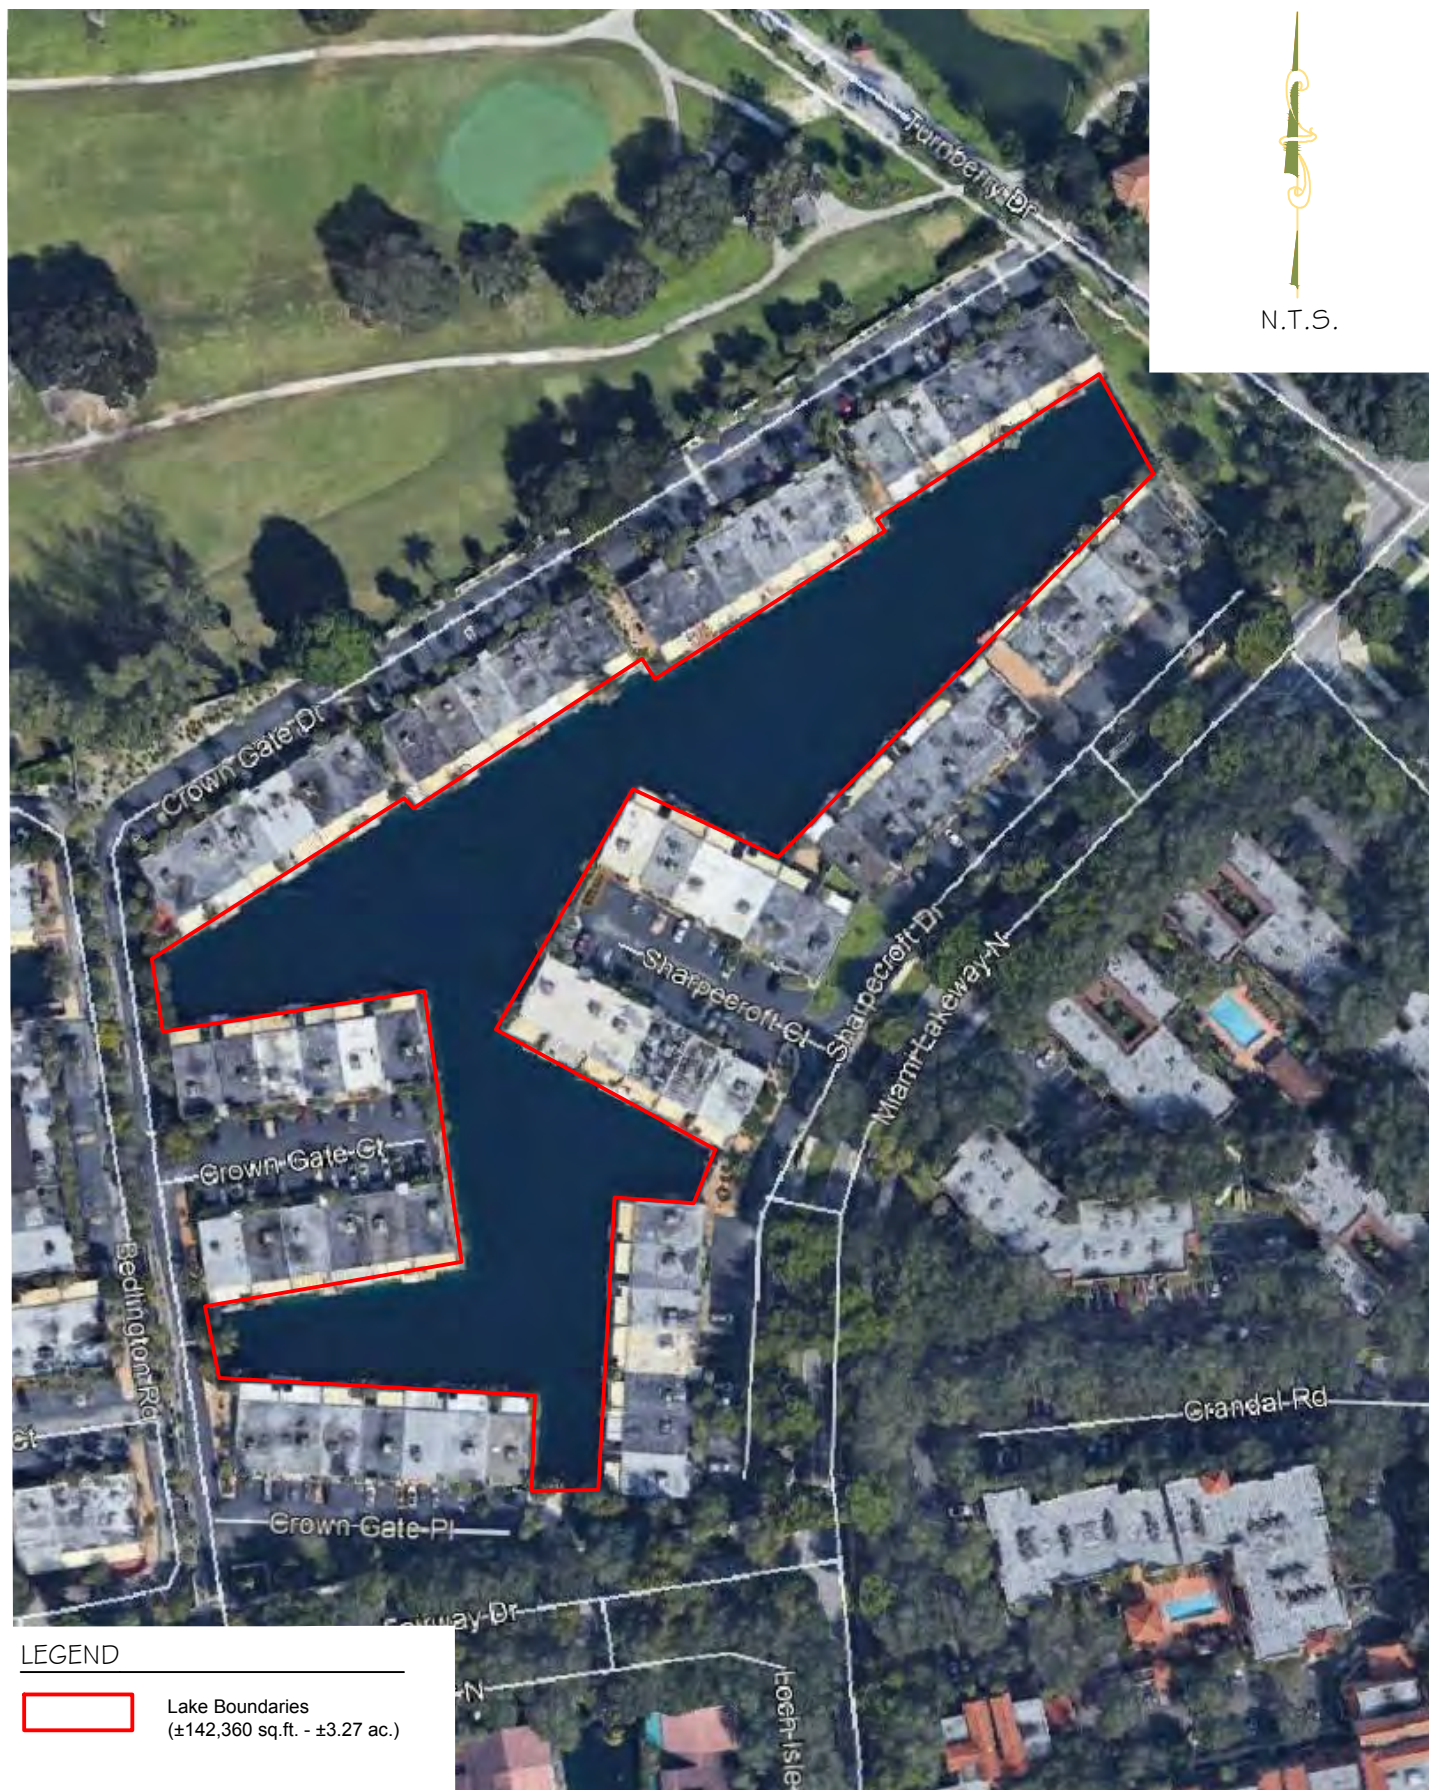
The inspection to evaluate the lake’s current condition was conducted on 5/3/18. It was observed there was a seawall surrounding the lake. Multi-family residences surround the lake and there are no lawns abutting the seawall, nearly all concrete decking. The lake depth was not measured due to the inaccessibility created by the seawall. The 2008 study stated the average depth was 15 feet. No fountains or aerators were observed at the time of inspection. A red-eared slider (*Trachemys scripta elegans*) and Muscovy duck (*Cairina moschata*) were observed. No submerged or emergent vegetation was observed. This lake appeared to contain pond dye.

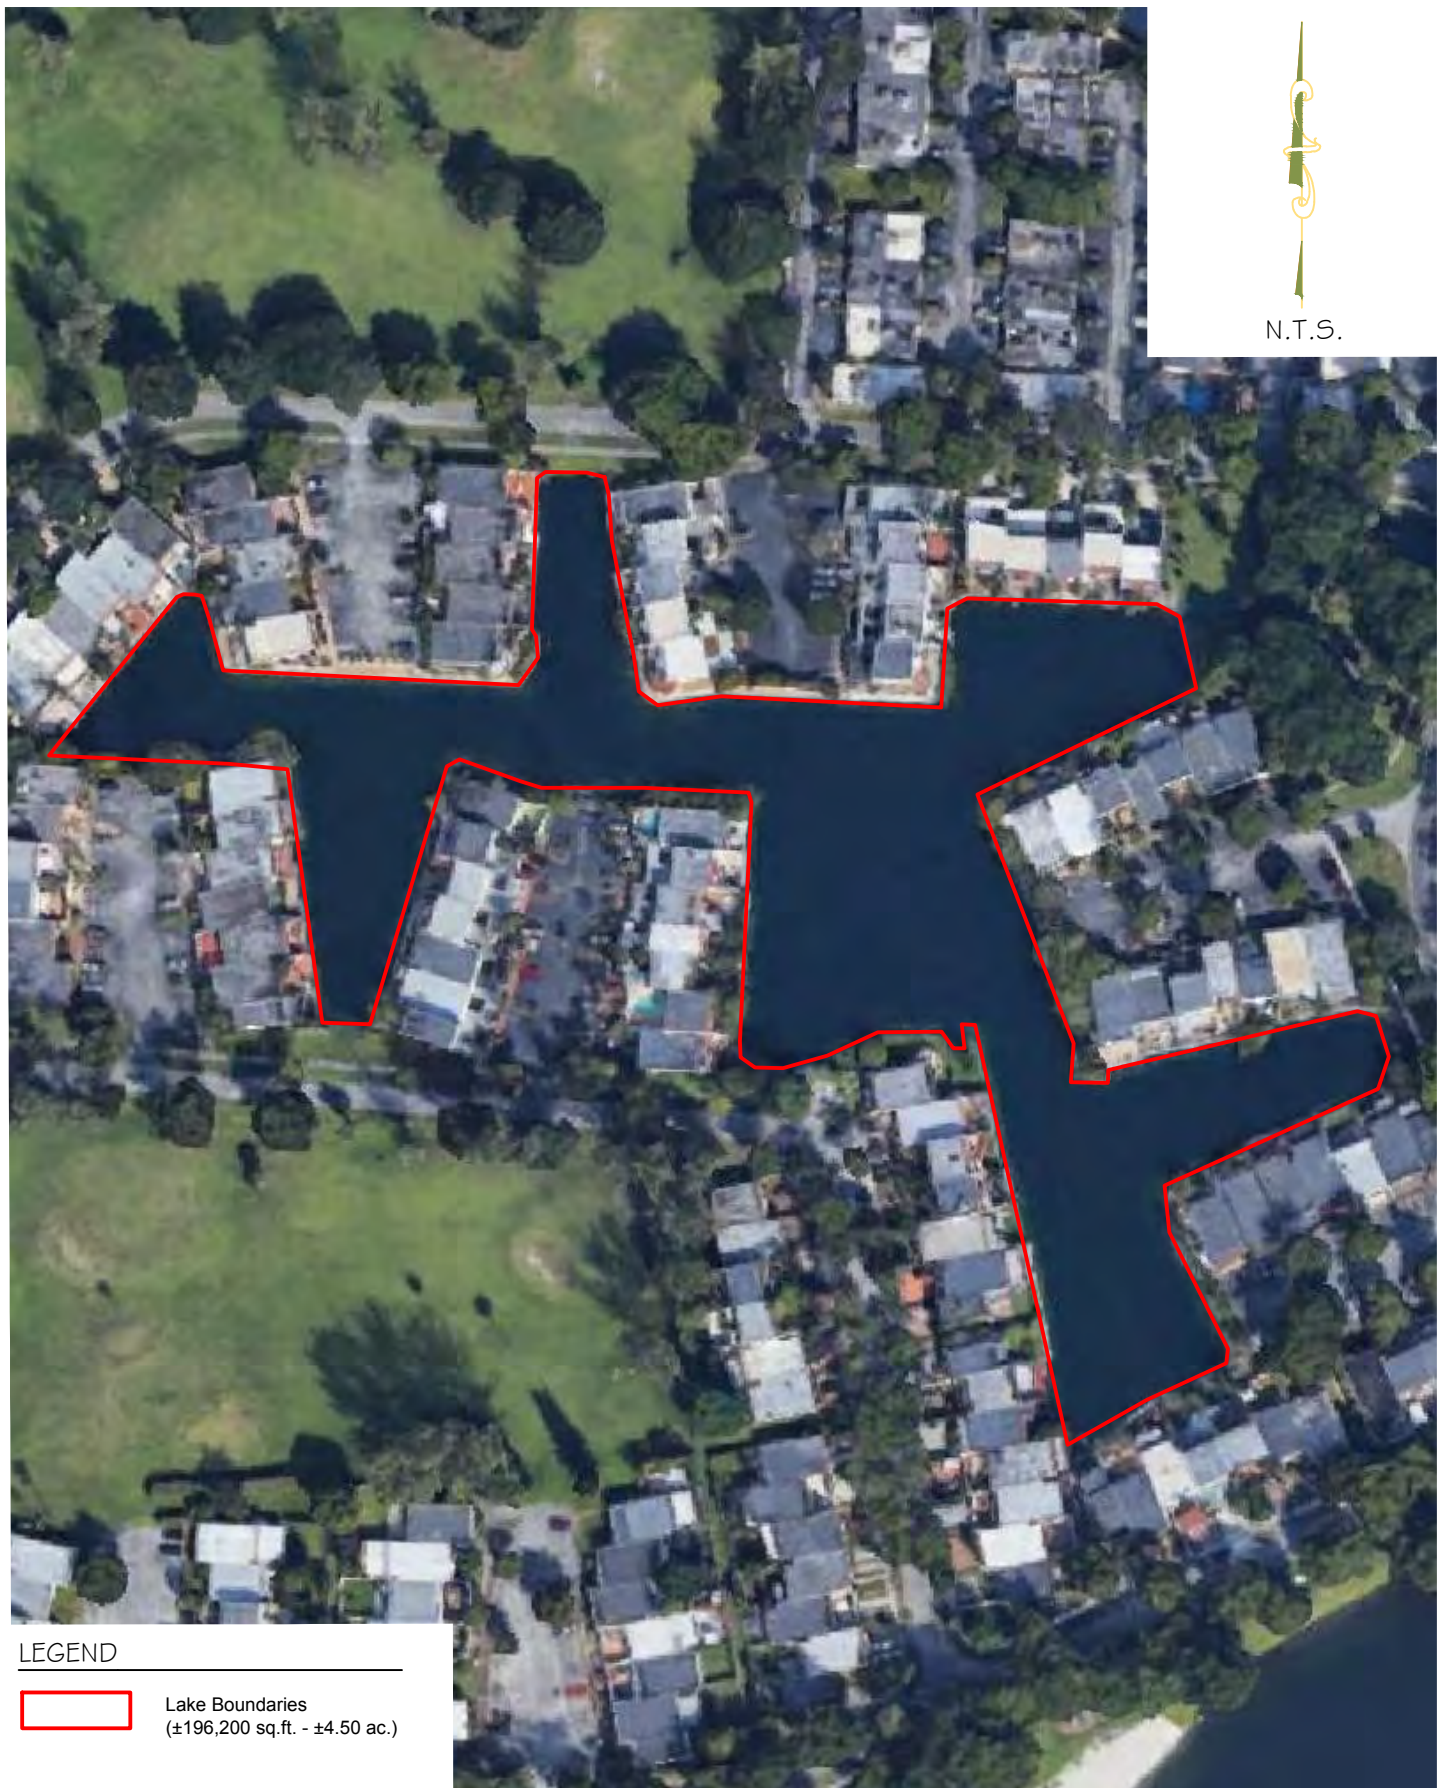
The inspection to evaluate the lake’s current condition was conducted on 5/1/18. It was observed that the entire shoreline consisted of a concrete sandbag seawall with a potential footer or rock ledge at the base. The lake depth was not measured due to the inaccessibility created by the seawall. The 2008 study stated the average depth was 12. feet. It was observed that the lake has aerators. No vegetation was observed, and observed wildlife was limited to the non-native Green Iguana (*Iguana iguana*). This lake appeared to contain pond dye.

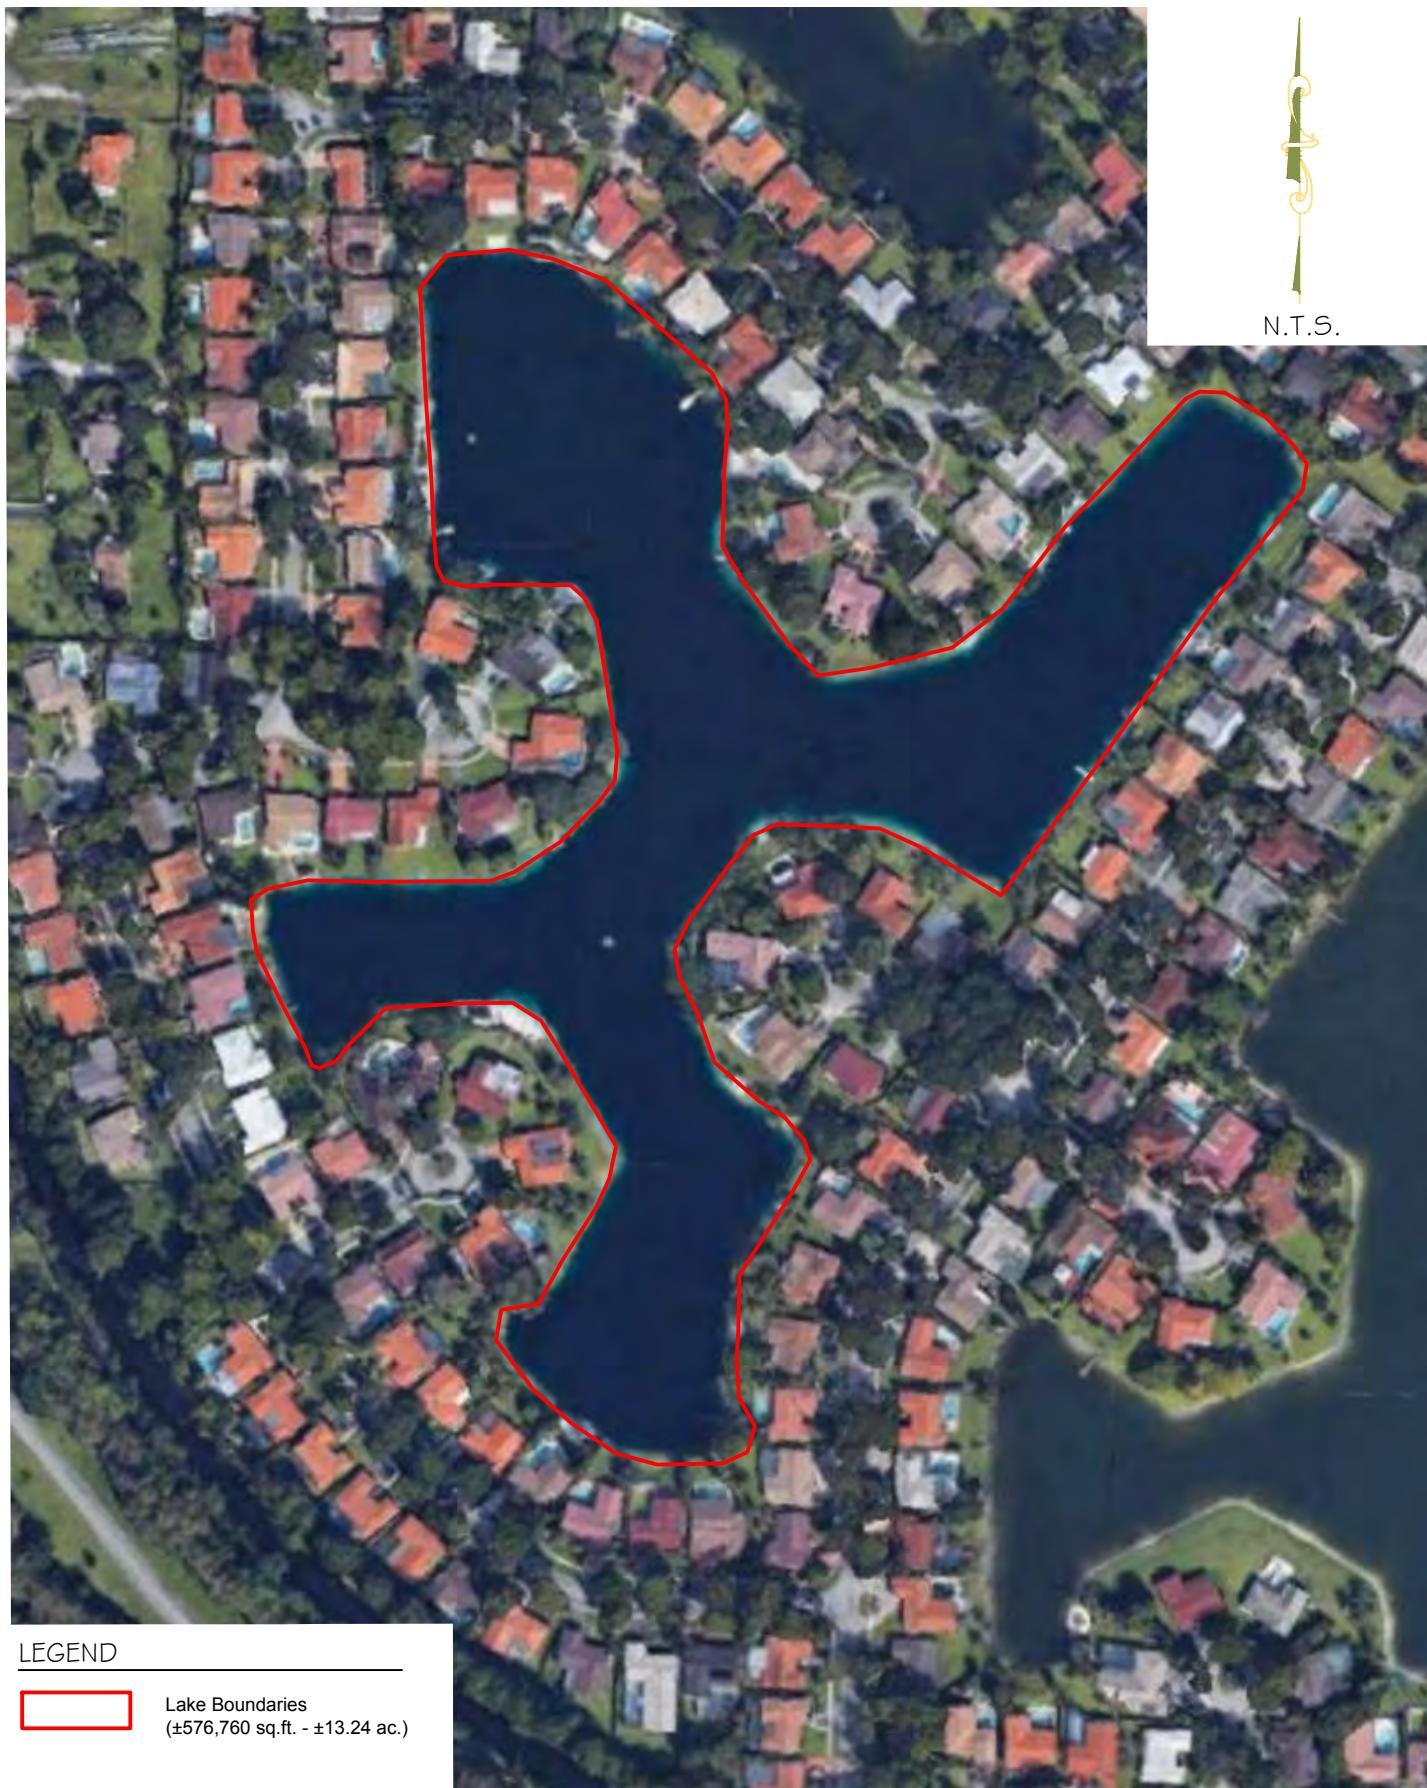
The inspection to evaluate the lake’s current condition was conducted on 5/3/18. It was observed that most of the shoreline was unconsolidated shoreline with a few concrete sandbag or concrete panel seawalls. All shorelines were adjacent to turf lawns for single family residences. The lake depth was measured to be 20 feet. During the inspection, it was noted that roadwork in the vicinity was being conducting and the closest outfall did have a turbidity curtain surrounding it. No fountains or aerators were observed at the time of the inspection. No vegetation along the shoreline or in the lake was observed at the time of the inspection. Observed wildlife was limited to the non-native Muscovy duck (*Cairina moschata*) at the time of the inspection. This lake appeared to contain pond dye.

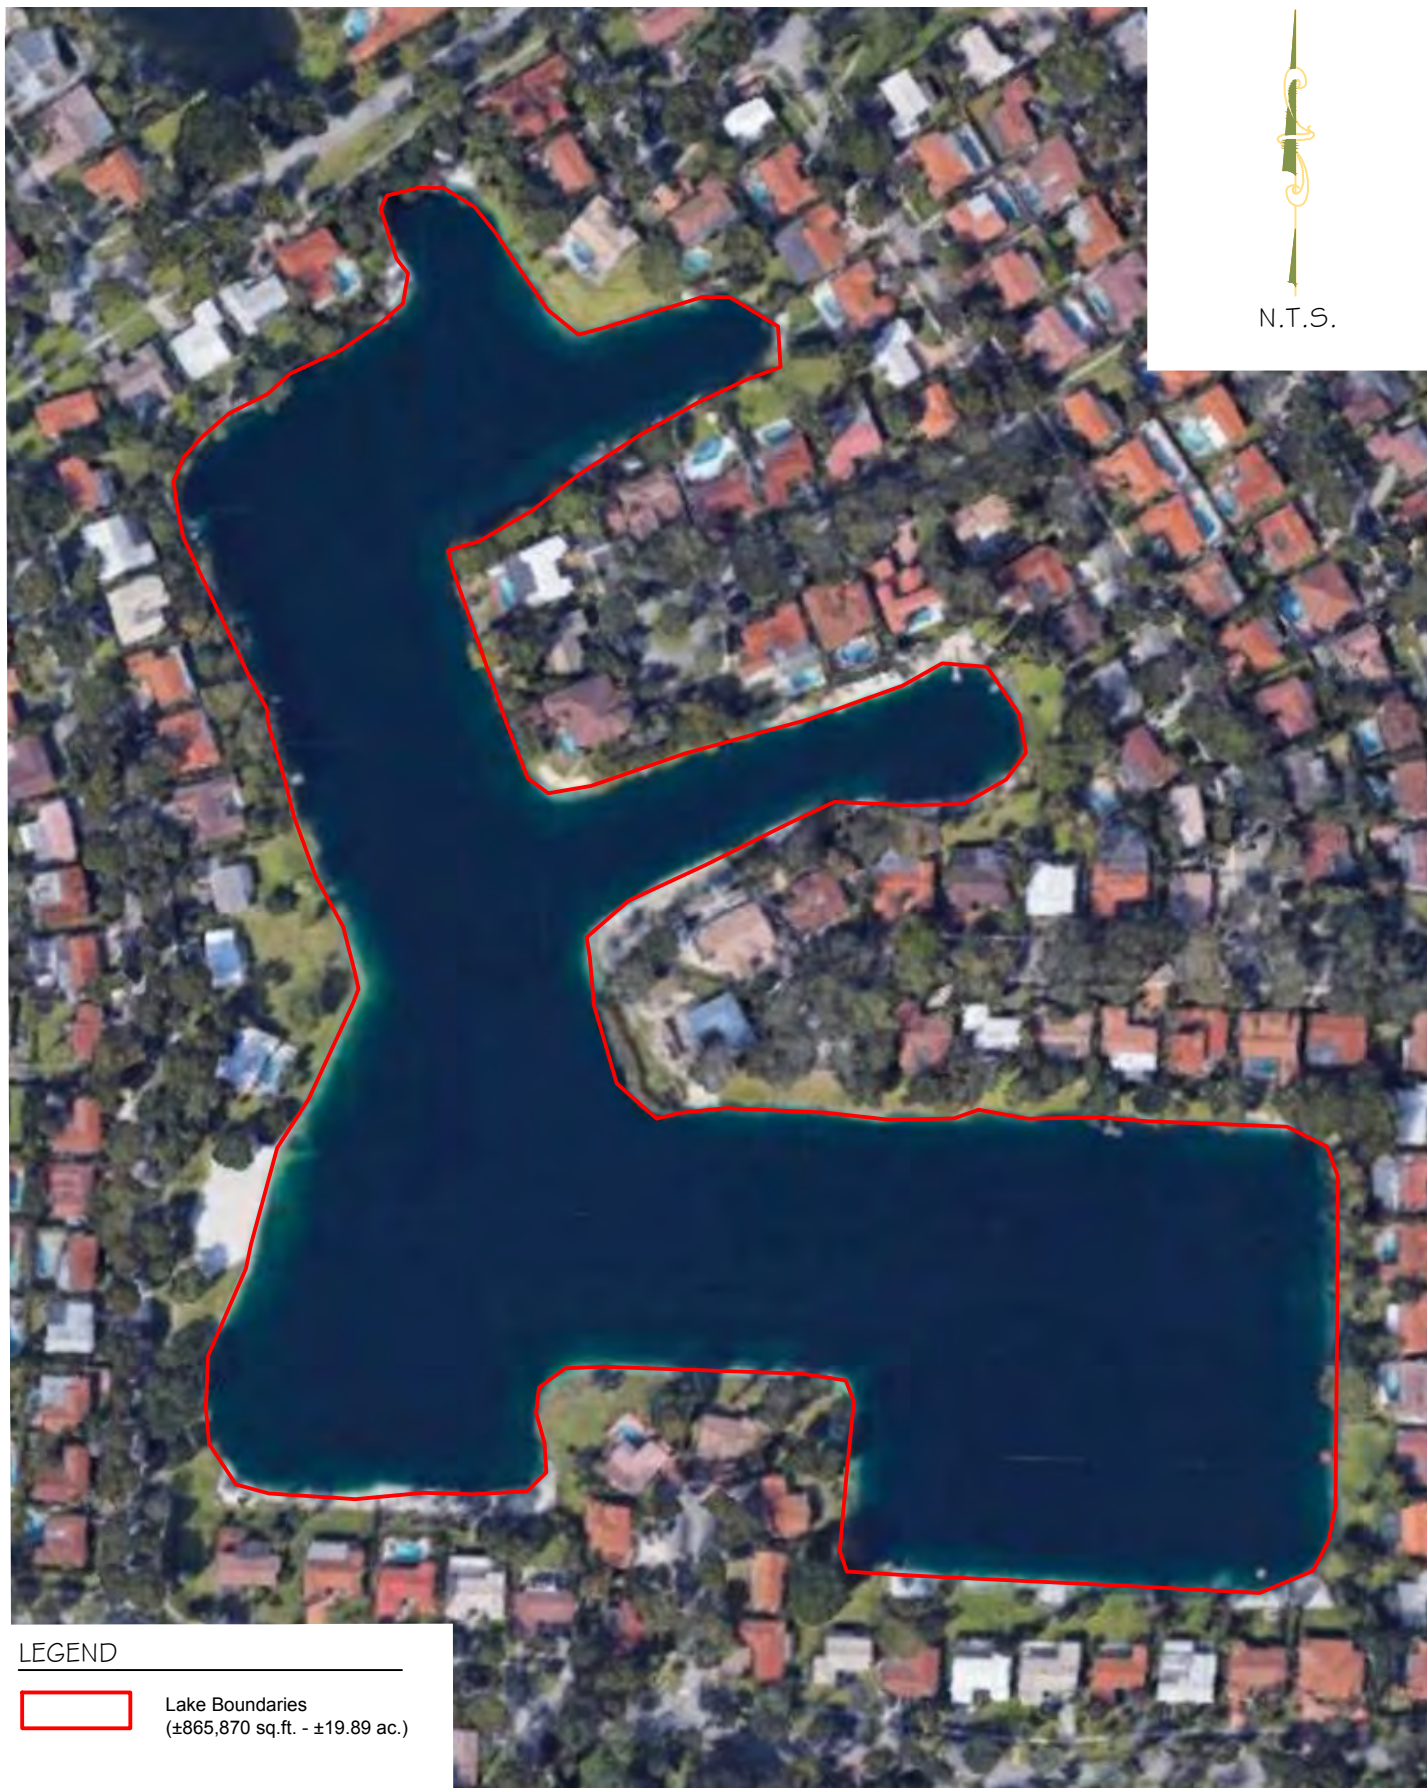
The inspection to evaluate the lake’s current conditions was conducted on 5/1/18. It was observed that the shoreline consisted mostly of an unconsolidated shoreline with some concrete sandbag and concrete panel seawalls. The lake depth was measured to be 16 feet. A public park with a beach access, and signage stating no pets, was located at the southwestern portion of the lake. Both public and private beaches were observed surrounding the lake. No fountains or aerators were observed at the time of the inspection. Observed vegetation included: eelgrass (*Vallisneria americana*) along the southwestern shoreline (adjacent to access area) and Cattail (*Typha* sp.). Observed wildlife included: invasive exotic Green iguana (*Iguana iguana*), non-native Egyptian goose (*Alopochen aegyptiaca*), American coot (*Fulica americana*), Double-crested cormorant (*Phalacrocorax auritus*), American white ibis (*Eudocimus albus*), and Common gallinule (*Gallinula galeata*). This lake appeared to contain pond dye, as it was an unnatural blue color.

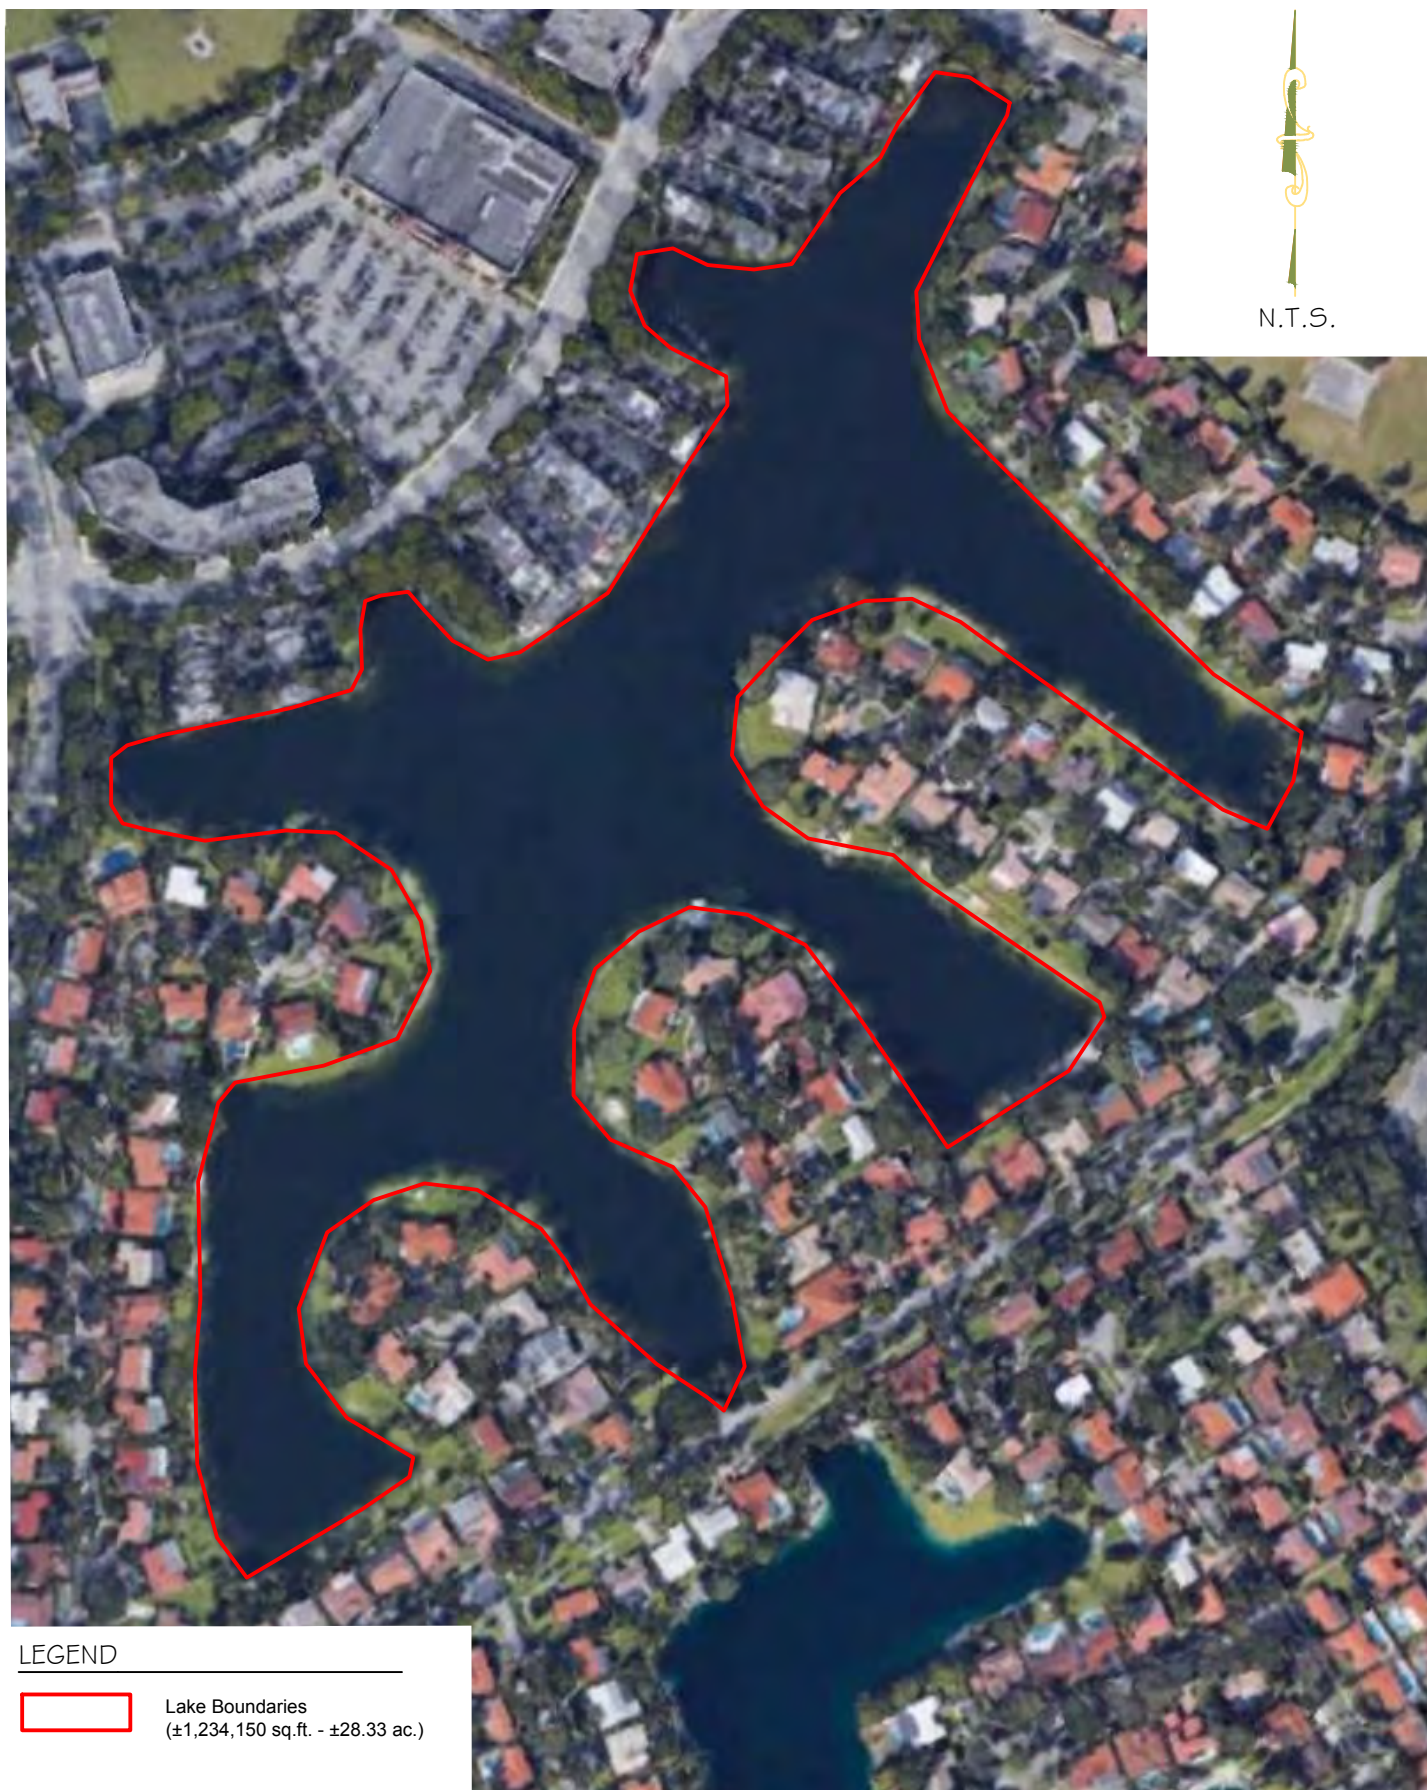
The inspection to evaluate the lake’s current conditions was conducted on 5/1/18. It was observed that the shoreline consisted of an unconsolidated shoreline and some seawalls. The shoreline of single family residences generally had lawns extending to the water’s edge while the multi-family residences generally have a seawall. Some of the Single Family Residential lots had docks. The lake depth was measured to be 33 feet. Lake access was located at the northwestern portion of the lake. No fountains or aerators were observed at the time of the inspection. Observed vegetation was limited Umbrella sedge (*Cyperus alternifolius*) along the northern shoreline (adjacent to access area). Observed wildlife was limited to invasive exotic Green iguana (*Iguana iguana*) and native Common gallinule (*Gallinula galeata*). This lake appeared to contain pond dye.

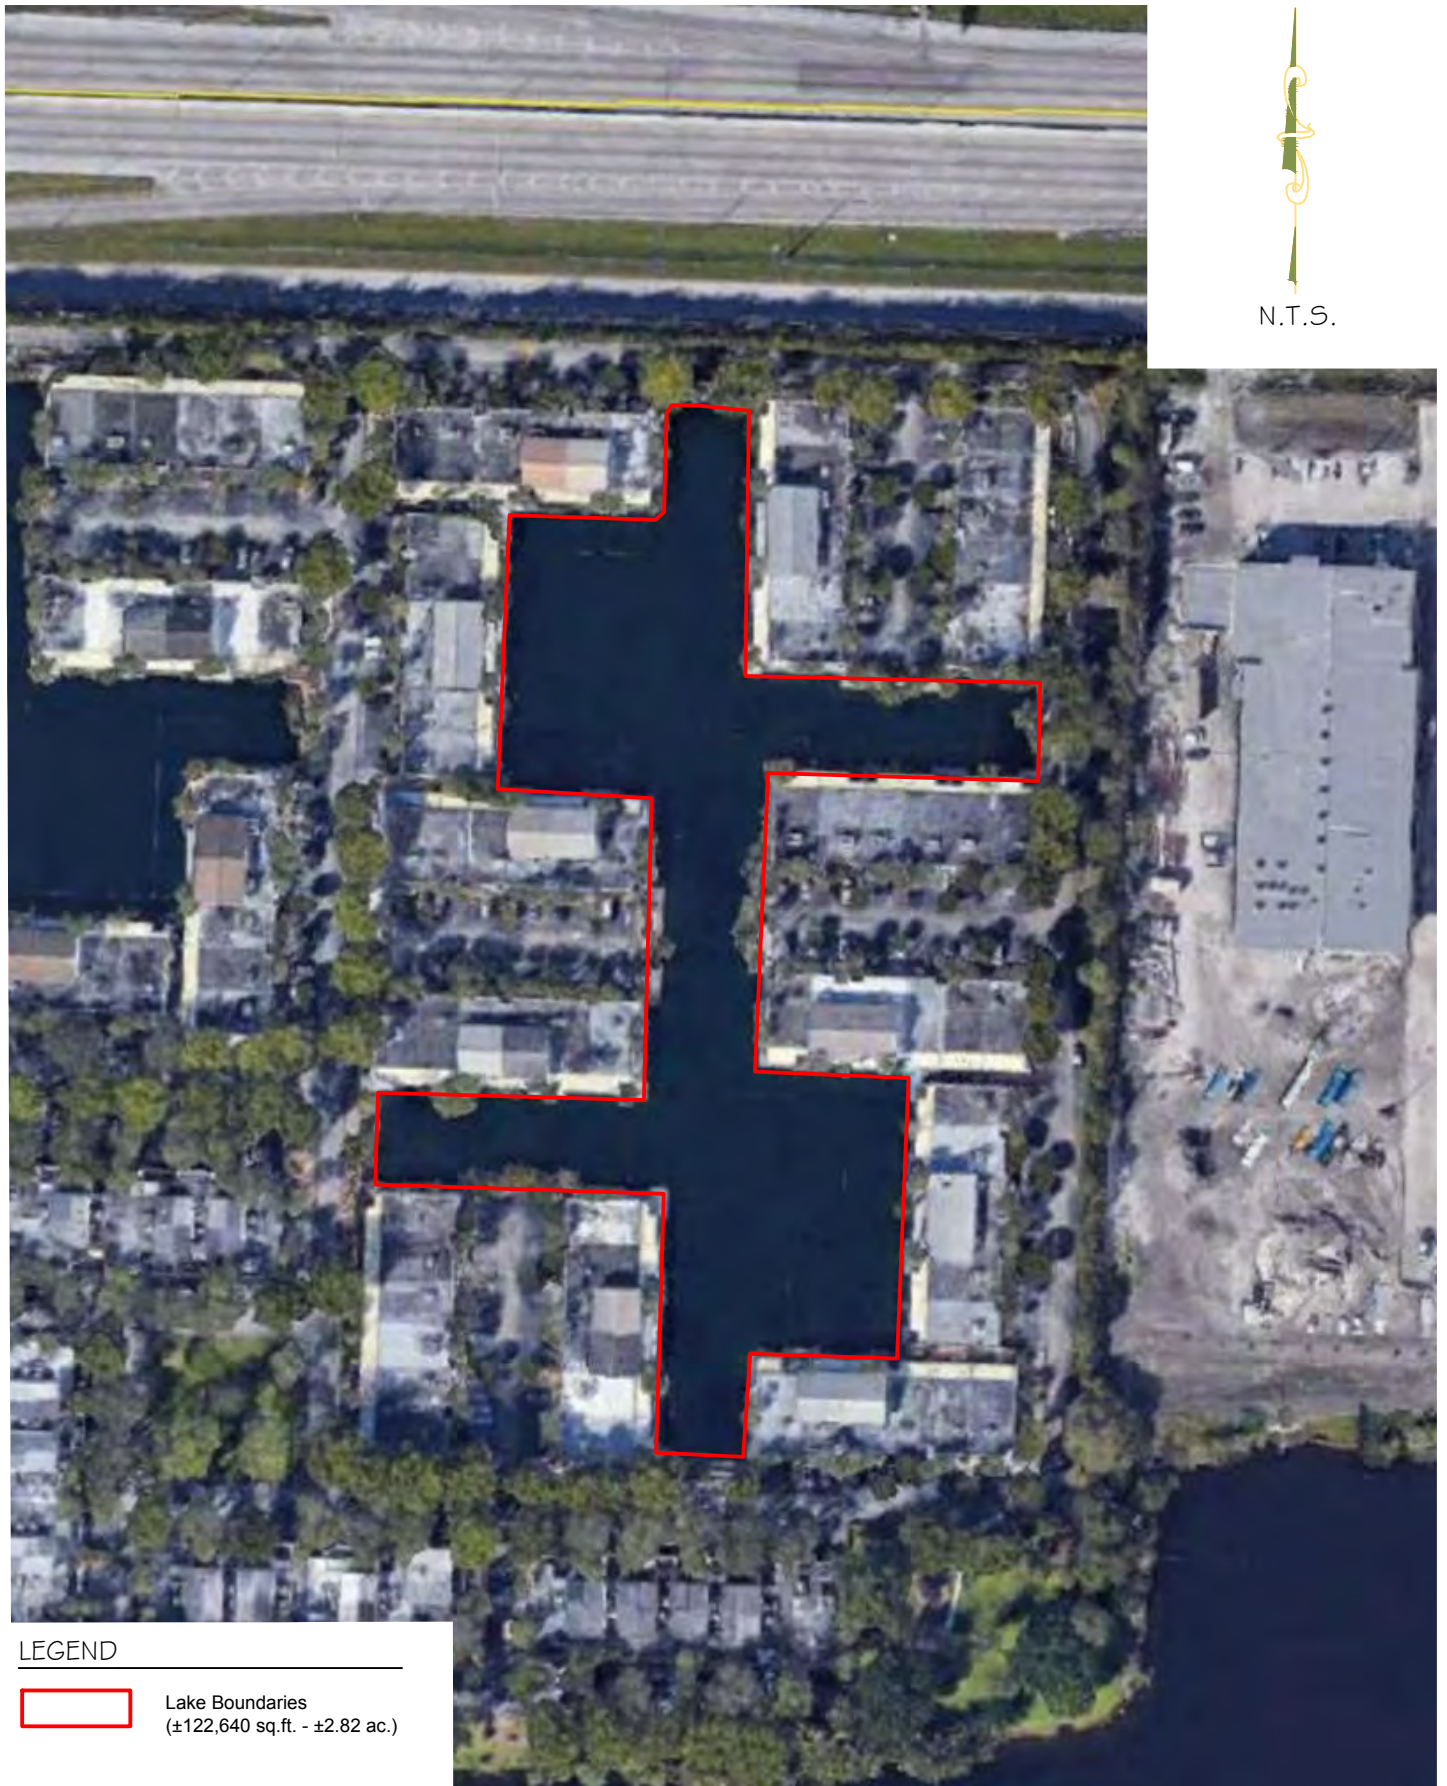
The inspection to evaluate the lake’s current condition was conducted on 5/3/18. It was observed there was a seawall surrounding the lake with a potential rock ledge or building footer visible below the waterline. Multi-family residences surround the lake and there are no lawns abutting the seawall, mostly concrete decking. The lake depth was not measured due to the inaccessibility created by the seawall. The 2008 study stated the average depth was 15 feet. Two aerators were observed. No wildlife or vegetation was observed at this lake. This lake appeared to contain pond dye.
