Final Report Review of Blast Documentation Data White Rock Quarry North (WRQN) Miami-Dade County Lake Belt

Florida Department of Financial Services

Lampl Herbert Consultants PO Box 10129 Tallahassee, FL 32302

June 12, 2017

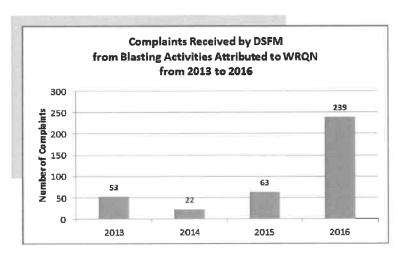
Figure 14: Complaints Received by DSFM from Blasting Activities Attributed to WRQN from 2013 to 2016

Neighbors to the WRQN filed a total of 239 complaints with the DSFM office during 2016 (Figure 14 and Figure 15); 214 occurred between April 1 and December 30. Presumably the higher PPV events would be expected to correlate in some manner to the number of homeowner complaints; however, the data do not express this correlation, suggesting other issues may be at work. The PPV data recorded for the last six months of 2016 from three reporting sources during blast events allowed LHC to check timing and wave propagation.

There appears to be a correlation between the geometric orientation of the mine face and wave propagation that results. Blasts on the north wall of mine generated the highest number of blasting complaints. The answer here may be the result of the physical orientation of the energy

source relative and the mine face and the subsequent wave forms propagating and interacting as they move north into the Miramar residential area.
