# Town of Miami Lakes

## Storm Water Management Master Plan and Drainage Capital Improvements Program Prepared for:

# Town of Miami Lakes Storm Water Management Master Plan and Drainage Capital Improvements Program

## *Table of Contents*

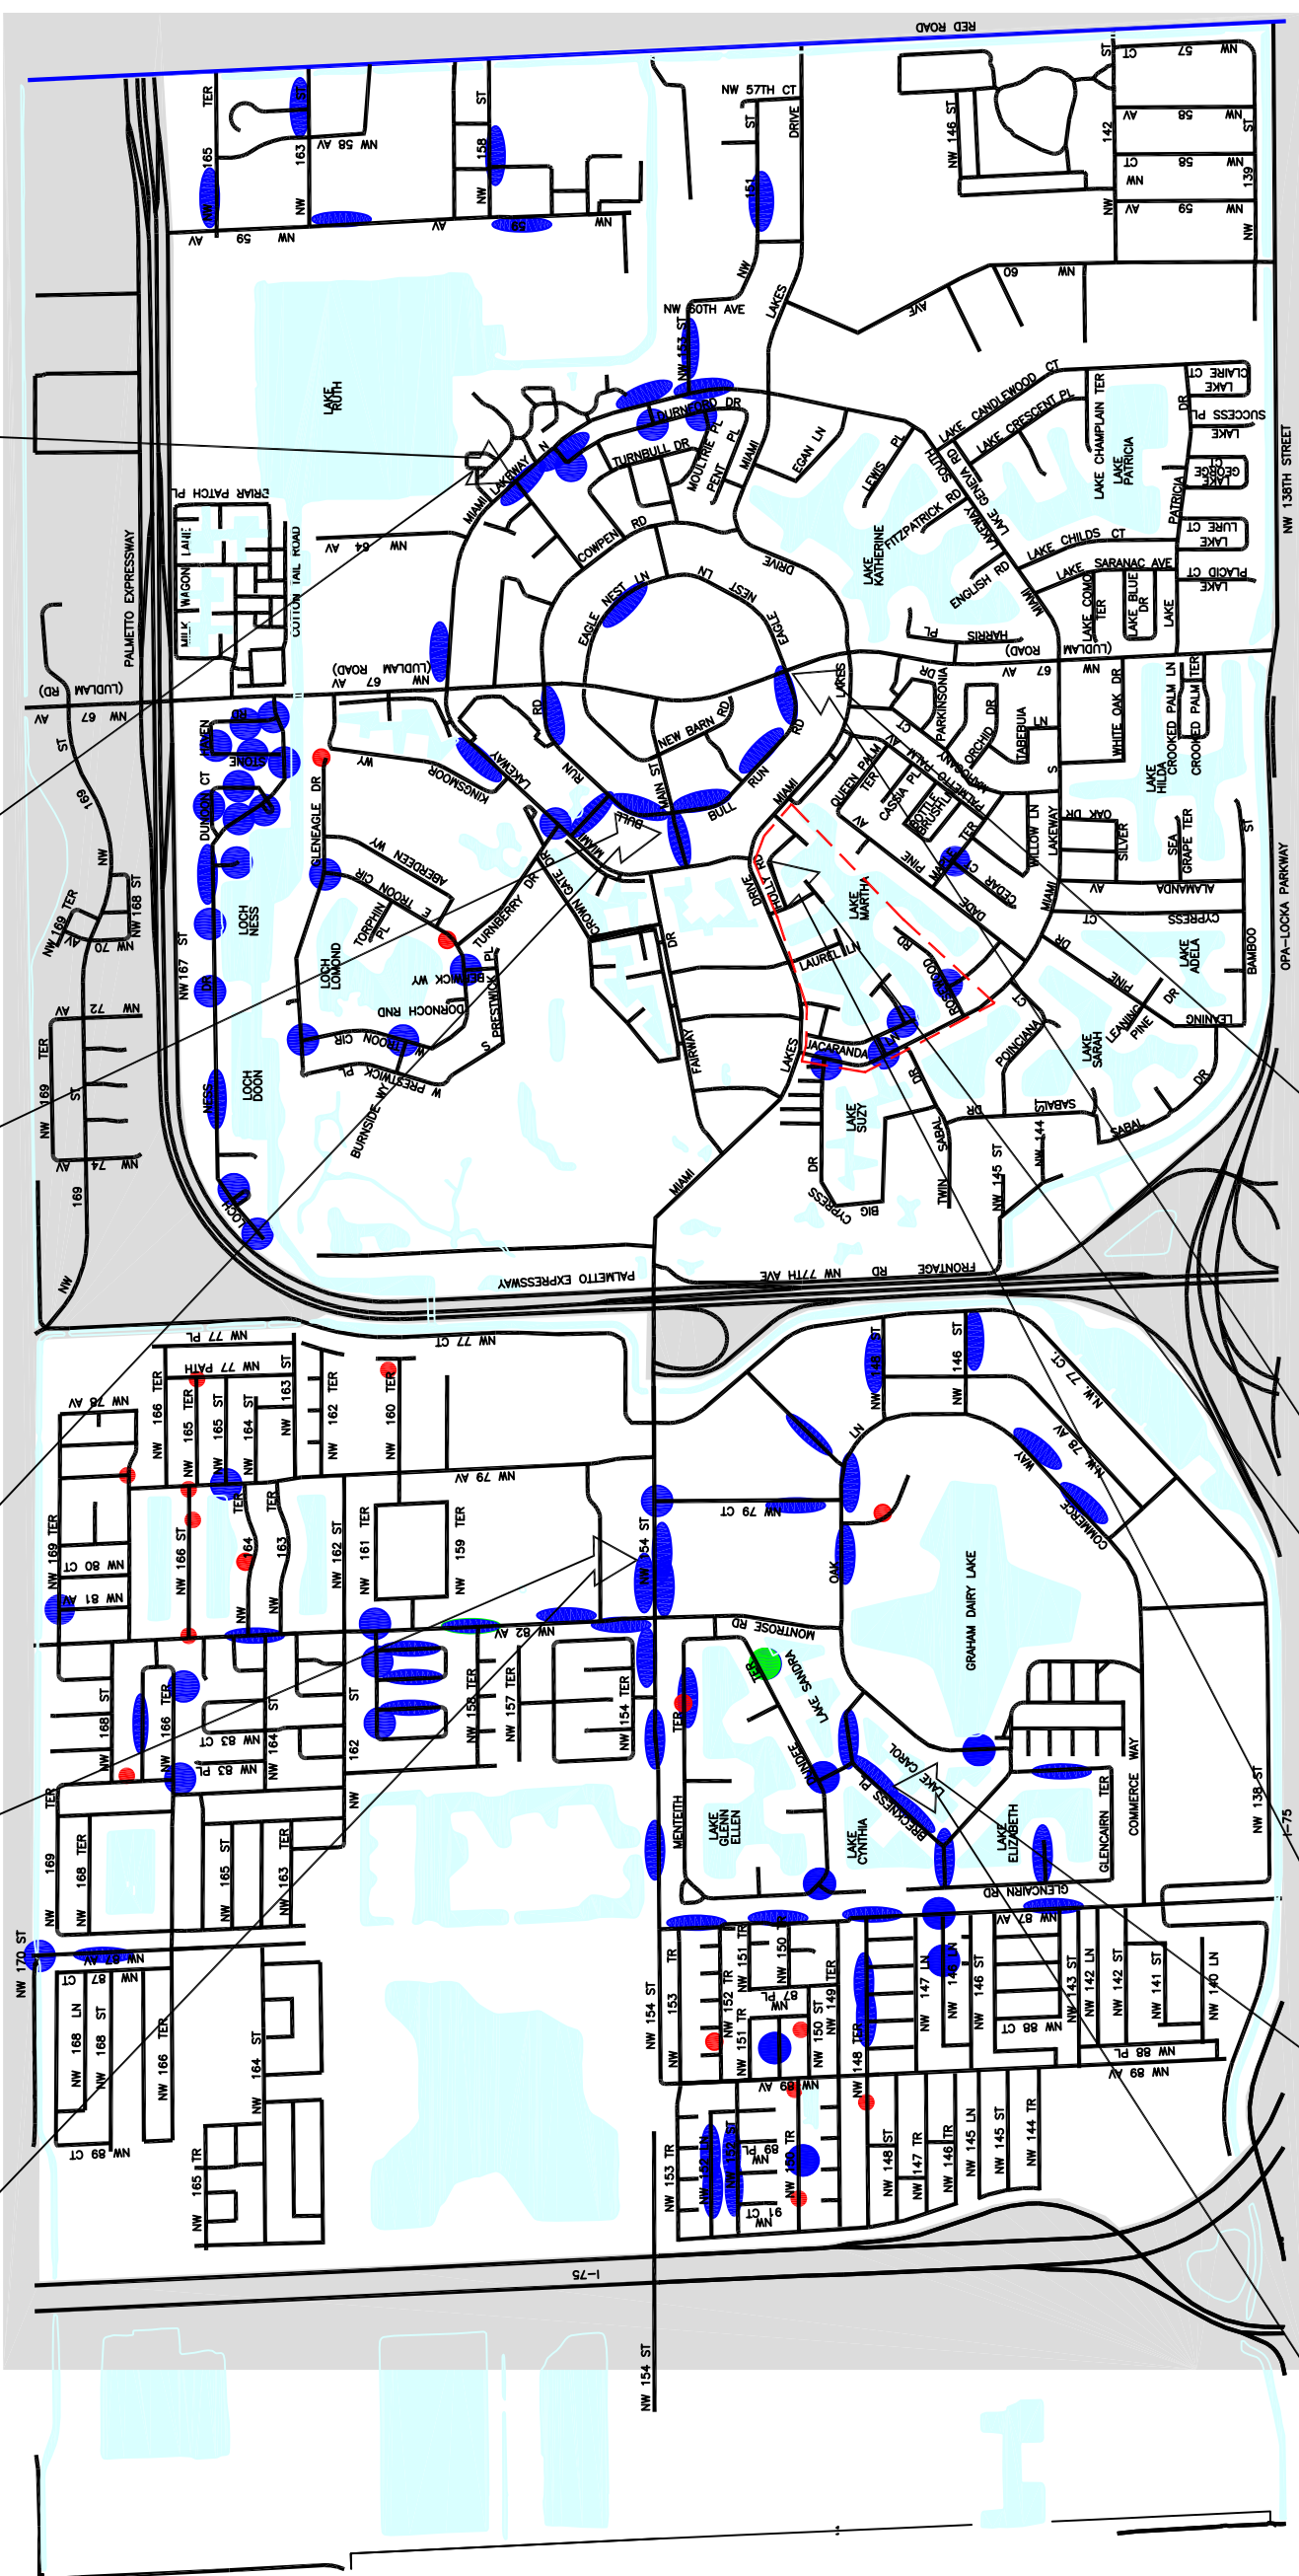
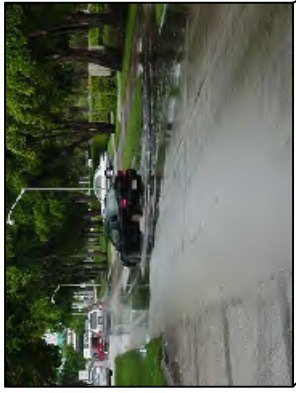
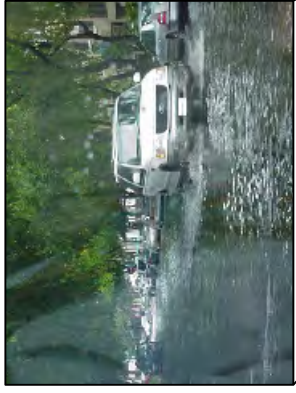
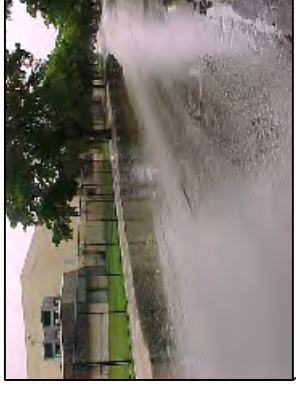
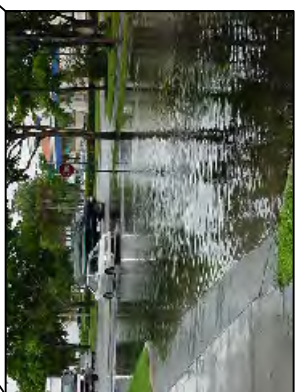
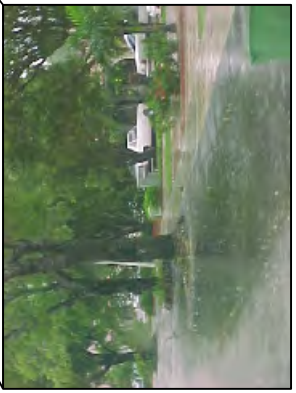
Figure 2. Drainage Deficiencies

This assessment was conducted during a rainy period between June 24 and July 11, 2002. Table 1 below details the rainfall for this period. The 3-year return storm event is estimated to be 6-inches in a 24-hour period. The rainfall for any single 24-hour event was less than a 3-year return storm event; however, the 15.68 inches of total rainfall within a 18-day period is very high, even for the typical South Florida rainy season. This provided saturated soils and high ground water tables, which would contribute to higher and longer ponding conditions, which exceed the typical 3-year return storm event. The roadway drainage conditions were assessed within the first 15 to 75 minutes after substantial rainfall events. Areas where stormwater accumulation extended into the roadway travel lanes were noted as flooding areas during this phase of the assessment and can be seen in Figure 2. The deficiencies ranged from roadside flooding that extended into the road for a period of a few hours after a major rainfall event to complete flooding of some sections of roadway lasting for several days after a storm. Photos of the drainage deficiencies can be found in Appendix A.

1. *Low areas without positive drainage.* Several of the areas where ponding within the roadway was noted consist of low areas with no drainage structure to convey water away from the roadway. This situation occurs most frequently at residential intersections, but there are some areas along the major roadways where low points without positive drainage exist as well.

Due to the lack of available information on the existing Bull Run storm drainage system, a computation for the comparison of the existing conditions with the above stated performance goals can not be made. However, based on the extent of the observed ponding (see Figure 2), it appears that many of the performance goals are not met in the Bull Run sub-basin.

Due to the lack of available information on the existing Miami Lakeway storm drainage system, a computation for the comparison of the existing conditions with the above stated performance goals can not be made. However, based on the extent of the observed ponding (see Figure 2), it appears that many of the performance goals are not met in the Miami Lakeway sub-basin.

Due to the lack of available information on the existing NW 154<sup>th</sup> Street storm drainage system, a computation for the comparison of the existing conditions with the above stated performance goals can not be made. However, based on the extent of the observed ponding (see Figure 2), it appears that many of the performance goals are not met in the NW 154<sup>th</sup> Street sub-basin.

Due to the lack of available information on the existing NW 82<sup>nd</sup> Avenue storm drainage system, a computation for the comparison of the existing conditions with the above stated performance goals can not be made. However, based on the extent of the observed ponding (see Figure 2), it appears that many of the performance goals are not met in the NW 82<sup>nd</sup> Avenue sub-basin.

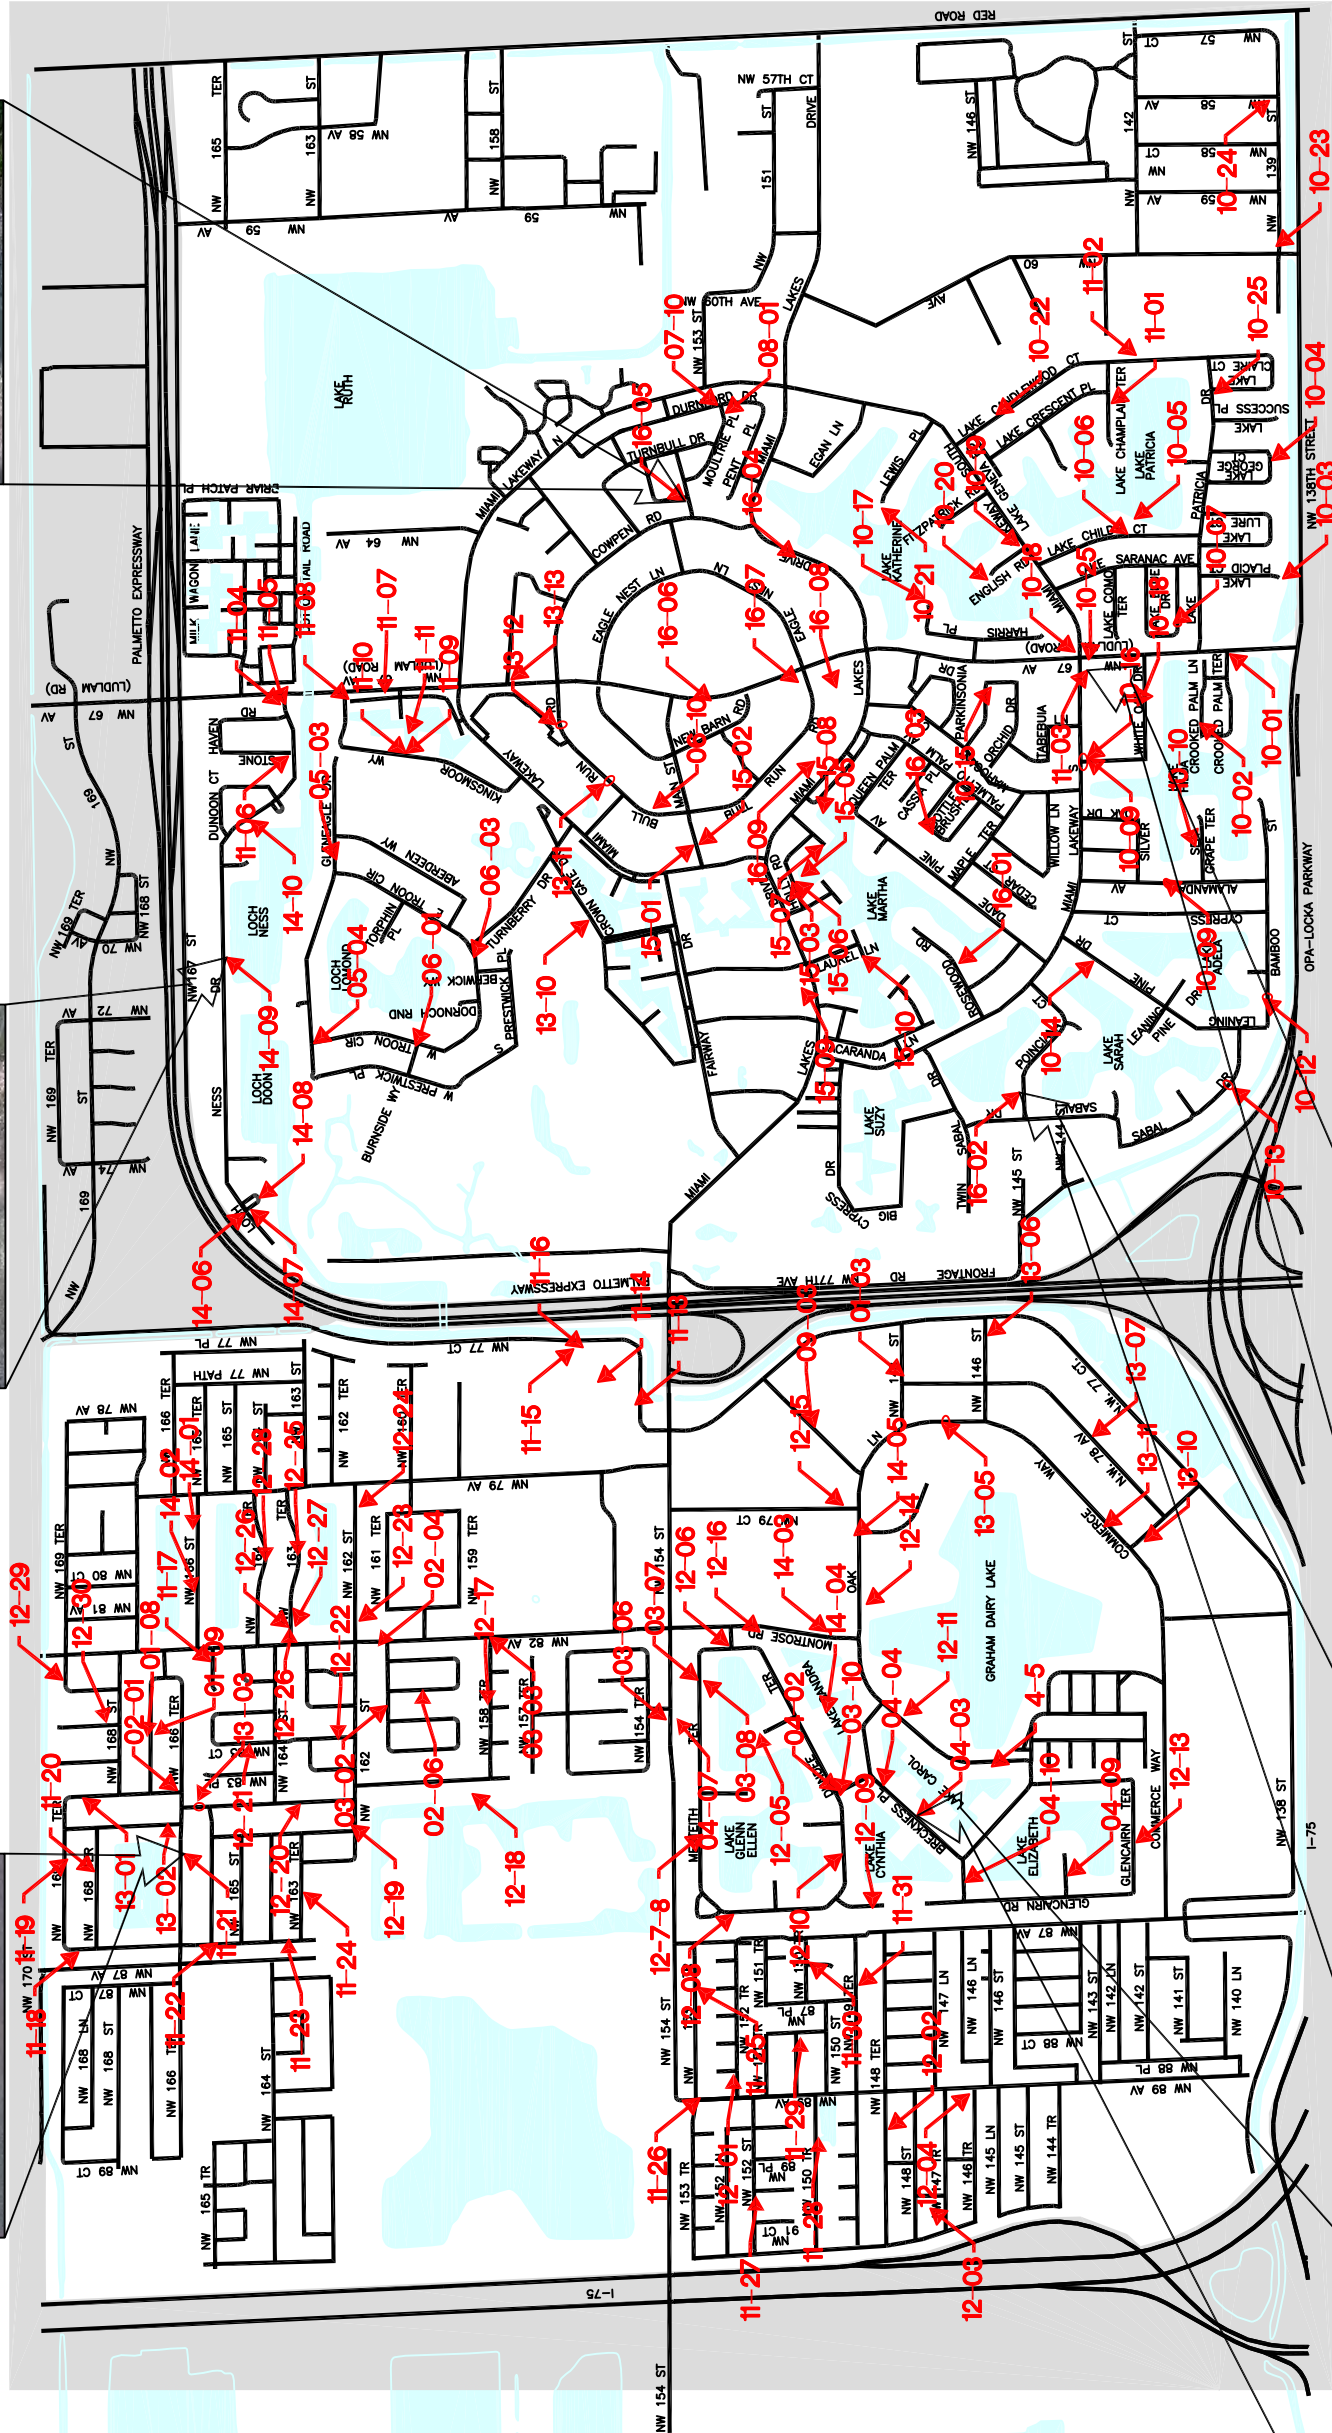
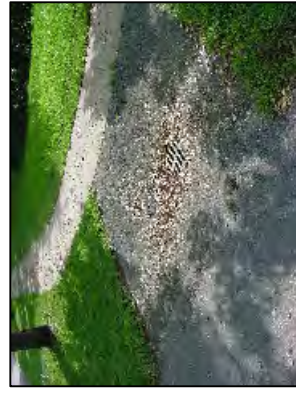
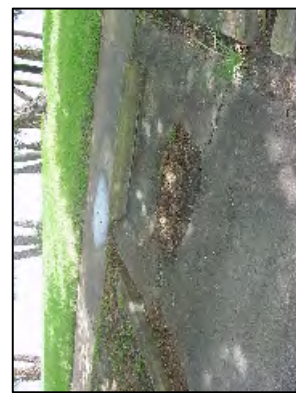
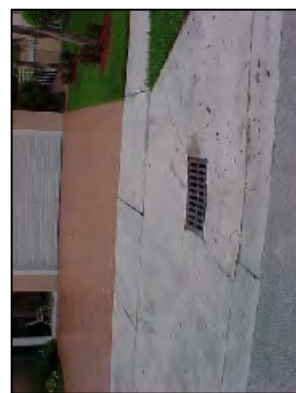
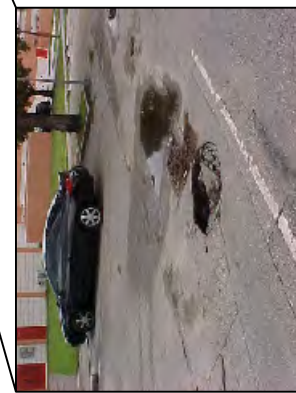
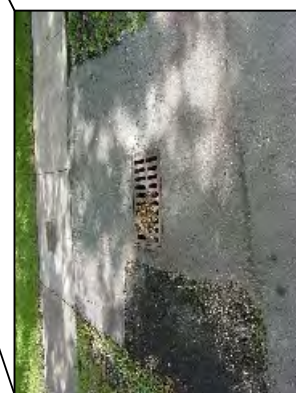
**Figure 3. Drainage Structure Inventory**

The third phase of the drainage assessment was an evaluation of drainage structures within the Town. Geographic Information System (GIS) data provided by DERM was used to map the location of the majority of the public drainage structures within the town. Approximately 200 of these structures were chosen for field evaluation. Structures in areas of roadway flooding as noted in the first and second phases of the drainage system evaluation. Additional structures were also evaluated to provide a geographically diverse array of structures. The location of the evaluated structures can be seen in Figure 3.

2. *Clogged inlets.* Another common condition found throughout the Town was clogged inlets. This happens when leaves and other debris accumulate on top of the drainage inlet cover, blocking the flow of water into the inlet. Even when leaves were not found to be blocking the drainage inlet cover, often the bottom of the inlet itself was filled with leaves, dirt and other debris.

4. *No baffles to protect exfiltration trench from oil and grease deposits.* None of the drainage structures observed contained pollution retardant baffles to prevent the accumulation of grease and oil within the trench. Grease and oil accumulation reduces the drainage effectiveness and lifespan of the exfiltration trench.

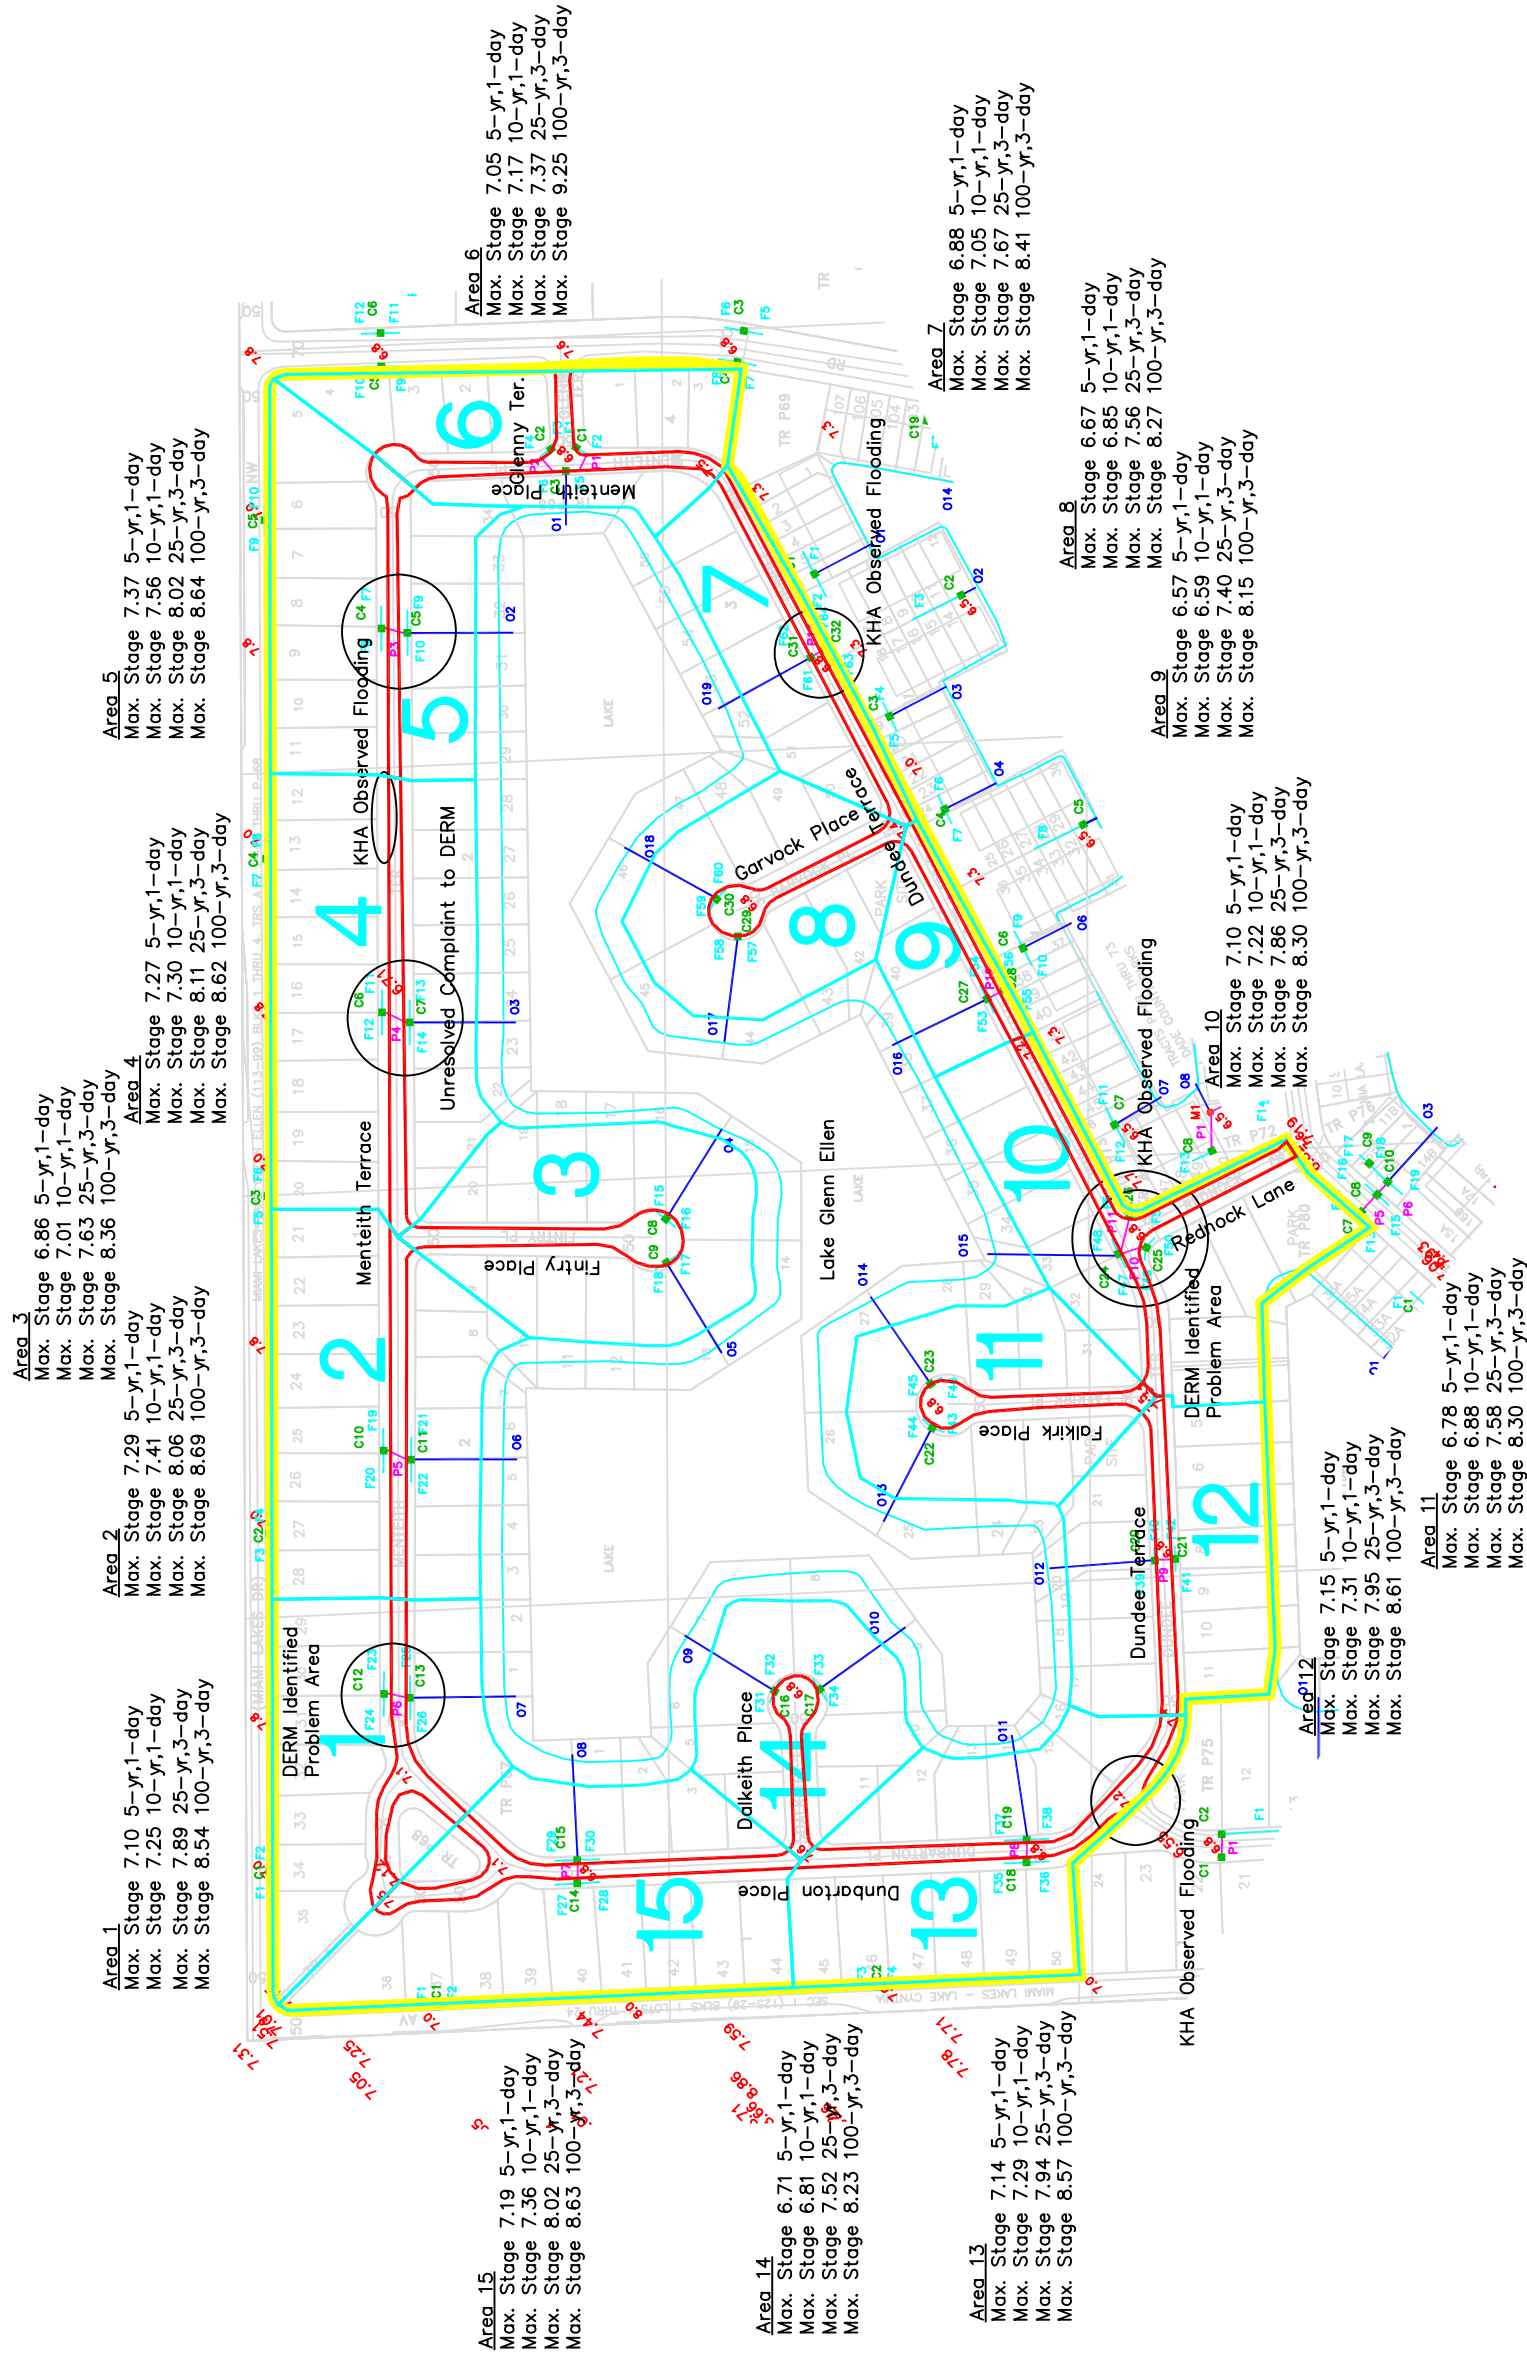
Figure 10. Glenn Ellen Sub-Basin (30-2022-003) - Existing

Figure 10 shows existing conditions for the Lake Glenn Ellen sub-basin. The sub-basin consists of approximately 49.1 acres of existing detached single family development with approximately 8,400 linear feet of roadway, including Menteith Terrace, Menteith Place, Dundee Terrace, Glenny terrace, Fintry Place, Garvock Place, Falkirk Place, Dunbarton Place, Dalkeith Place and a portion of Rednock Lane. The existing roads range in elevation from a low of approximately 6.4 to a high of approximately 7.5 feet. The sub-basin was subdivided into 15 areas. There are 19 outfalls into Lake Glenn Ellen. Areas 3, 8, 11, & 14 have two existing outfalls. Typically the low points have catchbasins with short (30 ± feet) sections of exfiltration trench on each side of the road connected to a positive outfall to Lake Glenn Ellen. Typically the exiting outfalls are 8-inch diameter pipes with a raised portion (goose neck) that acts as an overflow weir. The 8-inch outfall pipes are typically located on lot lines between existing houses. The status of drainage easement ownership for the outfalls must be verified. If drainage easements do not presently exist, they may have to be obtained. The ownership of the Lake and drainage rights should also be verified.

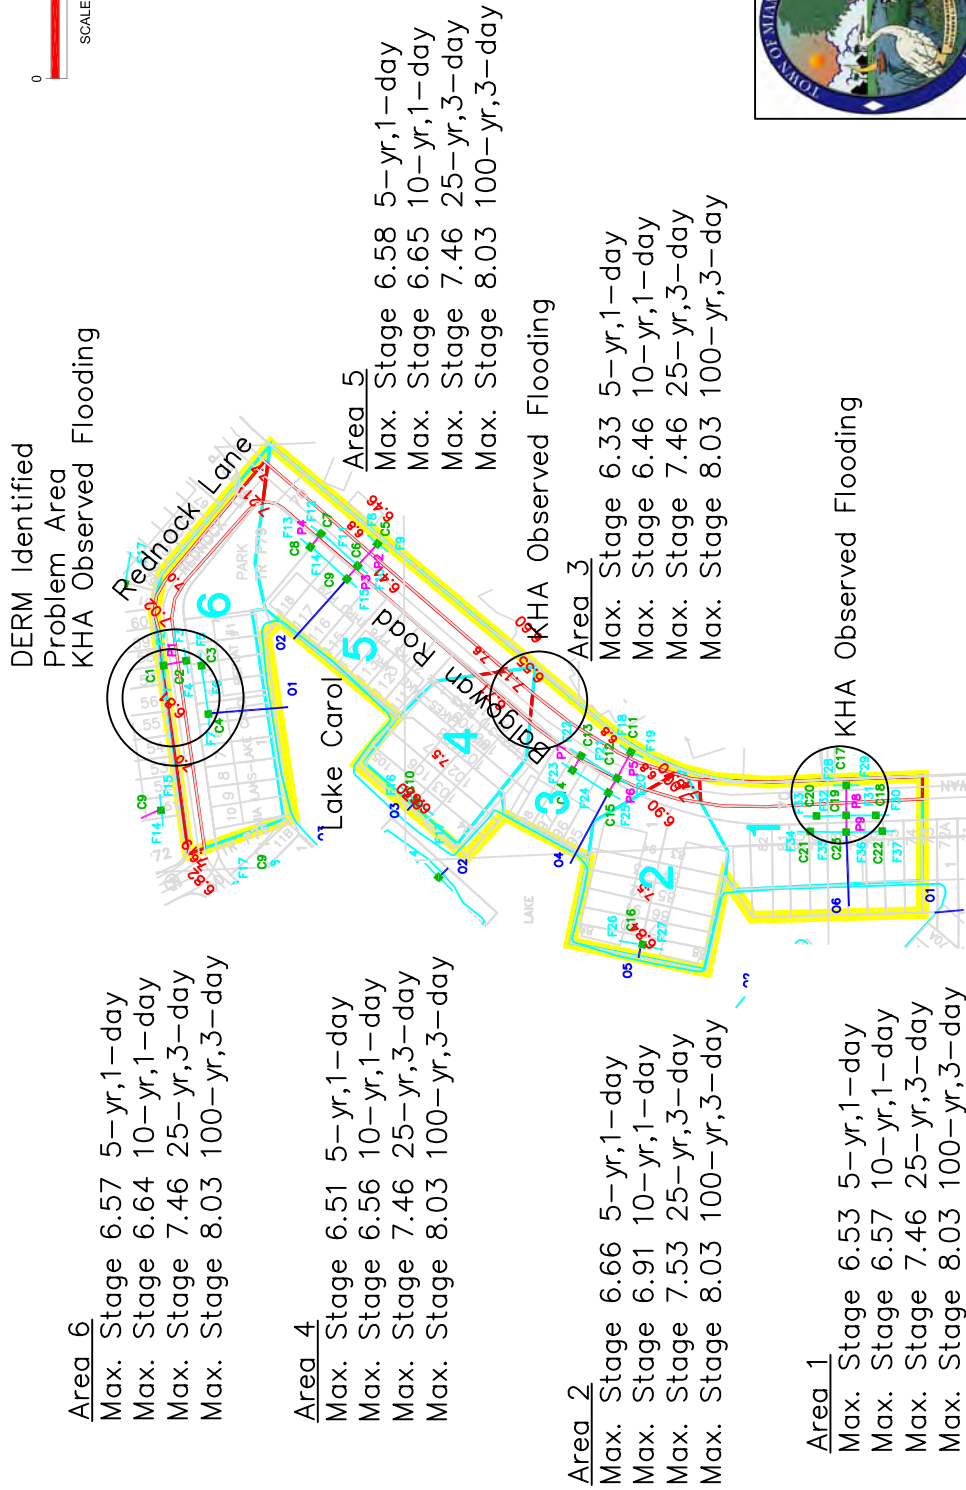
**Figure 20. Lake Carol 1 - Existing Drainage Sub-Basin (30-2022-010)**

Figure 20 shows existing conditions for the Lake Carol Section 1 sub-basin. The sub-basin consists of approximately 8.0 acres of existing residential townhouse development along approximately 1250 linear feet of Balgowan Road and 700 linear feet of Rednock Lane. The existing roads range in elevation from a low of approximately 6.5 to a high of approximately 7.6 feet. The roadway and townhouse parking areas have existing catchbasins, exfiltration trench, interconnecting culverts and six existing outfalls into Lake Carol.

The existing exfiltration trench drainage system, if properly maintained, meets the water quality requirements. The existing outfalls also meet the water quantity performance goals. Flooding and complaints were observed in Areas 1, 3, 4, 5 and 6.

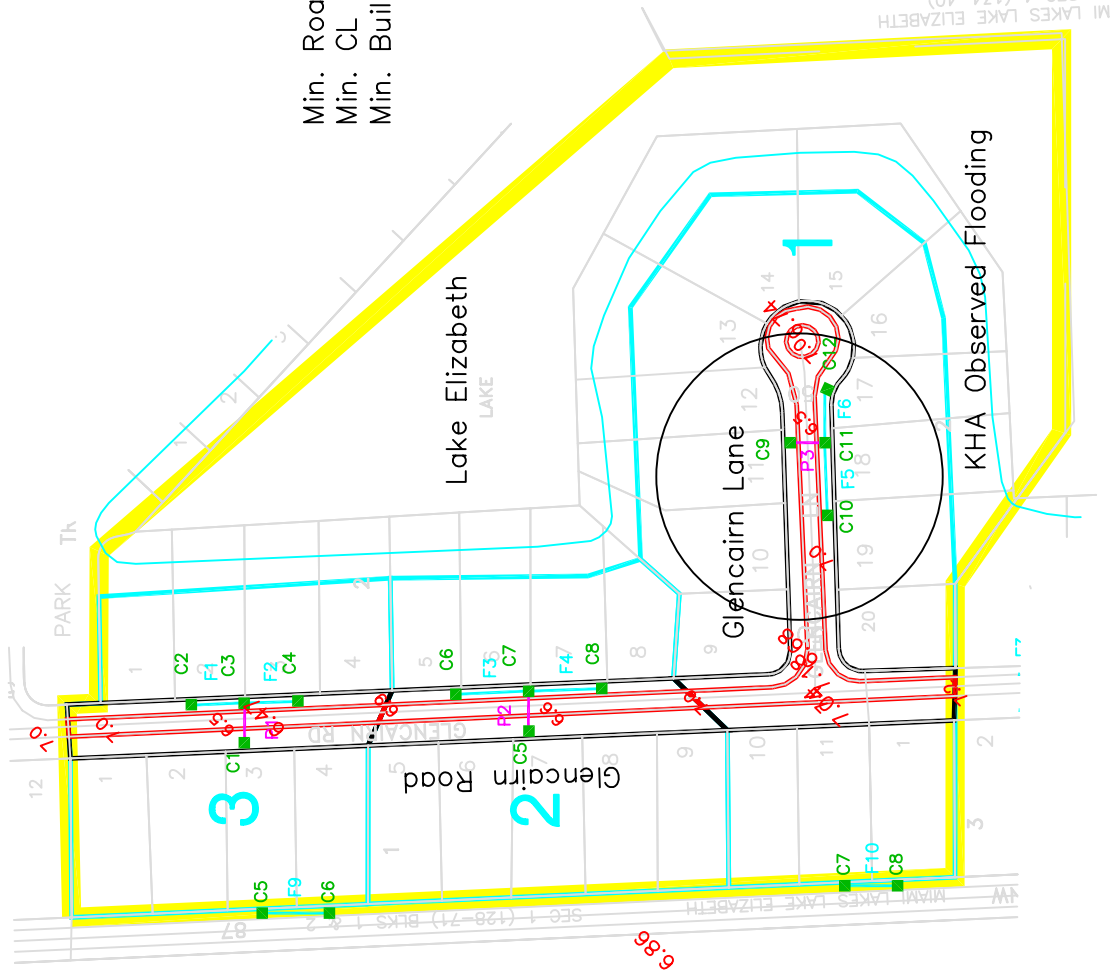
**Maintenance:** Due to the lack of outfalls the culverts and catchbasins may frequently clog with debris and sediment such that water flow is blocked or highly restricted. Frequent maintenance is required for the existing system.

**Lack of Outfalls:** Based on hydraulic analysis the system does not have sufficient capacity to meet the performance goals without positive outfalls to the Lake.

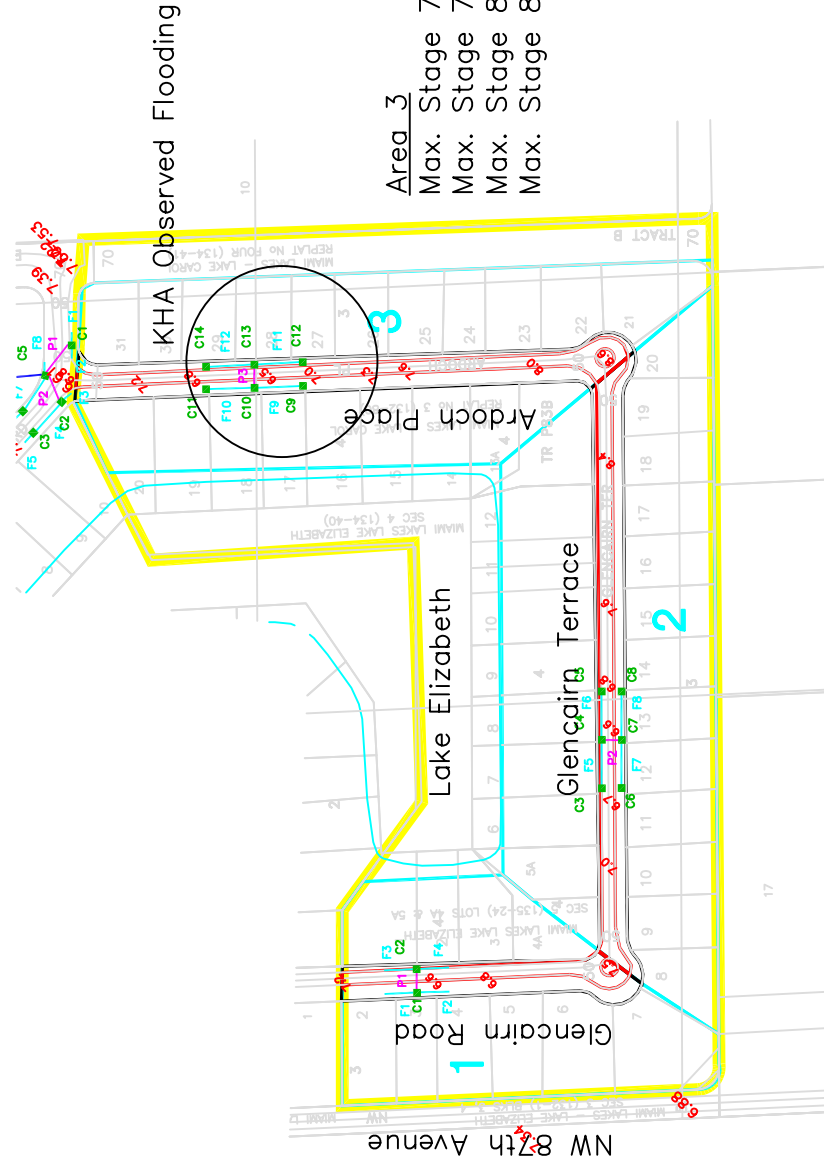
**Lack of Outfalls:** Based on hydraulic analysis the system does not have sufficient capacity to meet the performance goals without positive outfalls to the Lake.

**Area 1**  
 Max. Stage 7.62 5-yr, 1-day  
 Max. Stage 8.11 10-yr, 1-day  
 Max. Stage 8.60 25-yr, 3-day  
 Max. Stage 9.05 100-yr, 3-day

**Area 3**  
 Max. Stage 7.31 5-yr, 1-day  
 Max. Stage 7.52 10-yr, 1-day  
 Max. Stage 8.43 25-yr, 3-day  
 Max. Stage 8.89 100-yr, 3-day

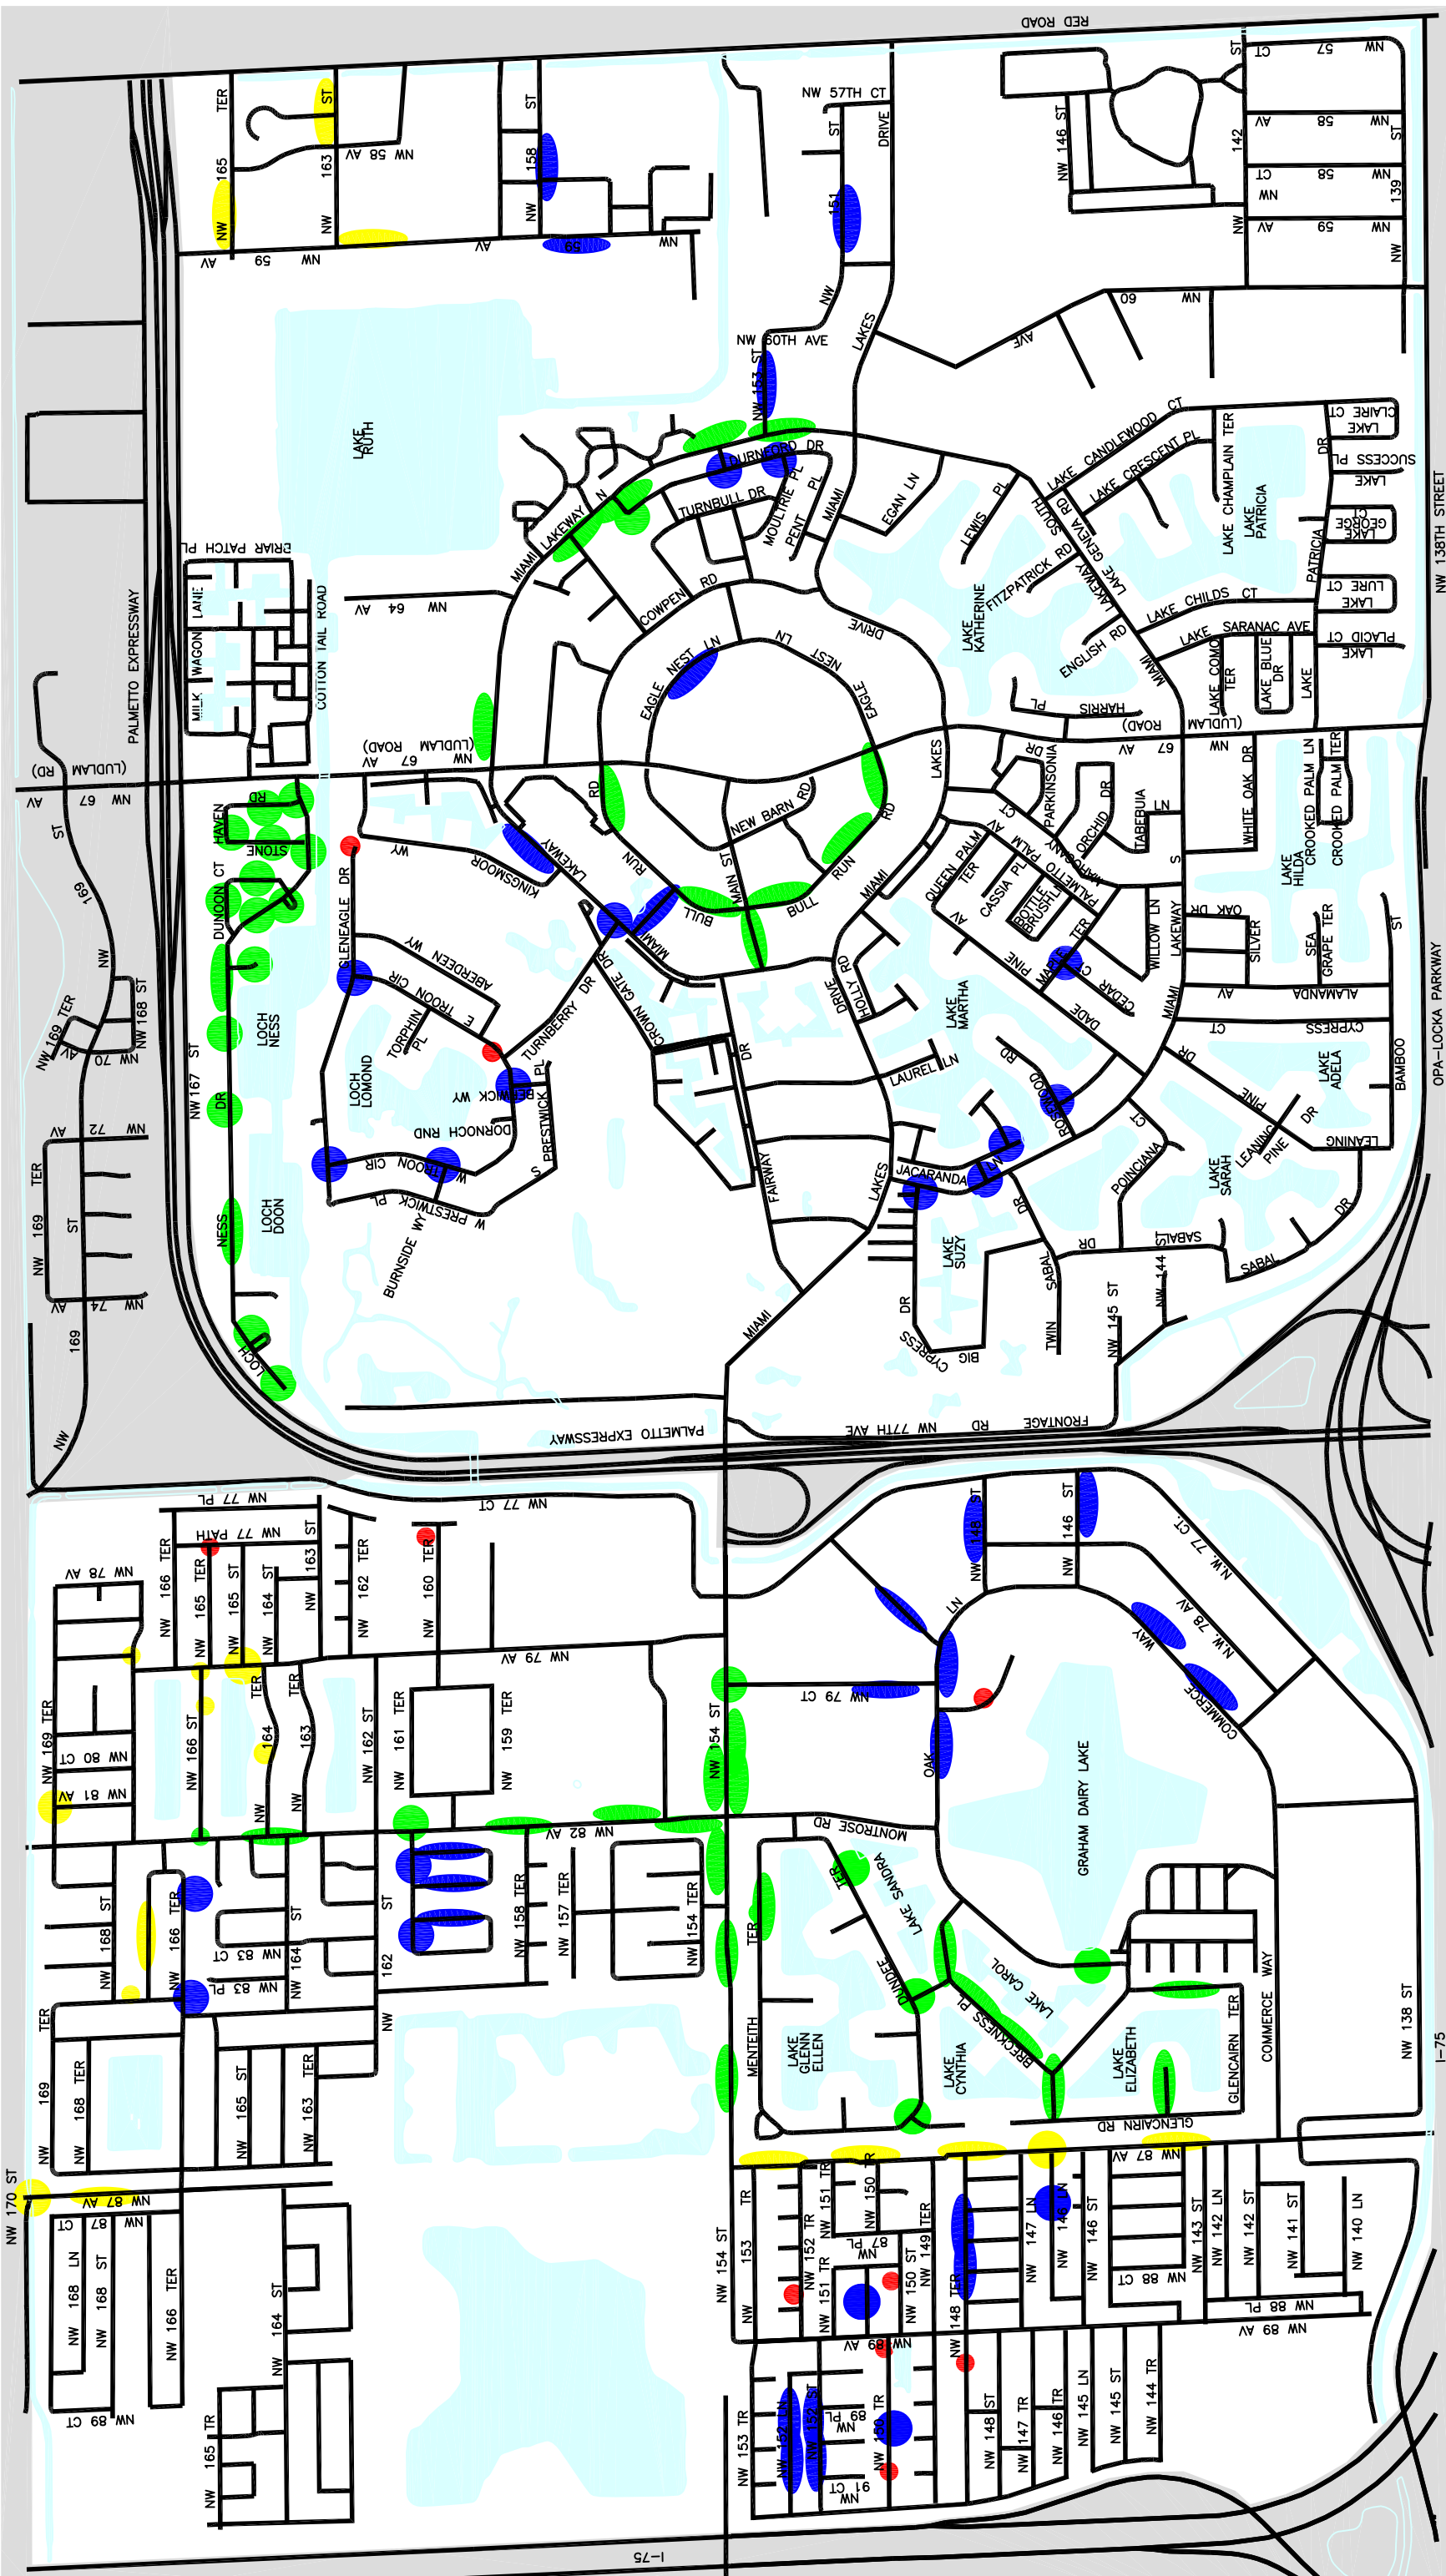
**Figure 36. Drainage Improvements**

The proposed CIP summary and schedule of work is contained in Table 18. Figure 36 shows the effect that the proposed projects would have on observed flooding areas and complaint areas throughout the Town. Table 19-34 detail the budgets for the recommended drainage improvements for each sub-basin based on the analysis described in the preceding sections of this report. Table 35 details the operations and maintenance budget. The projects are recommended to be coordinated with the roadway CIP project scheduling to insure that the drainage improvements are complete before or at the same time as the roadway improvements in the same area. This will require some adjustment to the roadway CIP schedule.
