MASTER PLAN

Update #1

Storm Water Master Plan Update #1

The Town of Miami Lakes,
Miami-Dade County, Florida

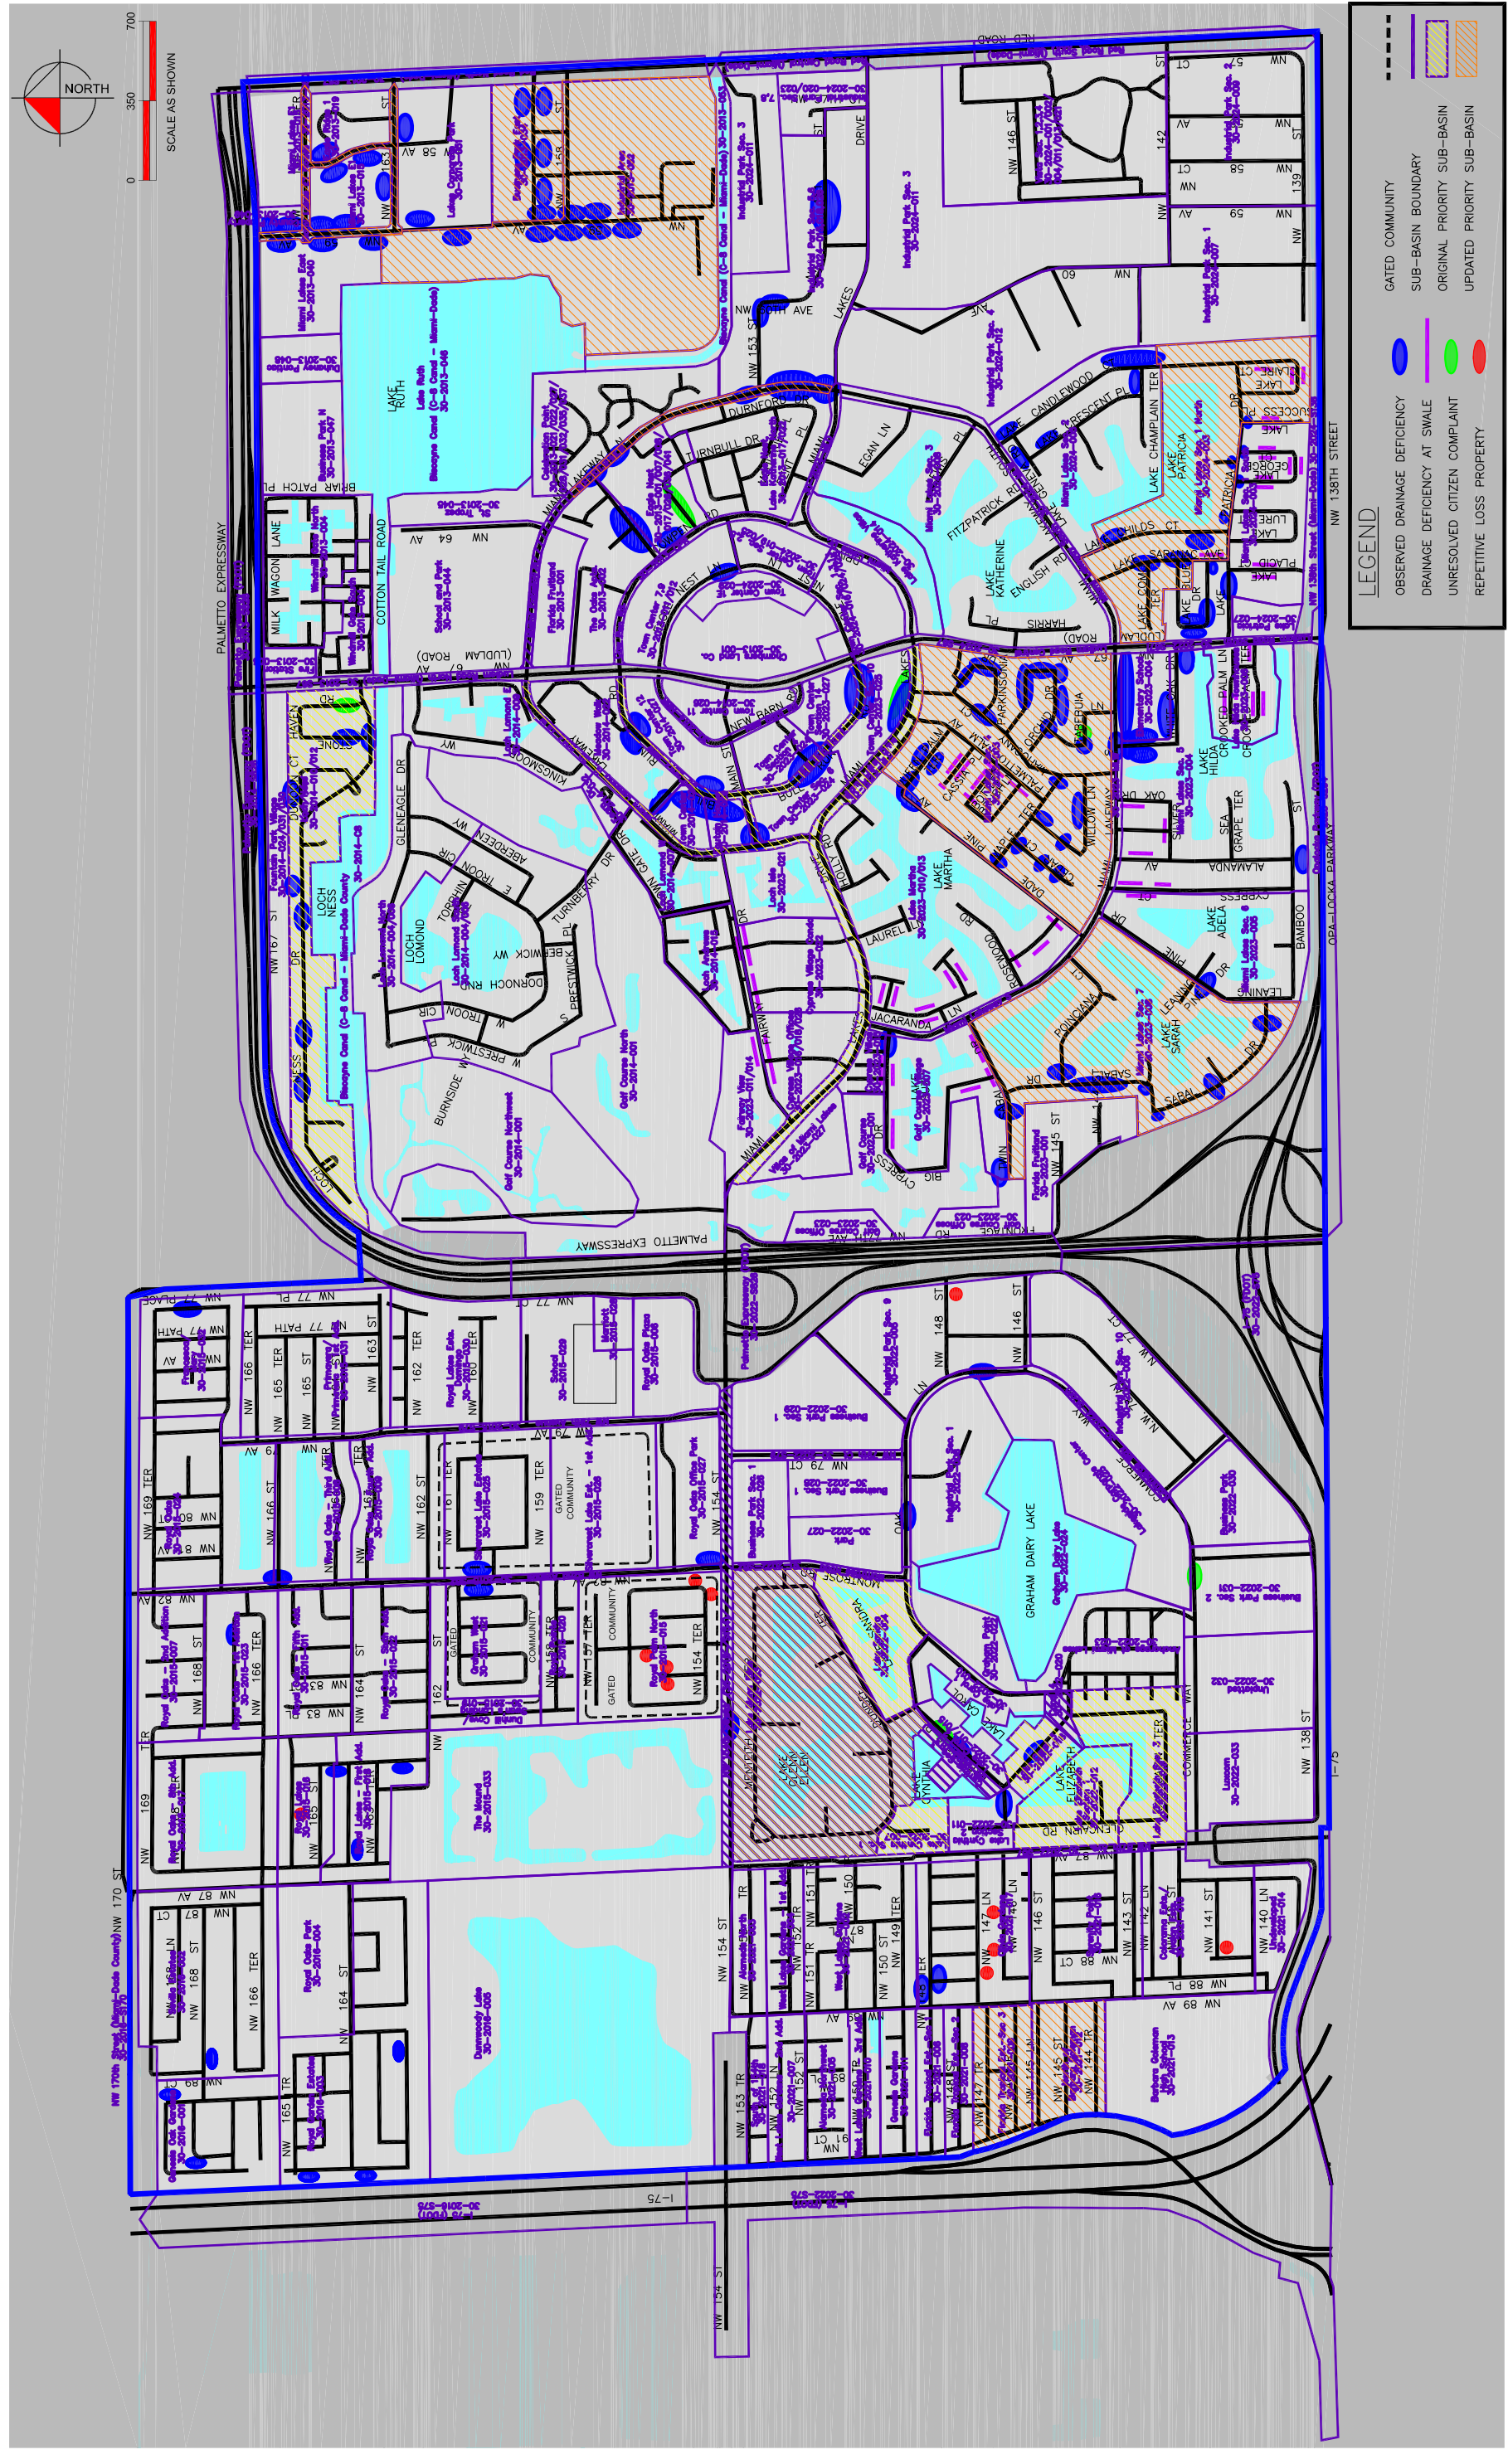
FIGURE 2. DRAINAGE DEFICIENCIES AND PRIORITY SUB-BASINS

The results of the field review can be seen in Figure 1. Based on this field review, it appears that some of the drainage deficiencies identified in the Town's original Storm Water Master Plan have been corrected by either improved maintenance by the Town or capital improvements projects completed by the Town under the Storm Water Utility or by Miami-Dade County under the FEMA/DORM program. However, there are still several areas within the Town where drainage deficiencies were observed.

Based on observed flooding, complaints, road conditions and the other parameters noted above, the Town selected sixteen sub-basins for more in depth study under the original Storm Water Master Plan. Since the time that the original Storm Water Master Plan was finalized, the Town of Miami Lakes has implemented drainage projects in six of the original sixteen priority sub-basins: Miami Lakeway North (construction completed), NW 154th Street (construction completed), NW 82nd Avenue (in design), Lake Glenn Ellen (under construction), Lake Cynthia Section 1 (under construction) and Lake Elizabeth Section 1 (construction completed). The drainage projects for which construction has been completed have already improved conditions in the areas that they serve. The projects that are either in design or under construction are anticipated to have the same effect once they are completed. Therefore, these six sub-basins have been removed from the drainage basin analysis section of this Storm Water Master Plan Update. The ten remaining priority sub-basins from the original Storm Water Master Plan and the eight new priority sub-basins identified as part of this Storm Water Master Plan Update are the subject of hydraulic and hydrologic analysis as part of this Storm Water Master Plan Update. The eight new sub-basins proposed for modeling are highlighted in Figure 2. They include: Lake Patricia, NE Industrial, Business Park East, Industrial Areas, Lake Martha, Olivia Gardens, South Miami Lakeway North, and Lake Sarah. In addition to modeling these eight new priority sub-basins, the budget information associated with the ten remaining capital improvement projects from the Town's original Storm Water Master Plan will be updated.

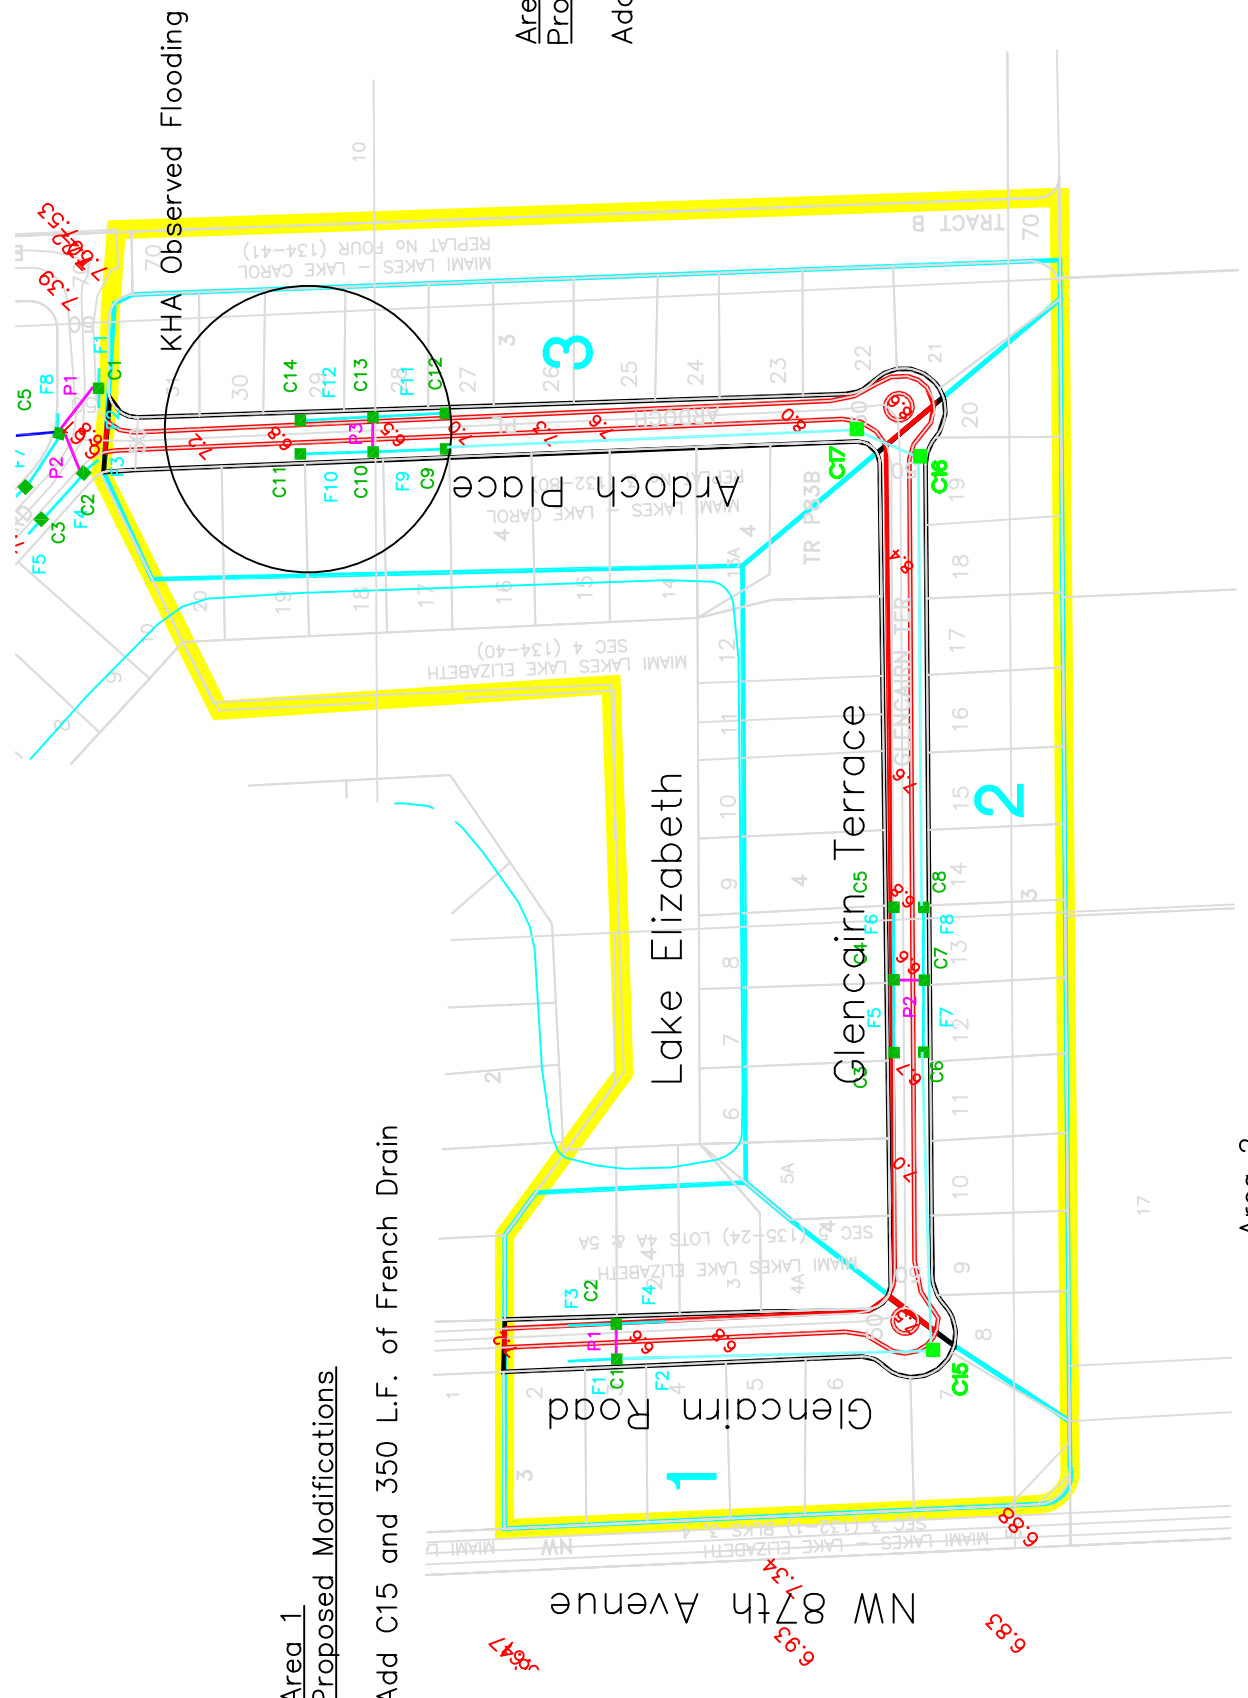
The existing exfiltration trench drainage system, if properly maintained, meets the water quality requirements in areas 1, 2 and 3. The lack of existing outfalls to provide positive drainage means that areas 1, 2, and 3 fail to meet water quality performance goals for the 5, 10, 25, and 100-year storm events.

Area 1
Proposed Modifications

Add C15 and 350 L.F. of French Drain

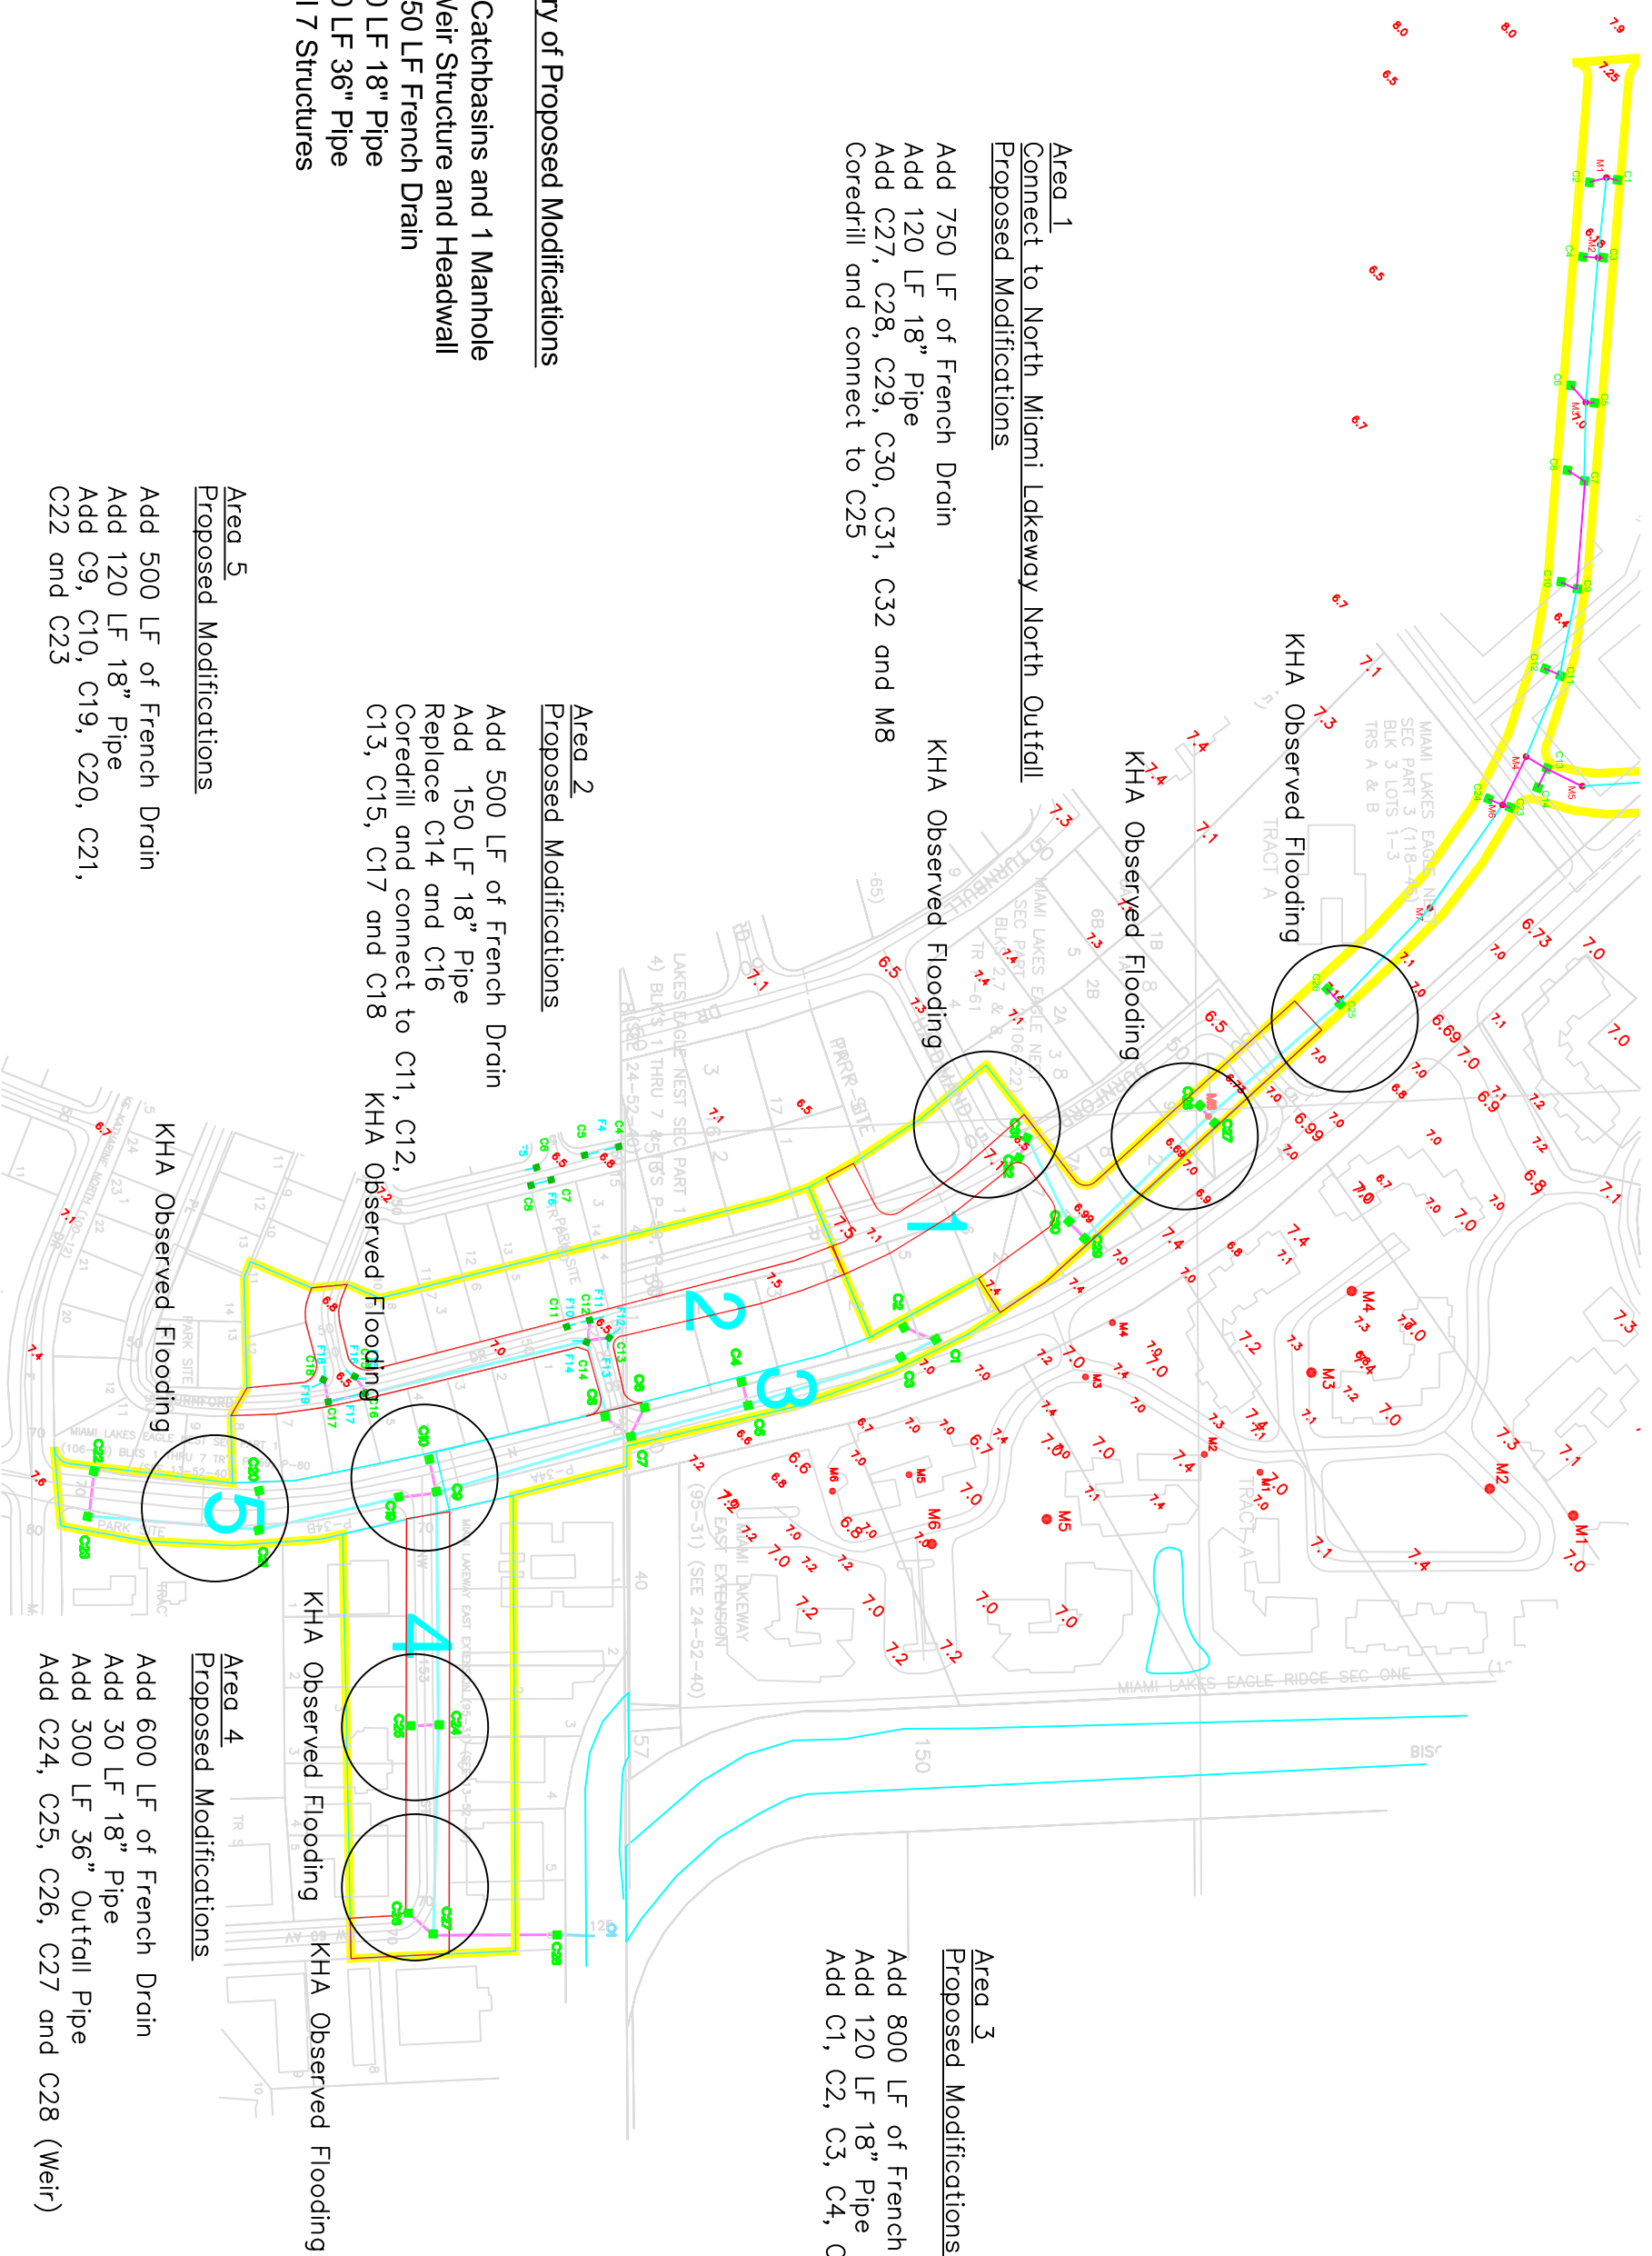
Figure 13.
 South Miami Lakeway North
 (30-2013-SMLN)

Figure 13 shows existing conditions for the South Miami Lakeway North Sub-basin. The sub-basin consists of approximately 4,100 linear feet of Miami Lakeway North NW 153rd Street, and Durnford

Drive roadway. It includes approximately 8.5 acres of road right-of-way. The existing roads range in elevation from a low of approximately 6.3 feet to a high of approximately 7.4 feet. The southern Miami Lakeway sub-basin is divided into five areas as shown in Figure 13. The availability of information on the existing roadway and storm drainage system is very limited. Plans could not be located in the Town or County records. From site observations the roadway areas appears to have few existing catchbasins and may have some existing exfiltration trench. There is no evidence of any existing outfalls or existing drainage wells.

Figure 13 notes proposed improvements proposed for the southern Miami Lakeway sub-basin. The Capital Improvements Program section of this report contains the budget for these proposed improvements.

Area 1
 Connect to North Miami Lakeway North Outfall
 Proposed Modifications

- Add 750 LF of French Drain
- Add 120 LF 18" Pipe
- Add C27, C28, C29, C30, C31, C32 and M8
- Coredrill and connect to C25

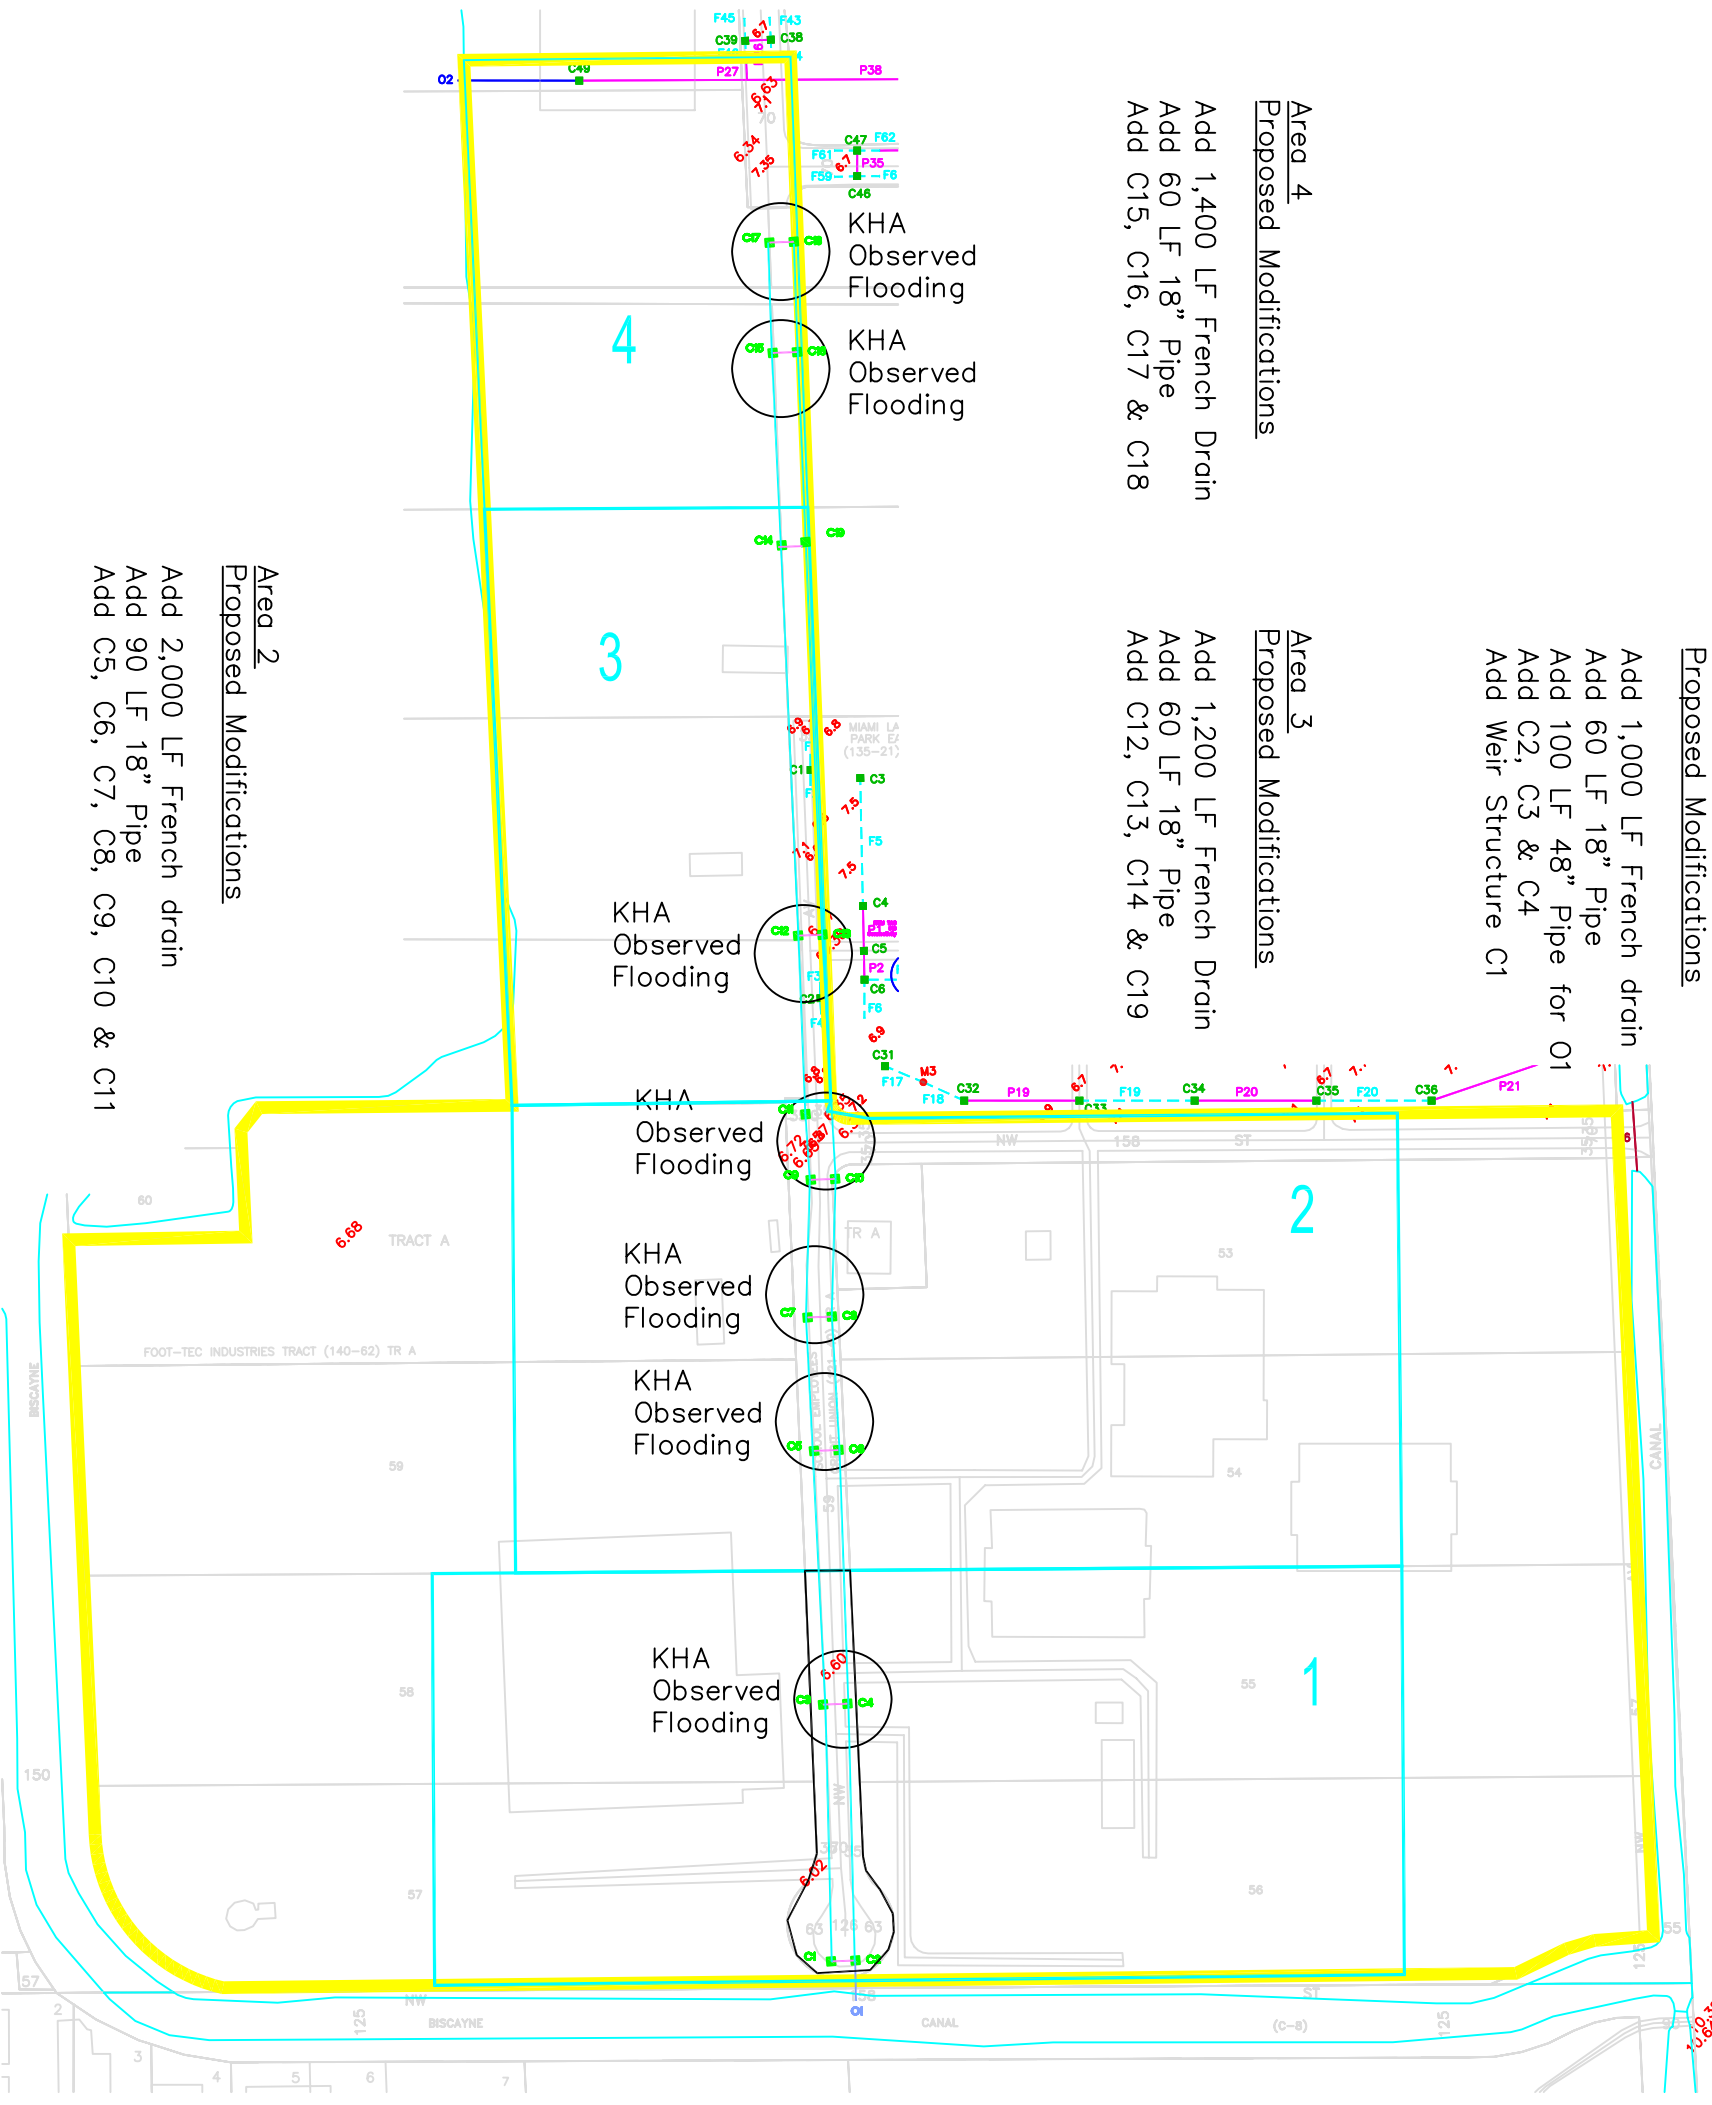
Inadequate Drainage Infrastructure: There are some low points in the roads which have existing catchbasin(s) and may have short sections of exfiltration trench, but no positive outfall. The capacity and performance of any existing exfiltration may be reduced due to sedimentation build up in the rock trenches and perforated pipes. Based on the observed ponding the existing catchbasins and short exfiltration trenches are inadequate.

Area 1
Proposed Modifications

- Add 1,000 LF French drain
- Add 60 LF 18" Pipe
- Add 100 LF 48" Pipe for 01
- Add C2, C3 & C4
- Add Weir Structure C1
