ADA TRANSITION PLAN

Sidewalks & Pedestrian Ramps

Town of Miami Lakes

SEPTEMBER 2015

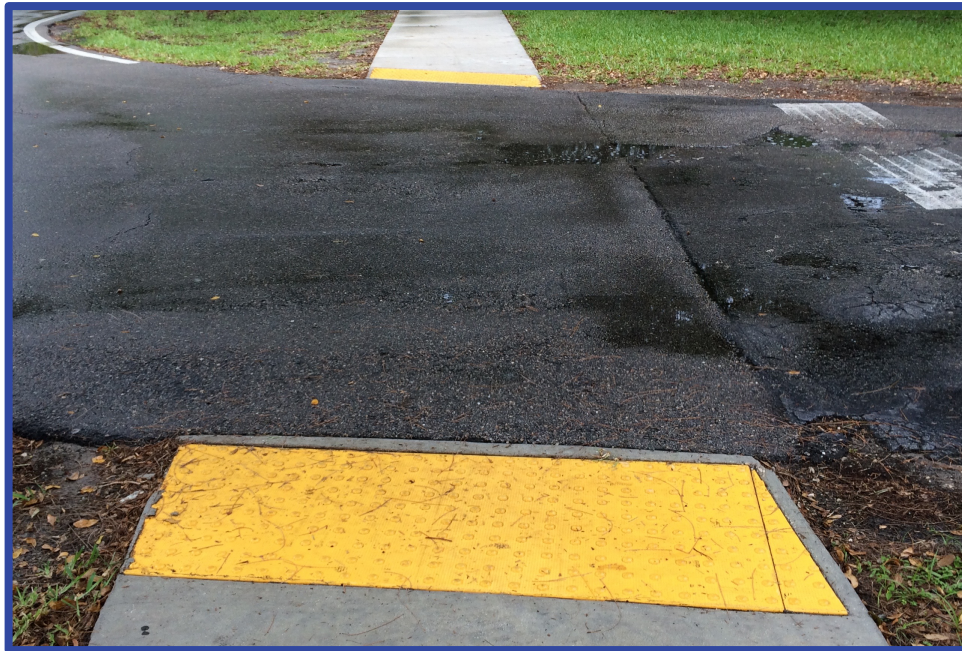
Figure 3 - Detectable Warning System

In general, most detectable warning systems are located at pedestrian ramps and along sidewalks that intersect driveways with sufficient volume such as those located by commercial/industrial centers or other facilities with numerous daily trips to the facility. A sample of a detectable warning system is shown in Figure 3.

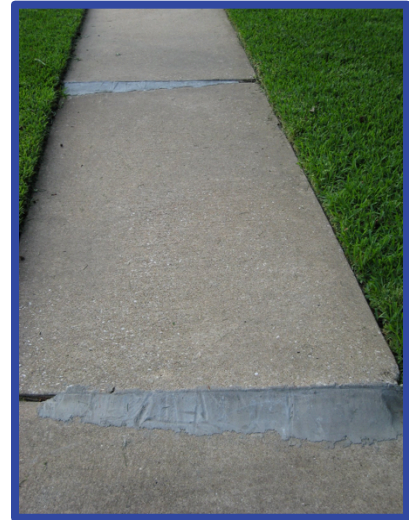
Figure 4 - Patching and Ramping

Patching and ramping is considered to be a quick and temporary repair method for addressing sidewalk heaves of less than ½ inch. This method uses concrete or asphalt to build a small fixed ramp on sidewalks and pedestrian ramps with heaves less than ½ inch. Ramping refers to the distance of the concrete or asphalt that is poured in order to maintain the allowable longitudinal or cross slope of the sidewalk or pedestrian ramp and address the accessibility barrier. Figure 4 shows an example of patching and ramping. New concrete typically adheres best to existing concrete by adding a bonding agent to the mix or by placing a bonding agent prior to placing the new concrete patch.

Patching and ramping is not a preferred remedial solution due to its typically short lifespan that is associated with the bond strength of the patch to the existing concrete and the ramped section's susceptibility to cracking and chipping. Additionally, concrete or asphalt patching on sidewalks and pedestrian ramps can be considered unattractive and can result in negative feedback from residents.

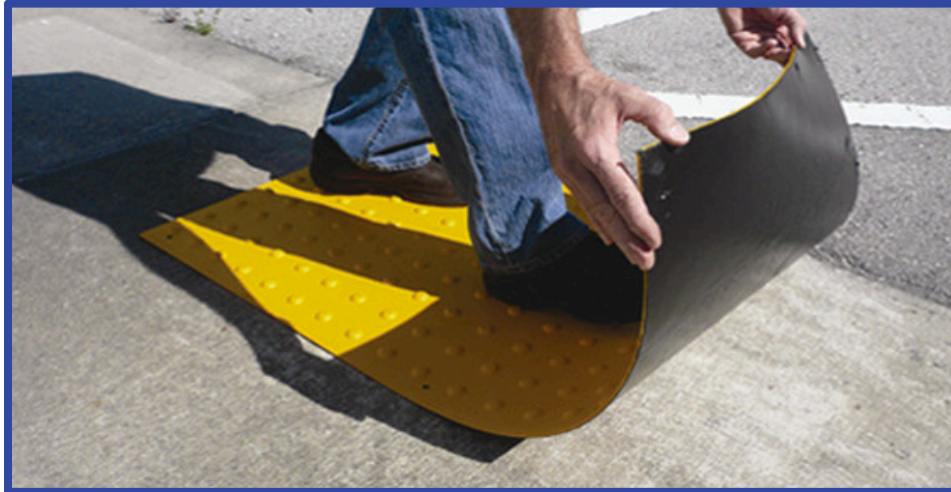
Figure 5 - Detectable Warning Installation

crossings. The most feasible solution for resolving this deficiency is to utilize detectable warning mats that can be adhered to an existing concrete surface using either an epoxy bonding agent or the mats pre-applied adhesive and a mechanical attachment using anchors drilled into the concrete. It should be noted that the concrete must be in good condition with no cracks or preexisting seams and the surface must be thoroughly cleaned to maximize adherence.
